## BUILDING DIAGNOSTICS INSPECTION

**CLIENT:** Enlightened Management

**ADDRESS:** 1000 Main Street  
Bethesda, MD

# Building Diagnostic Evaluation of Enlightened Towers

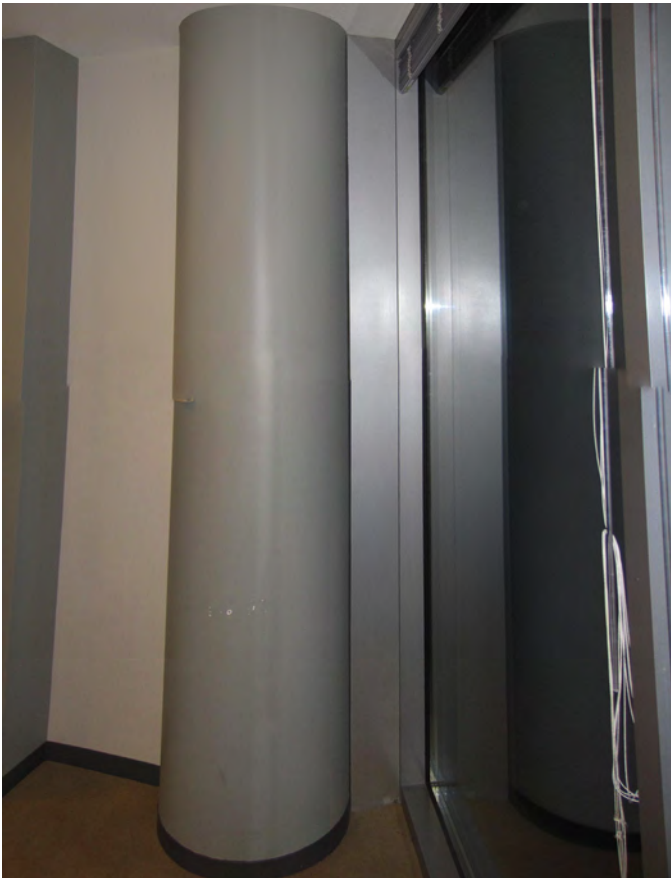
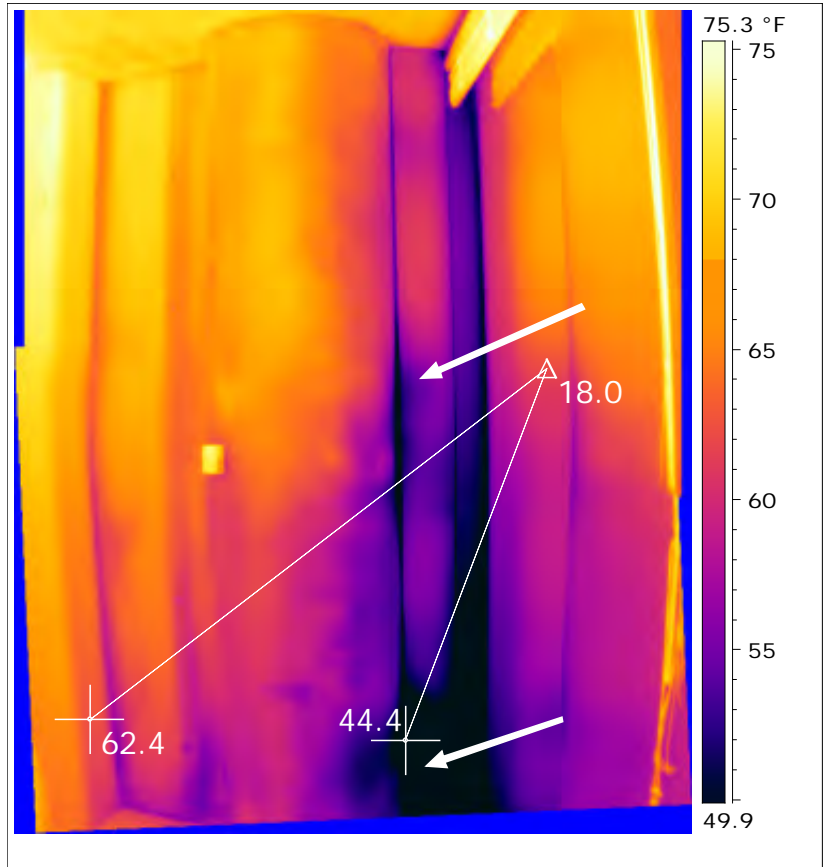
<b>CLIENT</b>	Enlightened Management	<b>BUILDING</b>	Enlightened	<b>PROBLEM #</b>	1
<b>FLOOR</b>	2	<b>ROOM</b>	2036	<b>WALL ORIENTATION</b>	North
<b>LOCATION ALONG WALL</b>	West end		<b>ADDITIONAL LOCATION</b>

**PROBLEM DESCRIPTION** Cold temperatures are present at the bottom of this column. Infiltration into the room occurs at the two areas (see arrows). This column extends through a soffit and then to ground, on the building exterior. Air infiltration into the columns may be occurring at the column base cover or the underlying soffit.

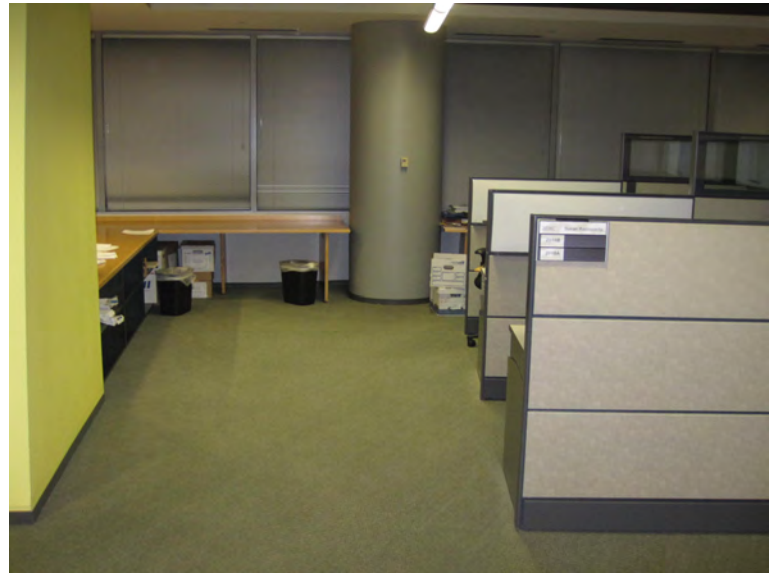
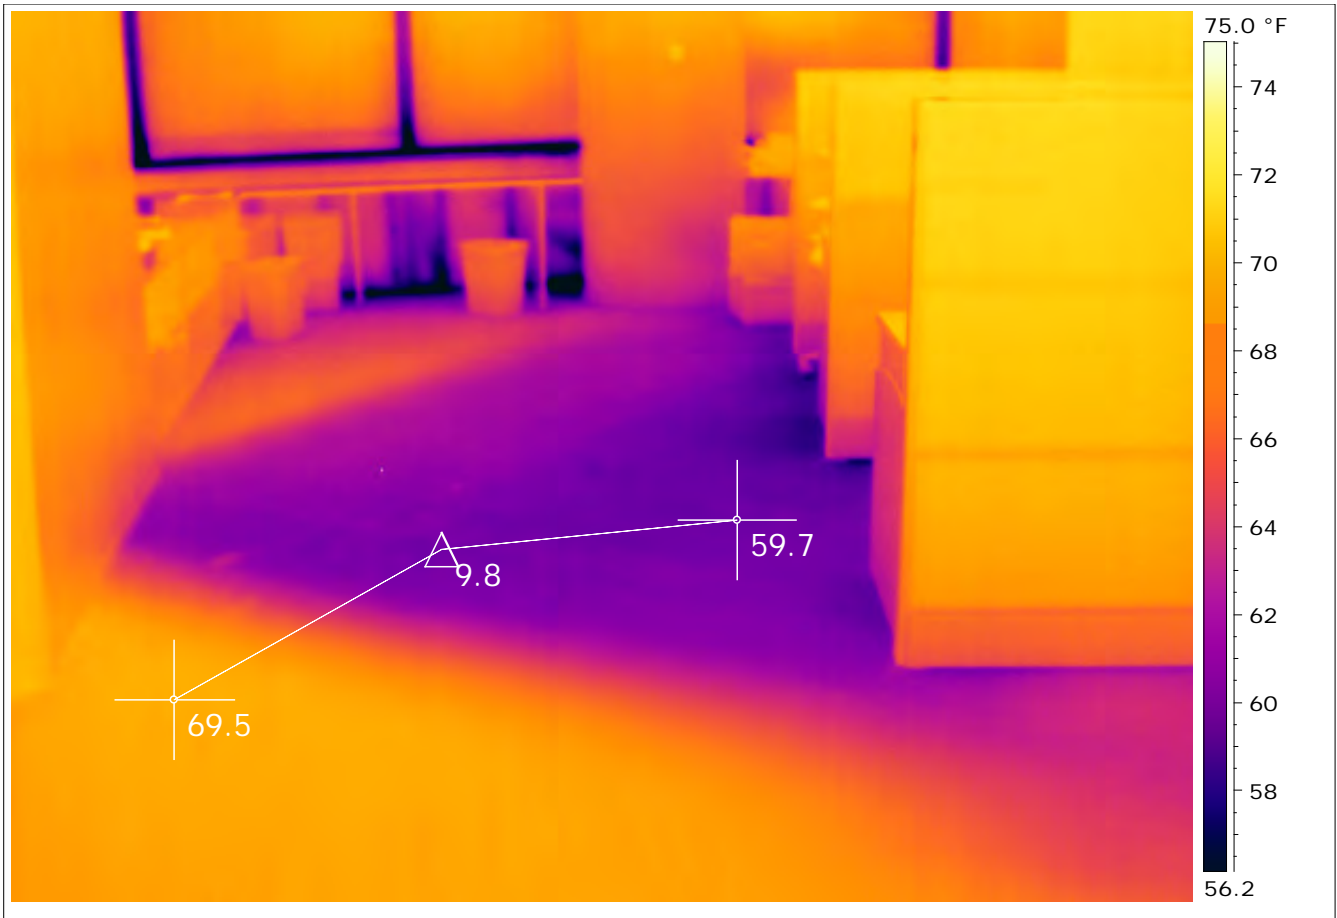
<b>CLIENT</b>	Enlightened Management	<b>BUILDING</b>	Enlightened	<b>PROBLEM #</b>	2
<b>FLOOR</b>	2	<b>ROOM</b>	2018C	<b>WALL ORIENTATION</b>	East
<b>LOCATION ALONG WALL</b>	North end		<b>ADDITIONAL LOCATION</b>

**PROBLEM DESCRIPTION** A soffit and loading dock area runs from this location around to the entrance bridge. The floor over this area is sharply colder as a result of air infiltration into the soffit area. This area must be sealed and/or insulated.

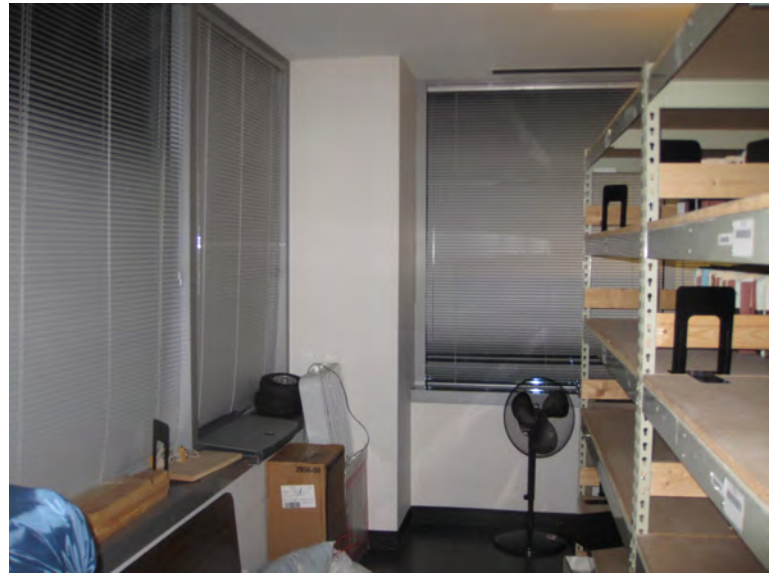
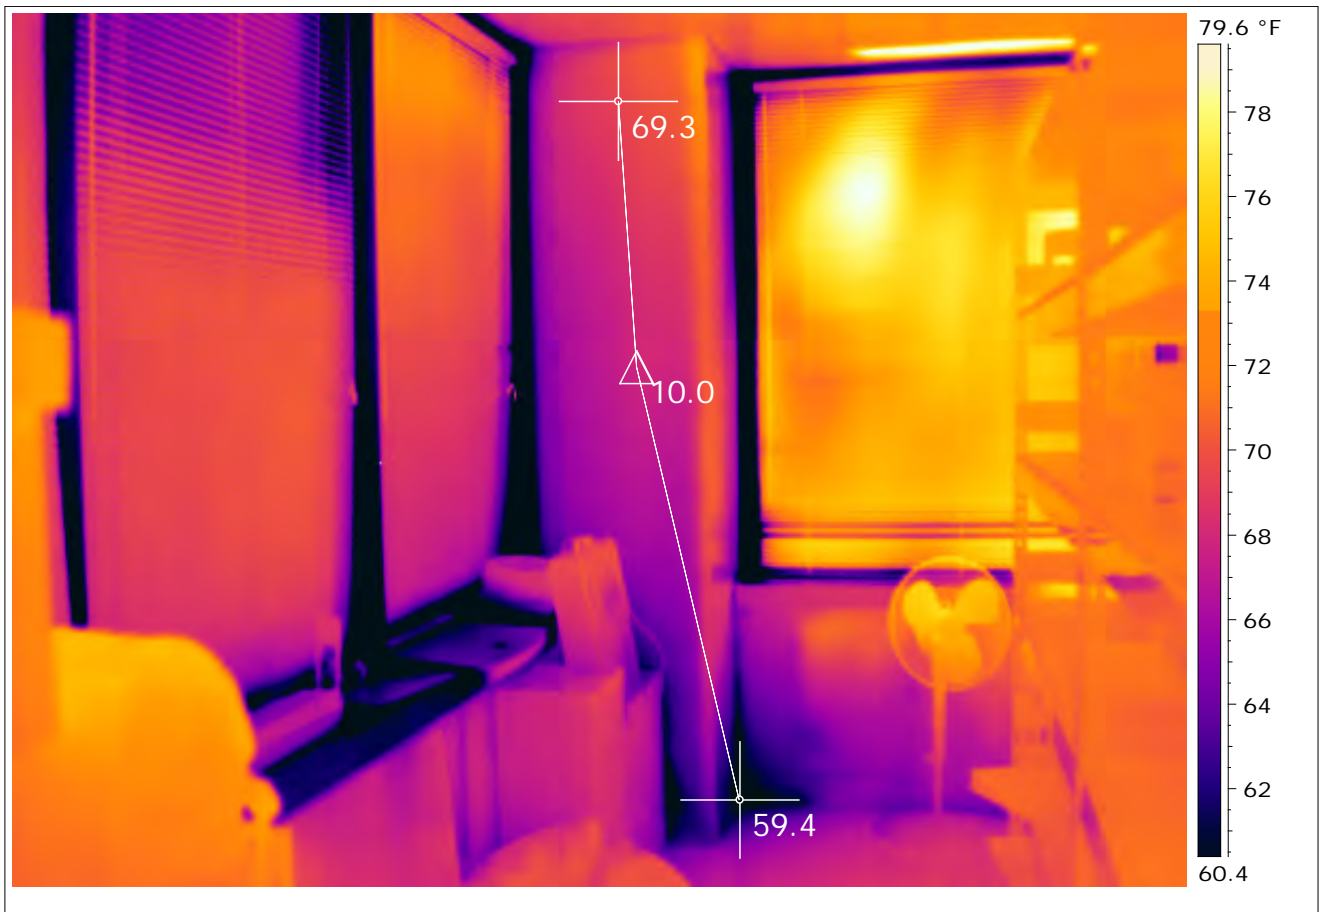
<b>CLIENT</b>	Enlightened Management	<b>BUILDING</b>	Enlightened	<b>PROBLEM #</b>	4
<b>FLOOR</b>	2	<b>ROOM</b>	File room	<b>WALL ORIENTATION</b>	South
<b>LOCATION ALONG WALL</b>	East end	<b>ADDITIONAL LOCATION</b>

**PROBLEM DESCRIPTION** Cold temperatures are present at the base of the column. Infiltration from the exterior column base is likely.

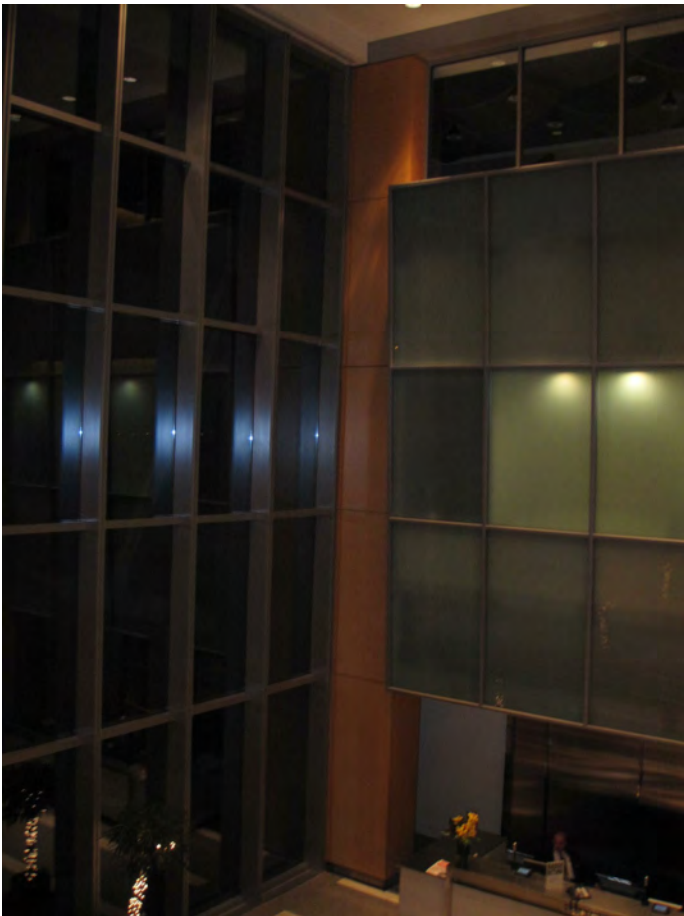
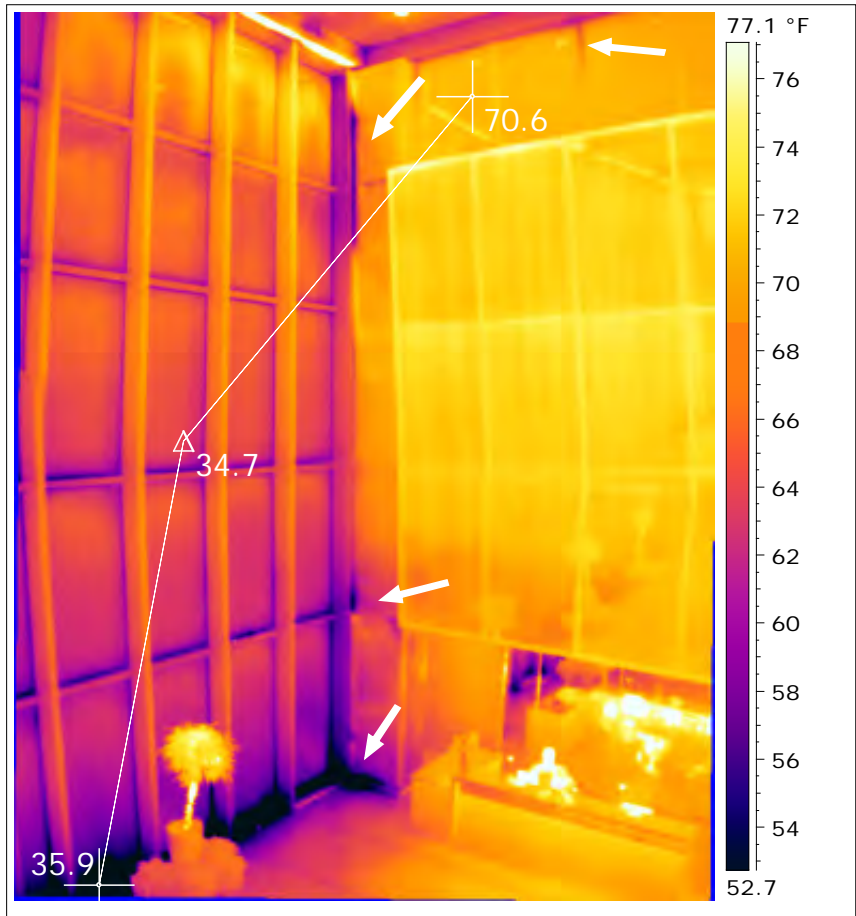
<b>CLIENT</b>	Enlightened Management	<b>BUILDING</b>	Enlightened	<b>PROBLEM #</b>	5
<b>FLOOR</b>	1	<b>ROOM</b>	Lobby by guard desk	<b>WALL ORIENTATION</b>	West
<b>LOCATION ALONG WALL</b>	Center		<b>ADDITIONAL LOCATION</b>

**PROBLEM DESCRIPTION** Six exterior columns are located outside the atrium. The columns run from ground level and terminate in a soffit at the top of the 3<sup>rd</sup> floor. The columns tie into the floor level of the atrium through a horizontal bridge structure. The north most column ties into the wood covered vertical bulkhead shown here. Air infiltrates into the column and flows into the wood covered bulkhead through the horizontal bridge structure. The air travels up the bulkhead and into the horizontal beam at the top of the atrium. The air flows into the adjacent office area in the ceiling. Arrows show infiltration from the bulkhead and beam into the atrium. Infiltrating air from the columns is likely flowing laterally, along the base of the glazing in a louvered structure at floor level, producing extremely low temperatures,

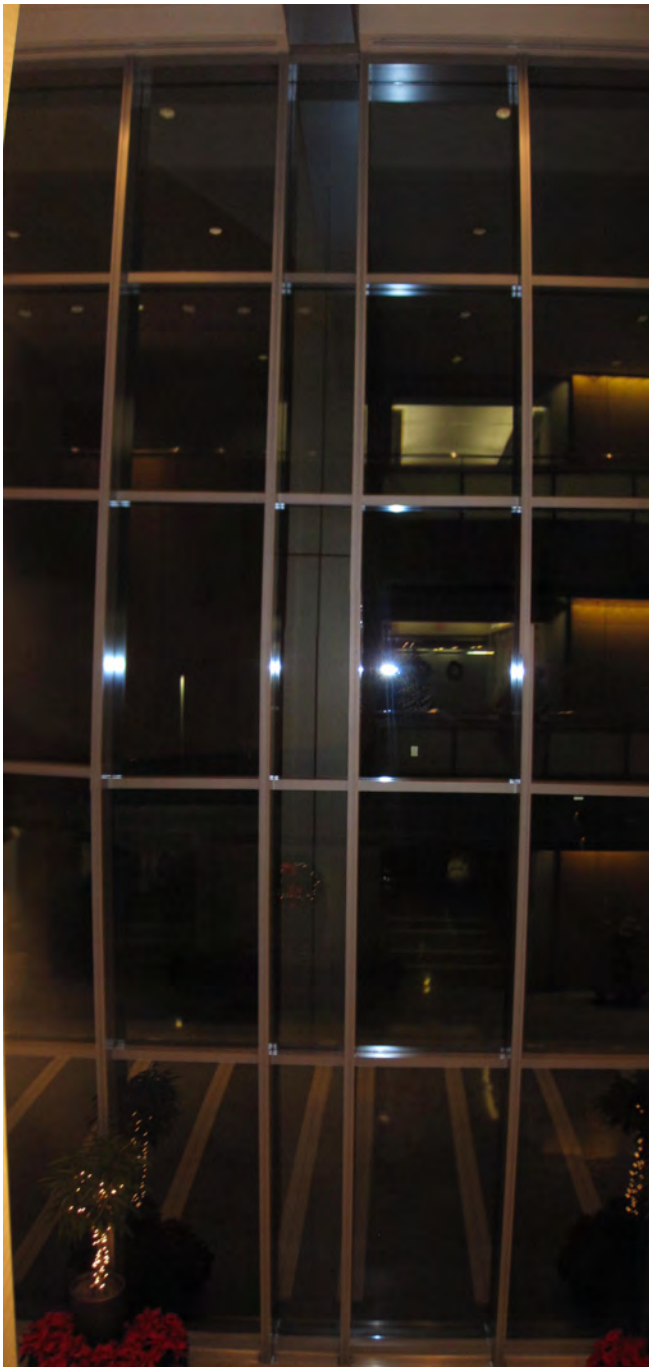
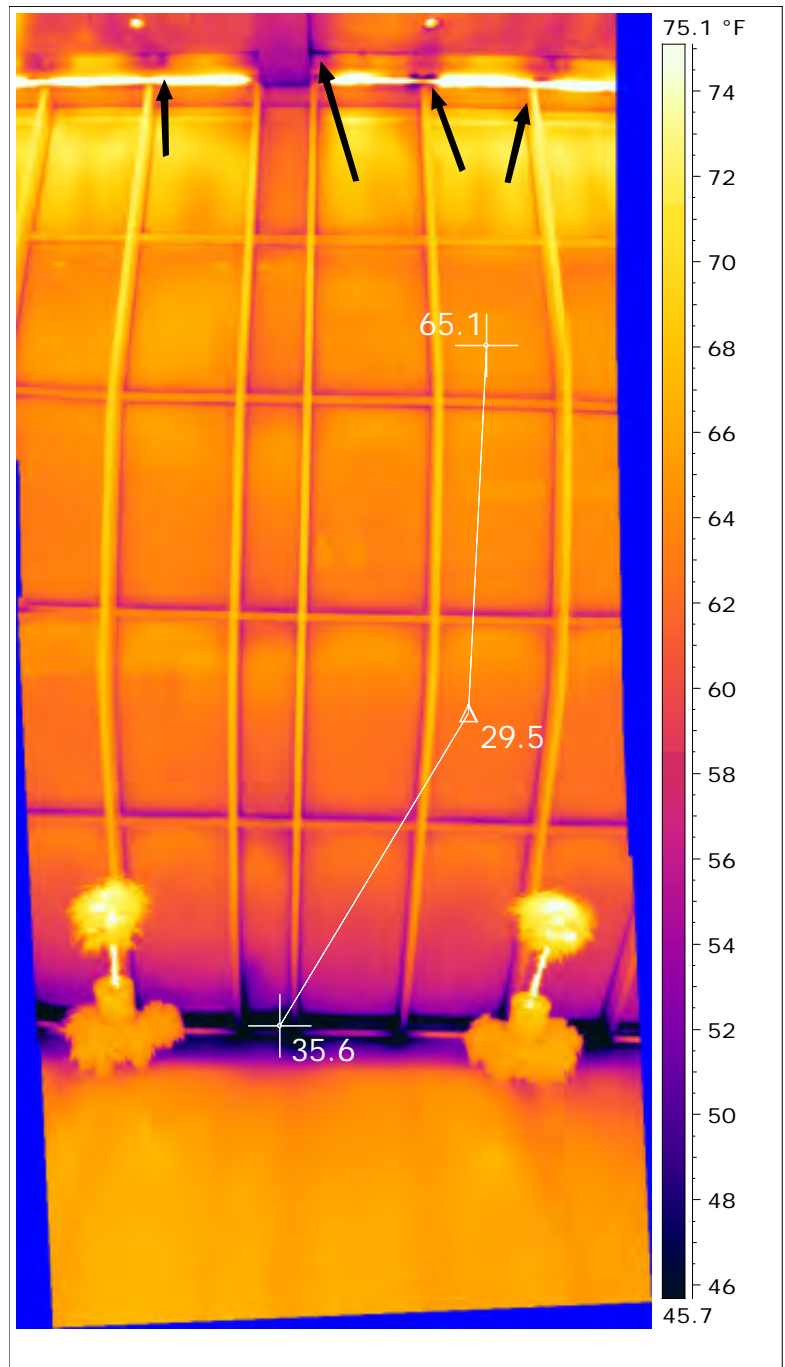
<b>CLIENT</b>	Enlightened Management	<b>BUILDING</b>	Enlightened	<b>PROBLEM #</b>	6
<b>FLOOR</b>	1	<b>ROOM</b>	Lobby. column A7	<b>WALL ORIENTATION</b>	West
<b>LOCATION ALONG WALL</b>	Center		<b>ADDITIONAL LOCATION</b>

**PROBLEM DESCRIPTION** This image shows the impact of column A7. Infiltration occurs at floor level from the horizontal bridge structure. This produces very low temperatures at floor level. The column terminates at a soffit area. Infiltration from the column and/or soffit is causing cold air to enter the building at the atrium ceiling. Infiltration is seen at the enclosed beams and along the glazing reveal (black arrows). This air can be seen flowing above the ceiling and entering adjacent conditioned spaces.

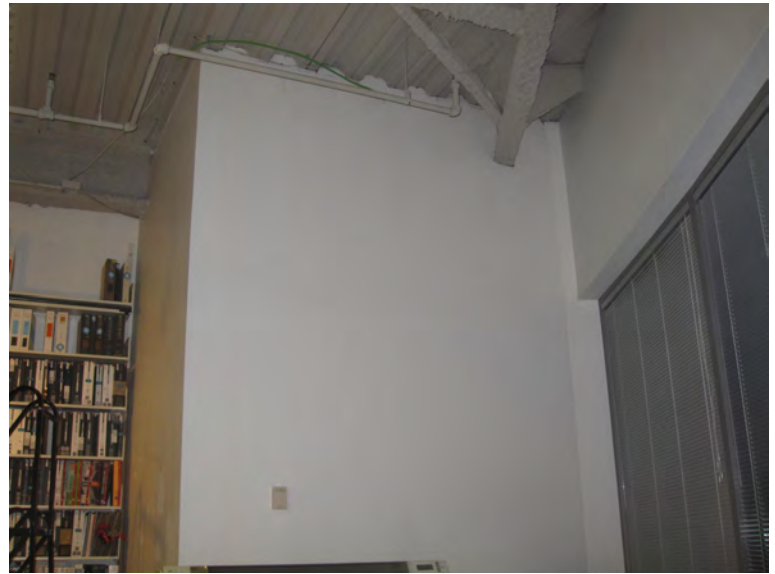
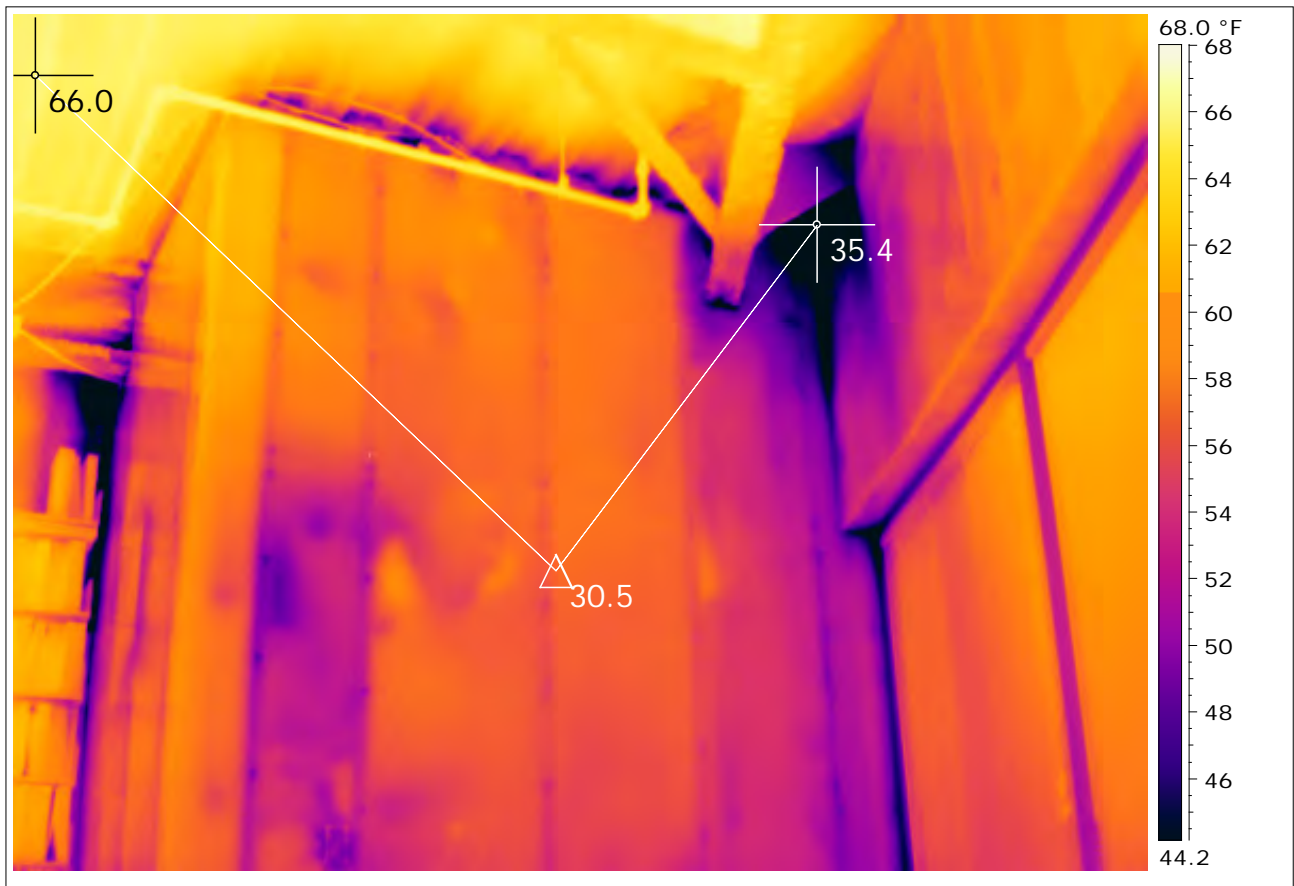
<b>CLIENT</b>	Enlightened Management	<b>BUILDING</b>	Enlightened	<b>PROBLEM #</b>	7
<b>FLOOR</b>	1	<b>ROOM</b>	Suite 101	<b>WALL ORIENTATION</b>	South
<b>LOCATION ALONG WALL</b>	East end		<b>ADDITIONAL LOCATION</b>

**PROBLEM DESCRIPTION** This bulkhead is part of the entry vestibule at the end of the bridge on the east side of the building. The east elevation on floors 1-3 forms a semi-circle. The bottom of the 2<sup>nd</sup> floor of this area is soffit and loading dock. This soffit has produced infiltration problems that have resulted in tenant complaints. Infiltration from the soffit appears to flow into suite 101 through this bulkhead. Substantial volumes of air are flowing into the space: Infiltration velocity at this corner was measured to be 381 fpm.

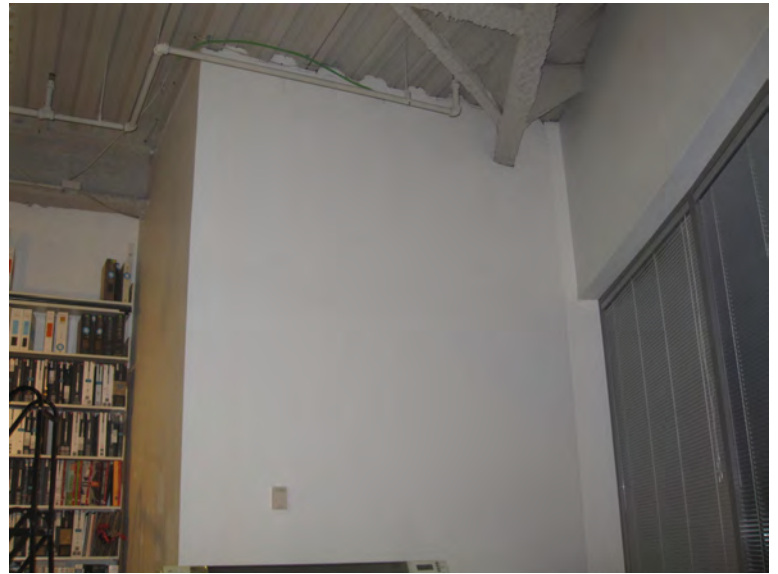
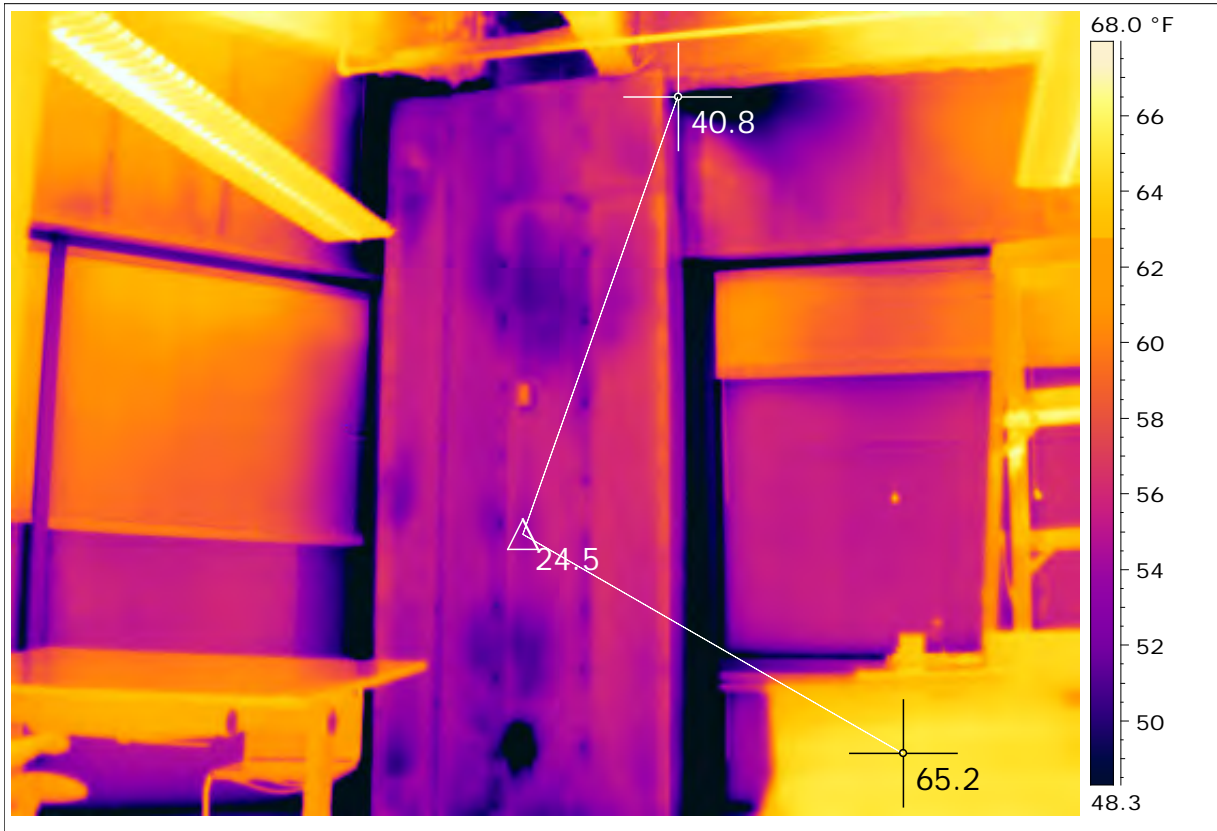
<b>CLIENT</b>	Enlightened Management	<b>BUILDING</b>	Enlightened	<b>PROBLEM #</b>	8
<b>FLOOR</b>	1	<b>ROOM</b>	Suite 101	<b>WALL ORIENTATION</b>	South
<b>LOCATION ALONG WALL</b>	East end		<b>ADDITIONAL LOCATION</b>	S.E. column

**PROBLEM DESCRIPTION** Infiltration is seen at the top of the column bulkhead. The column enclosure is open both to the interior and the back of the precast. The infiltration source may be the 2nd floor roof parapet.

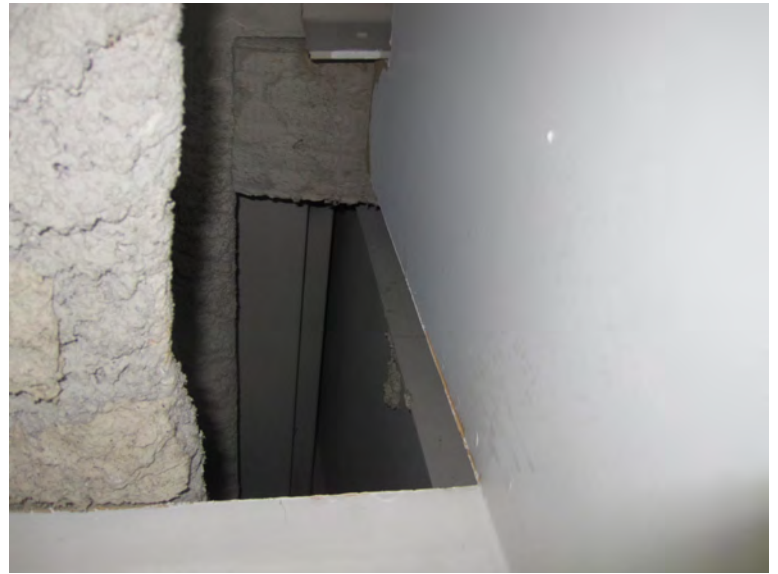
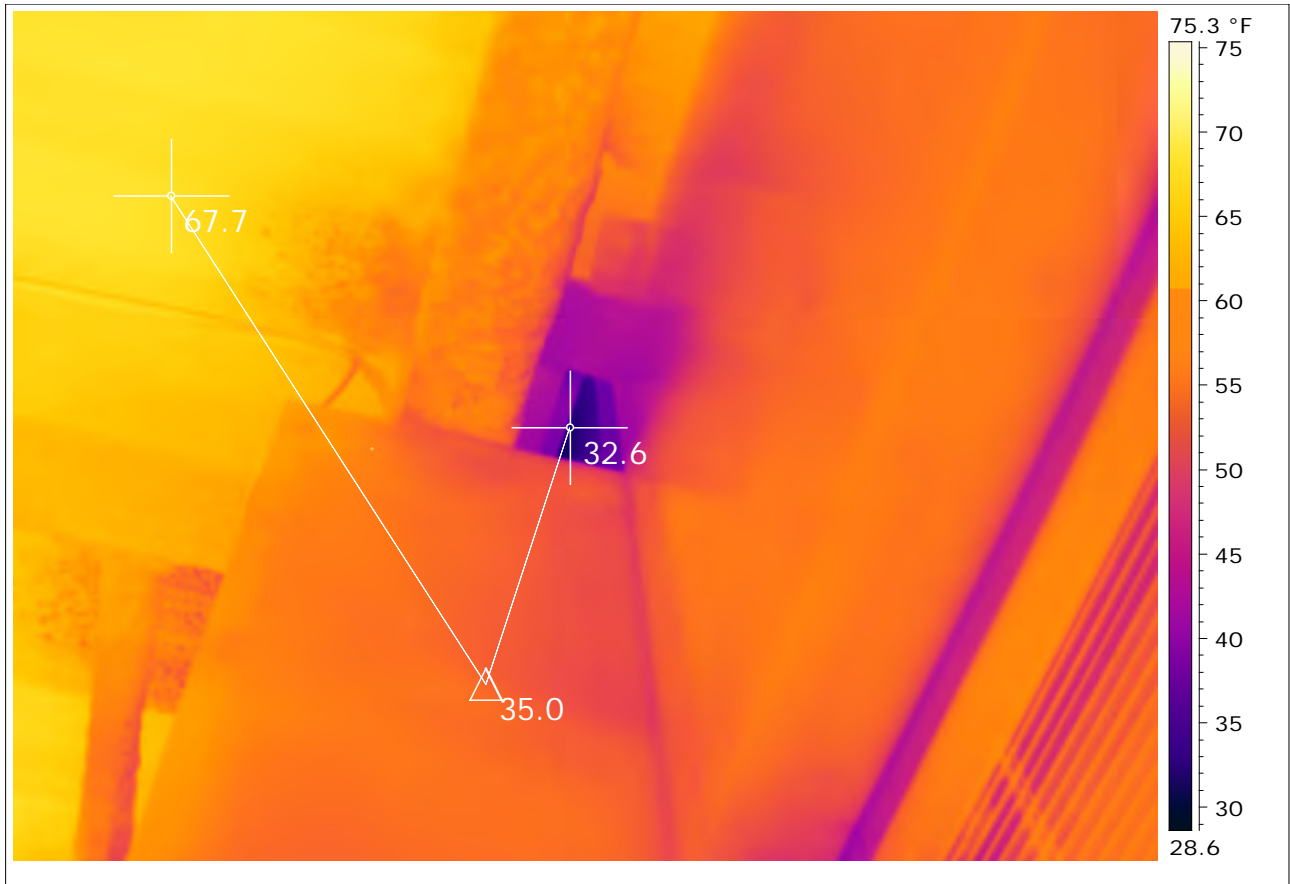
<b>CLIENT</b>	Enlightened Management	<b>BUILDING</b>	Enlightened	<b>PROBLEM #</b>	9
<b>FLOOR</b>	1	<b>ROOM</b>	Suite 101	<b>WALL ORIENTATION</b>	South
<b>LOCATION ALONG WALL</b>	East end		<b>ADDITIONAL LOCATION</b>	S.E. Column

**PROBLEM DESCRIPTION** Top of column bulkhead shown in problem 8. The back of the precast is visible. A strong down ward air flow can be felt at the open metal edge on the right.

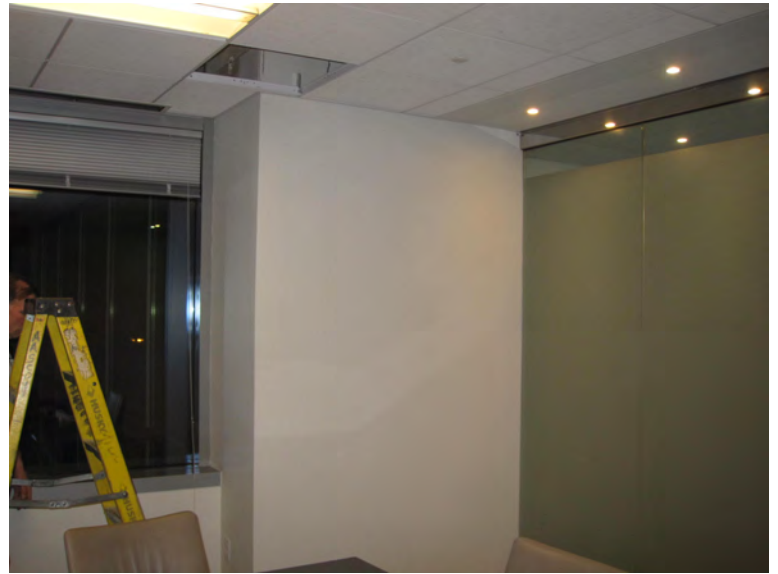
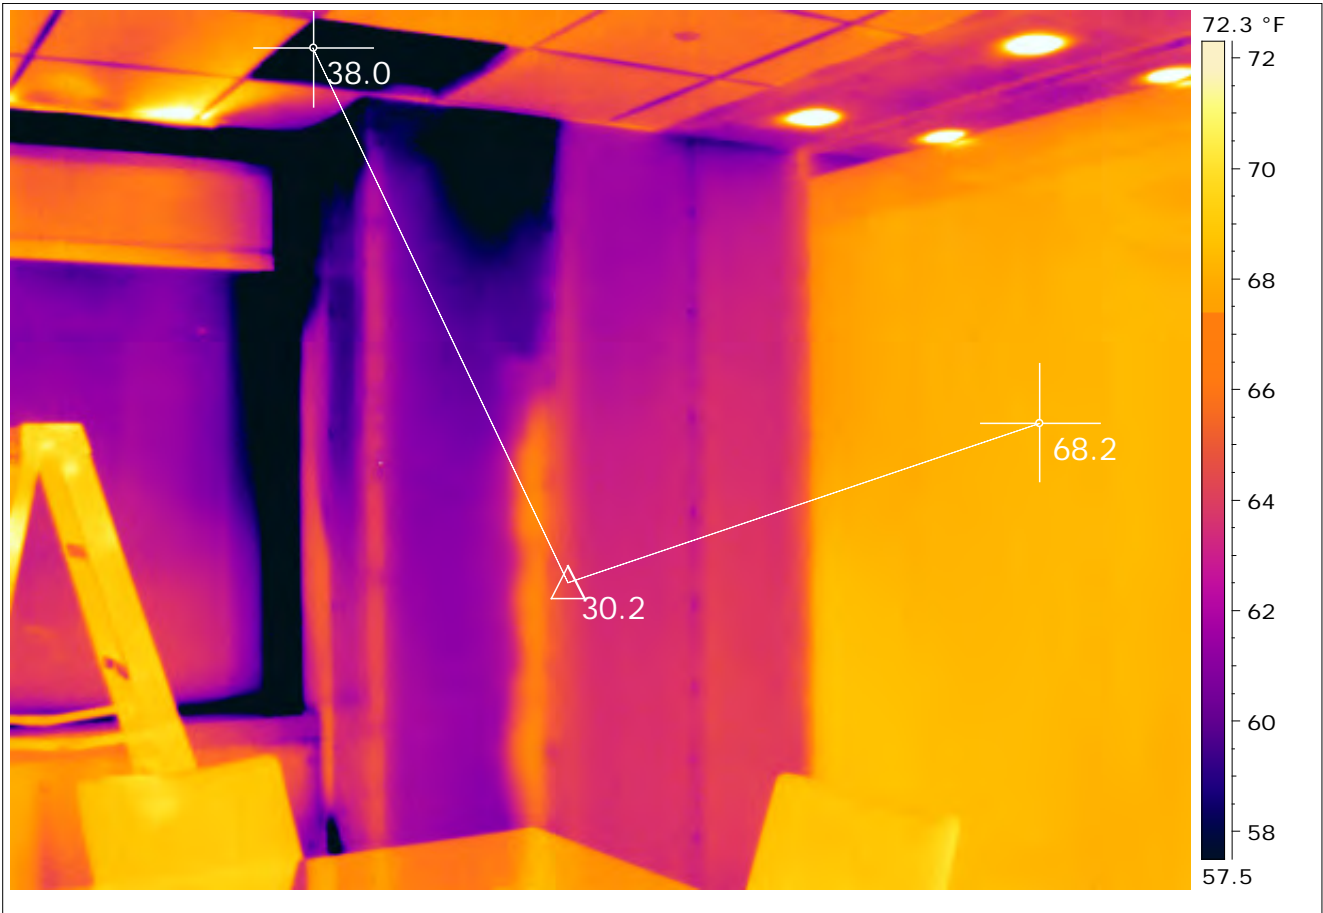
<b>CLIENT</b>	Enlightened Management	<b>BUILDING</b>	Enlightened	<b>PROBLEM #</b>	10
<b>FLOOR</b>	3	<b>ROOM</b>	Conference room 3F	<b>WALL ORIENTATION</b>	West
<b>LOCATION ALONG WALL</b>	South end	<b>ADDITIONAL LOCATION</b>

**PROBLEM DESCRIPTION** Cold air is present at this interior column bulkhead. This bulkhead is open to the soffit that extends from the atrium ceiling. Infiltrating air from the soffit is flowing into this bulkhead.

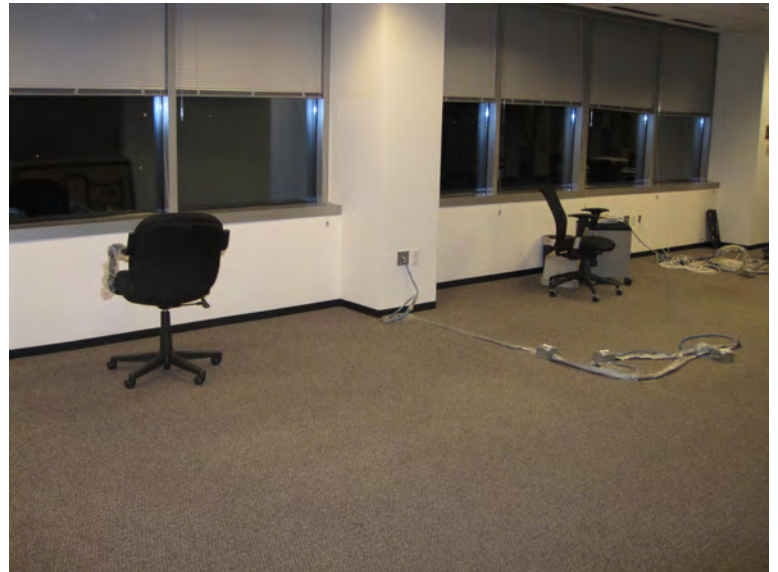
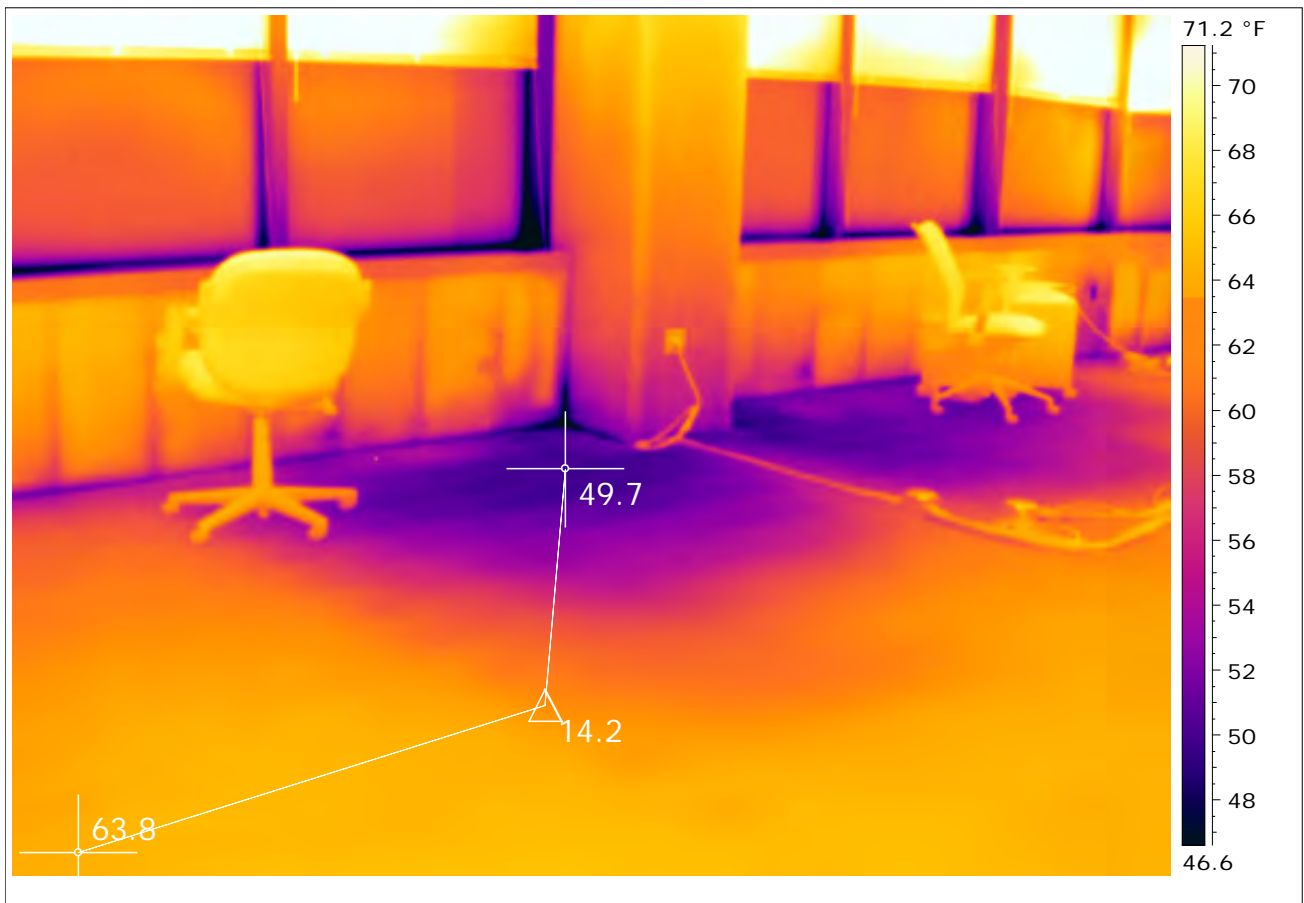
<b>CLIENT</b>	Enlightened Management	<b>BUILDING</b>	Enlightened	<b>PROBLEM #</b>	11
<b>FLOOR</b>	4	<b>ROOM</b>	A7 column	<b>WALL ORIENTATION</b>	West
<b>LOCATION ALONG WALL</b>	Center		<b>ADDITIONAL LOCATION</b>

**PROBLEM DESCRIPTION** This floor area is located above the soffit on the west side of the atrium. This column extends to ground level and is a likely infiltration conduit. The floor around the columns are cooled by air traveling up the columns or entering at the soffit and impinging on the bottom of the pan deck. The infiltrating air then mixes with the return air in the ceiling plenum.

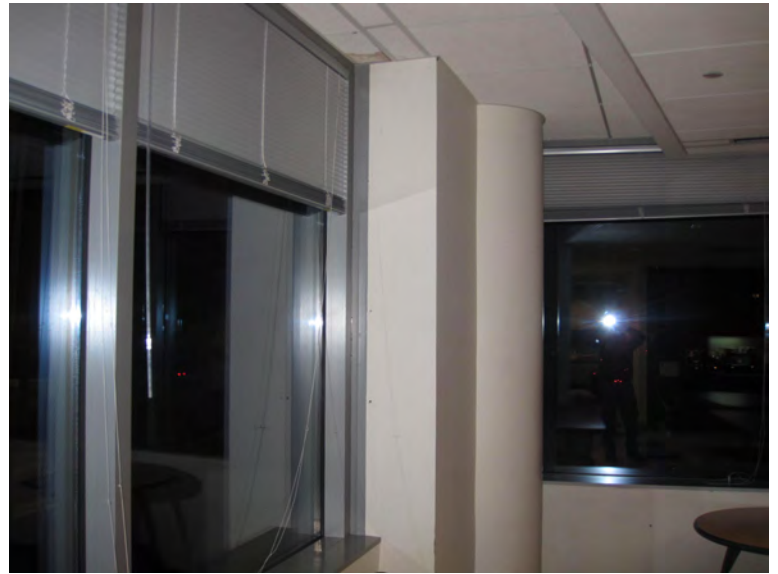
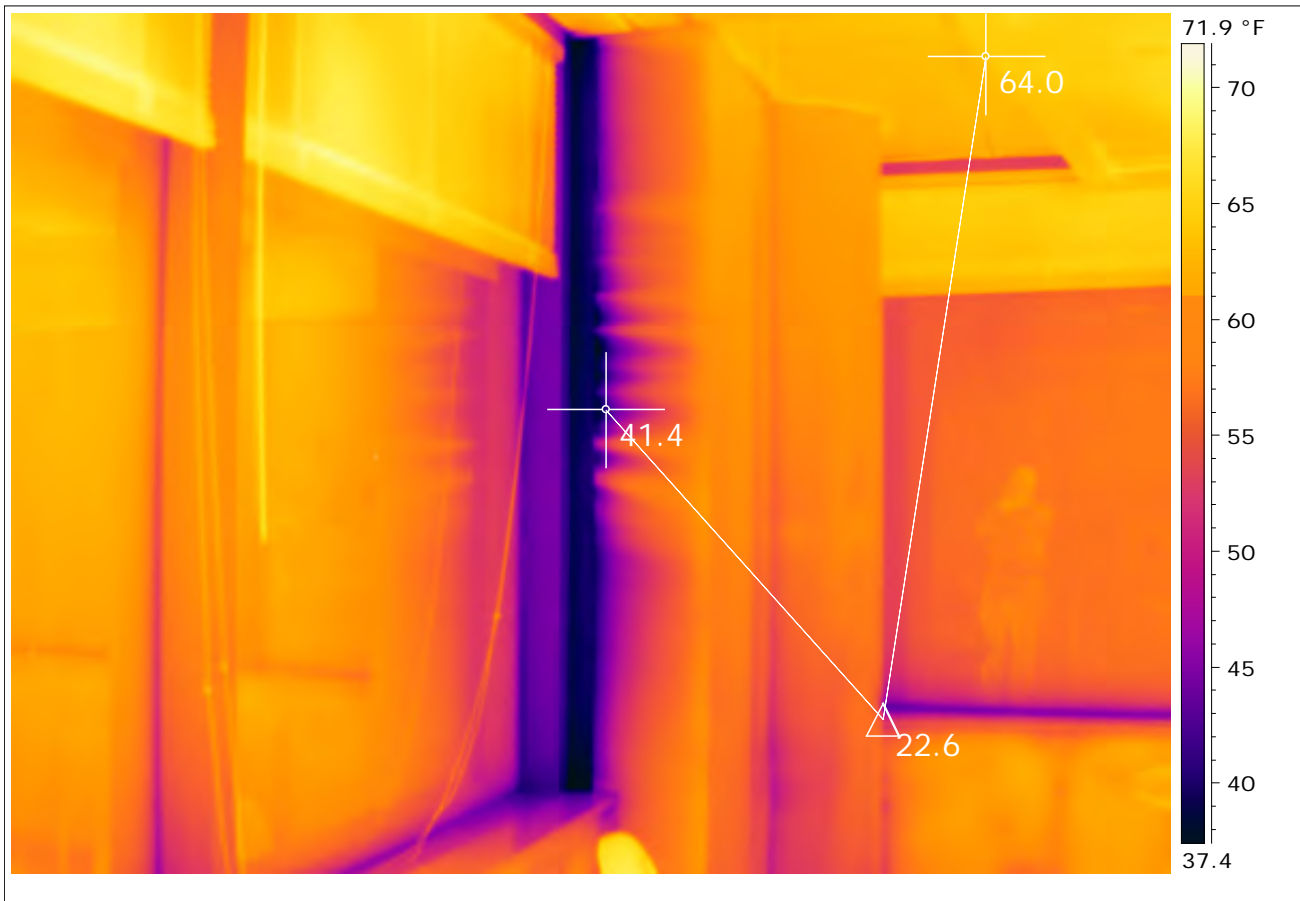
<b>CLIENT</b>	Enlightened Management	<b>BUILDING</b>	Enlightened	<b>PROBLEM #</b>	12
<b>FLOOR</b>	4	<b>ROOM</b>	Break room	<b>WALL ORIENTATION</b>	South
<b>LOCATION ALONG WALL</b>	East end	<b>ADDITIONAL LOCATION</b>	Column 11D

**PROBLEM DESCRIPTION** Cold air is infiltrating at an open joint along the window frame. The air source is like behind the column and the underlying soffit. Visual inspection of the exterior fascia from a nearby window revealed an open horizontal joint.
