# Predictive Testing Report

**CLIENT:** MAJOR WIDGETS

**DATE:** May 25, 2009

**SUBJECT:** Infrared, vibration and ultrasonic survey of electrical and mechanical equipment

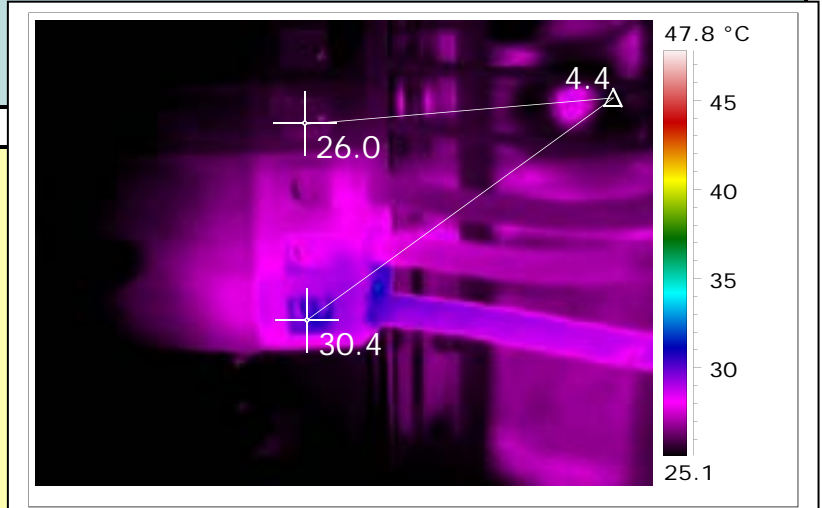
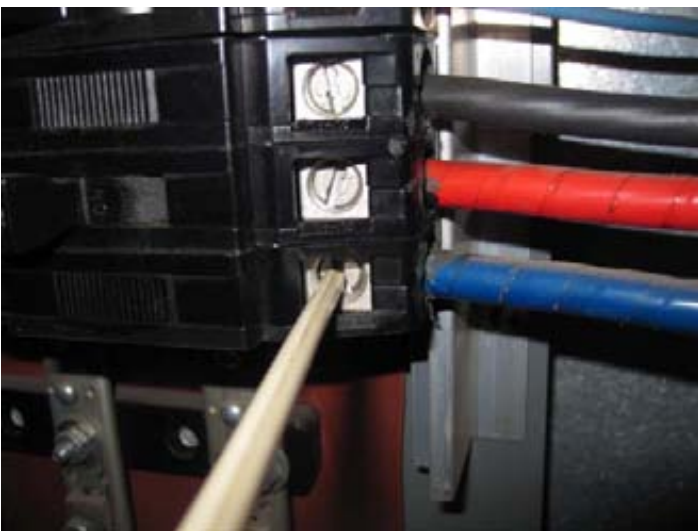
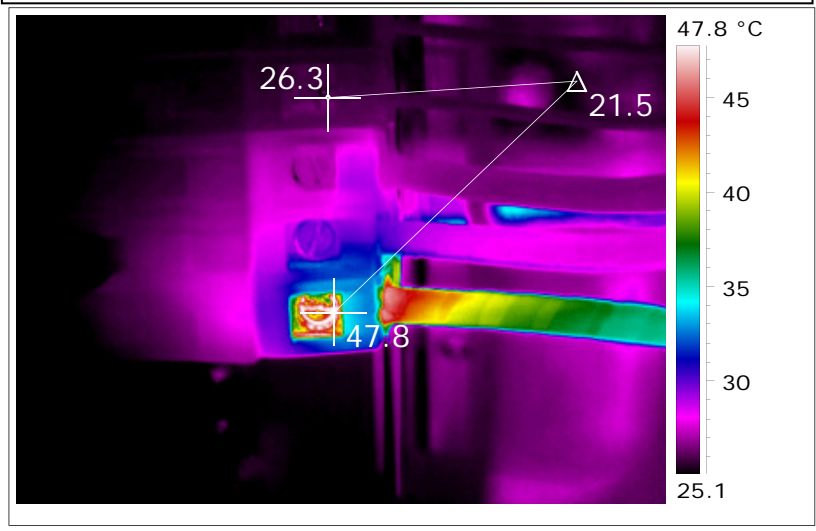
<b>CLIENT</b>	Major Widgets
<b>PROBLEM NUMBER</b>	1
<b>EQUIPMENT</b>	Main electric room, emergency lighting panel

**PROBLEM DESCRIPTION** 3 pole breaker 20-24, #24, load side, shows excessive heat. FOP test shows a loose connection.

**RECOMMENDATION** Problem repaired  
No further action required.

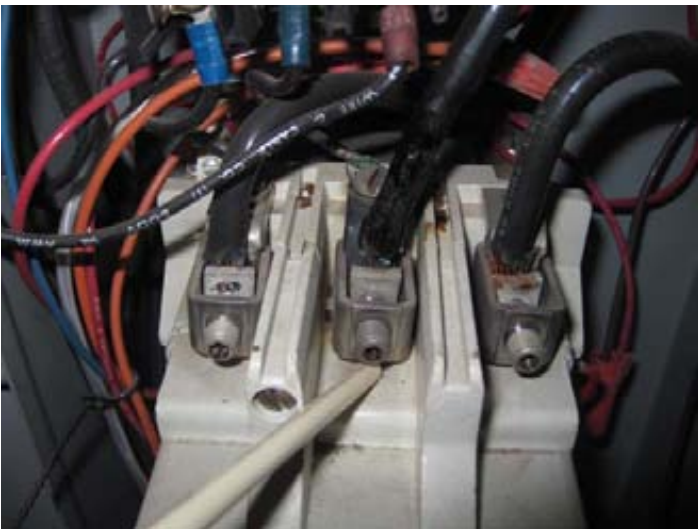
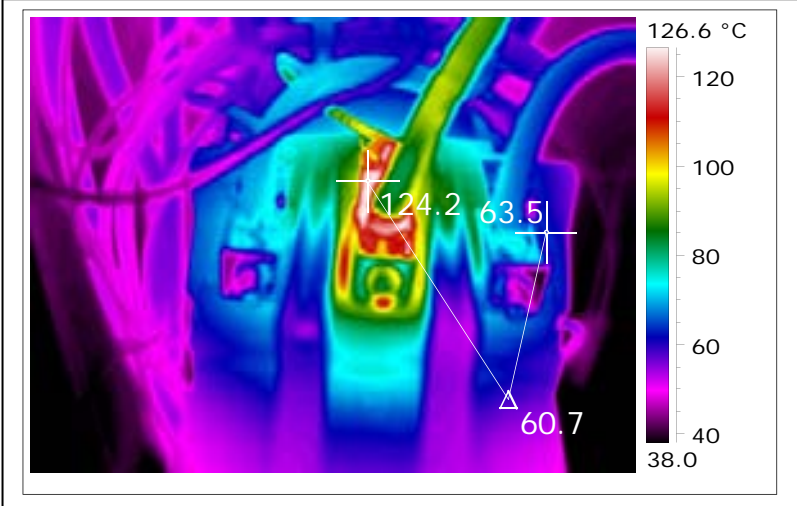
<b>CLIENT</b>	MAJOR WIDGETS
<b>PROBLEM NUMBER</b>	2
<b>EQUIPMENT</b>	Penthouse, pump 2 contactor

**PROBLEM DESCRIPTION** Contactor, line side, B phase, shows excessive heat. FOP test shows poor internal contact. Feed is damaged from heating.

**HIGH PRIORITY: Yes**

**RECOMMENDATION** Open contactor. Check internal connections. Check contact surfaces. Reassemble, using FOP test to ensure proper operation. Repair damaged feeder.

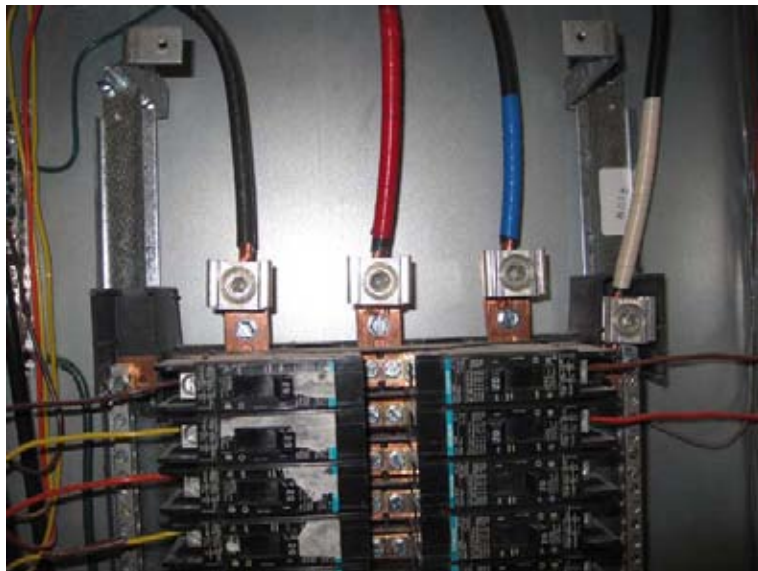
<b>CLIENT</b>	MAJOR WIDGETS
<b>PROBLEM NUMBER</b>	3
<b>EQUIPMENT</b>	15059, 5th floor, west electric room, Panel EH5

**PROBLEM DESCRIPTION** Main feeds In 480V panel are color coded for 208V. This is a code violation.

**RECOMMENDATION** Install proper phase/voltage colors on the feeders.

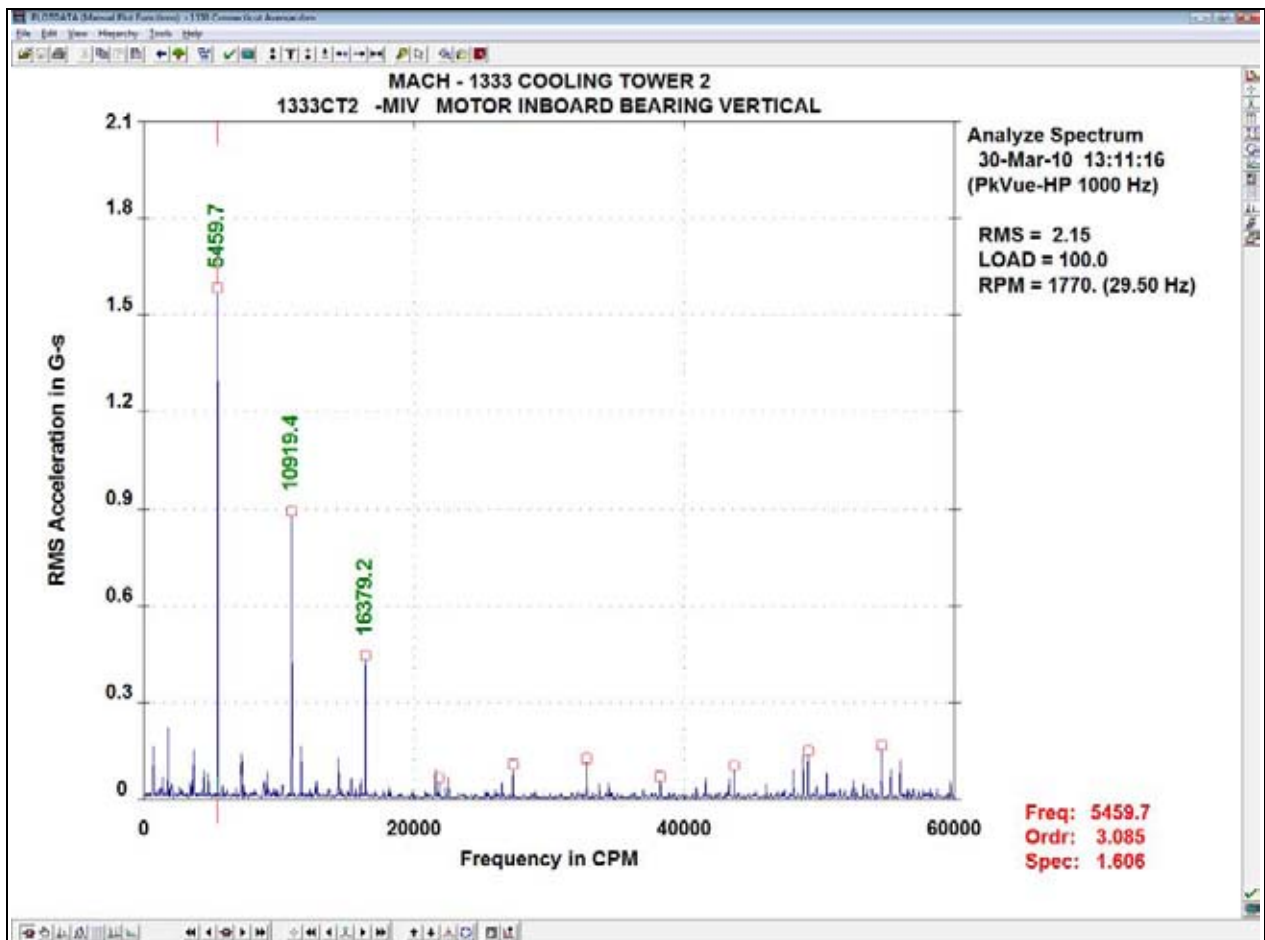
**MACHINE:** 1333 Cooling Tower 2

**PROBLEM DISCUSSION:** A bearing defect is present in the motor. It is unclear whether it is the inboard or outboard bearing, since bearing fault frequencies are found at both locations and with similar amplitudes. Both bearings should be changed.

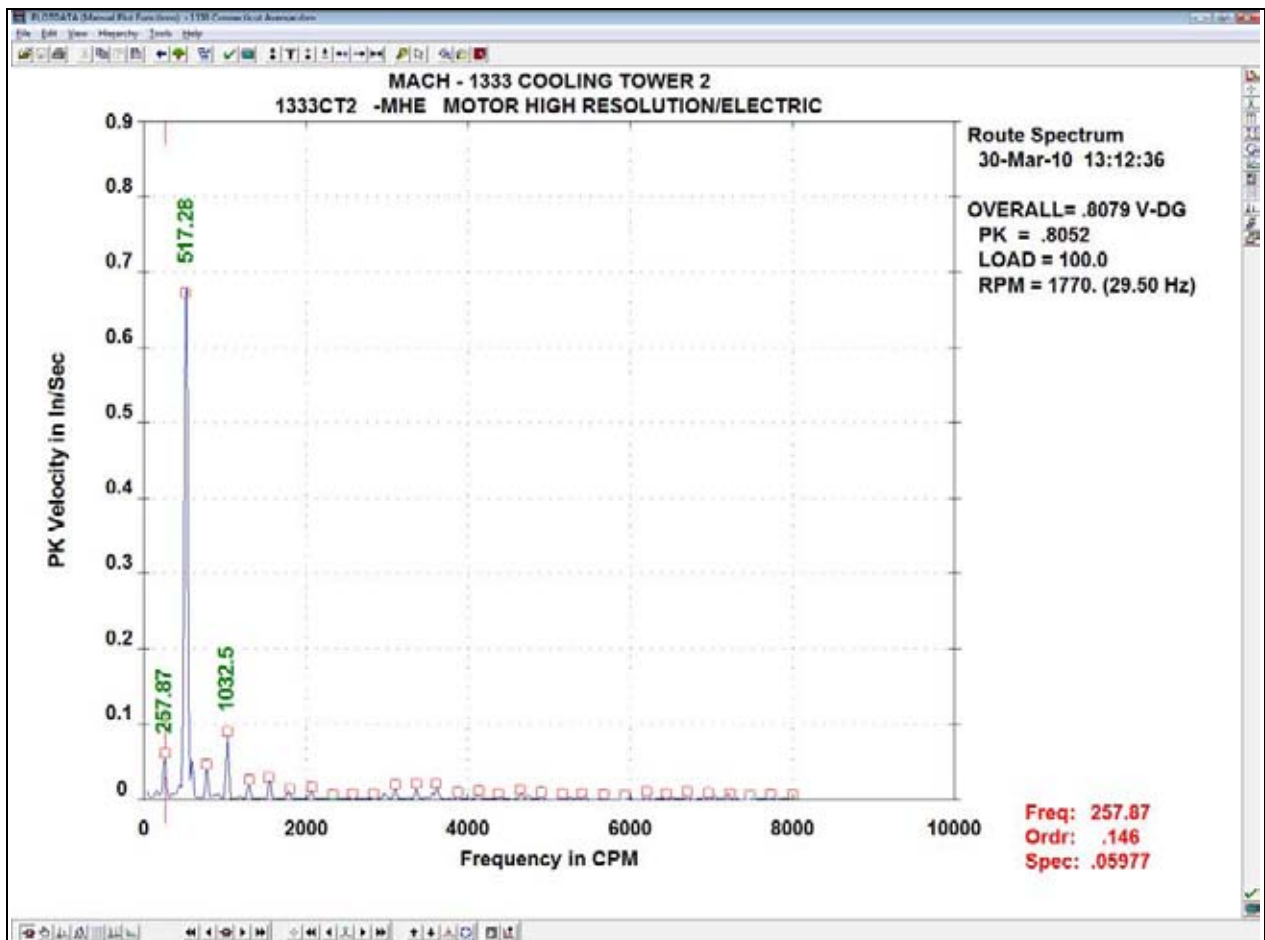
**MACHINE:** 1333 Cooling tower 2

**PROBLEM DISCUSSION:** High belt vibration is present at the motor. Check the belts for wear and tension. Check the sheave alignment between the two fans and the motor.
