Roof Testing Report

SUBJECT: Roof evaluation of Oak Grove Square

This document presents the results of our inspection of the roof at Oak Grove Square, located at the above address. The objective of the inspection was to locate and recommend remedial actions for deficiencies in the roofing system.

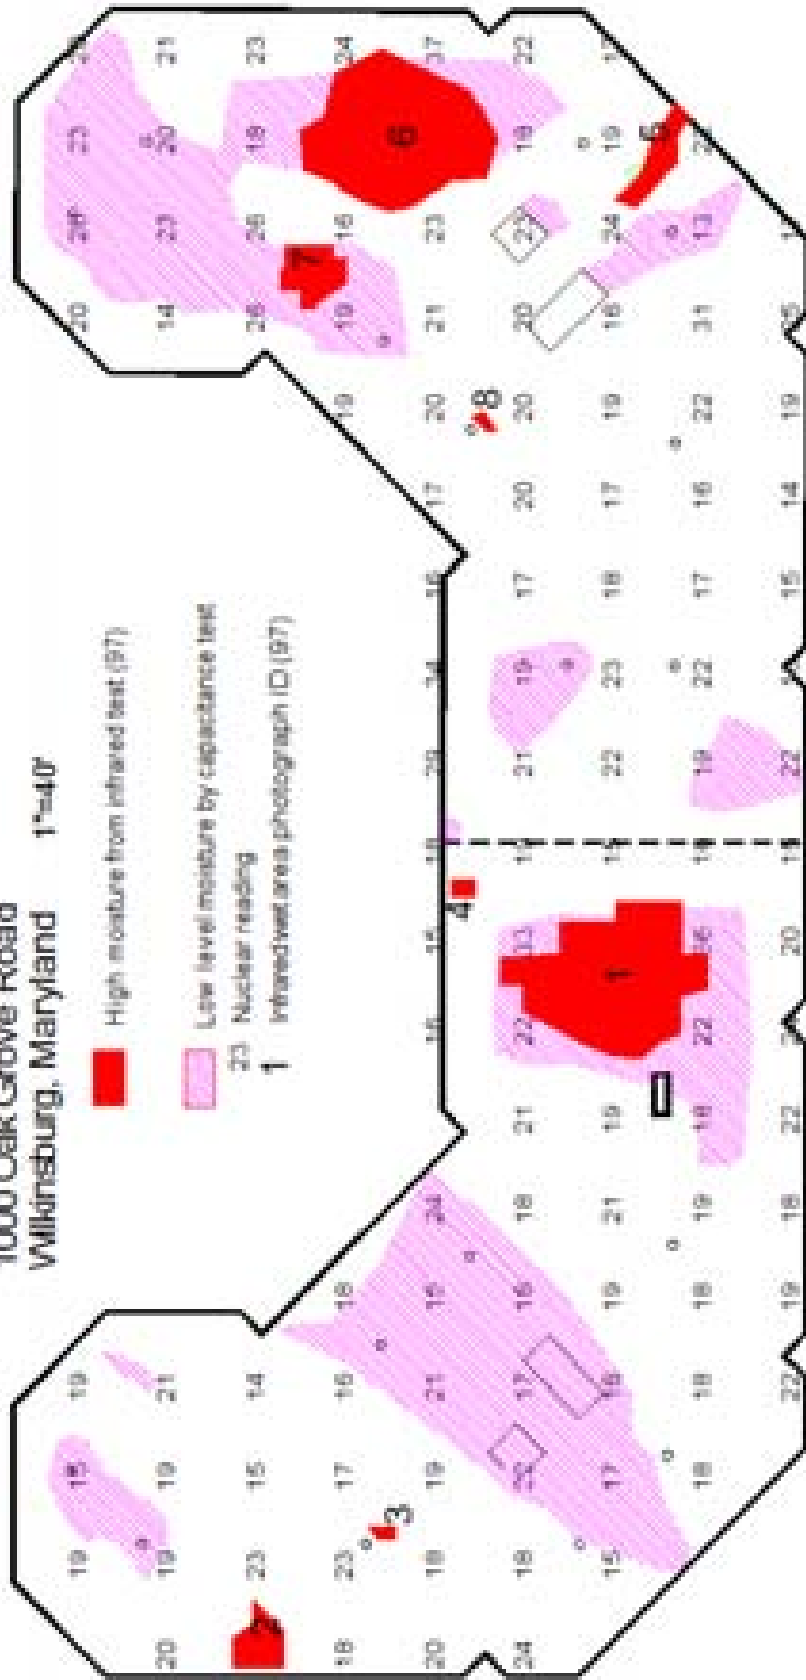
Oak Grove Square

Wet Area	Nuclear Reading	Approximate Area (ft2)	Leak Source
1	79	1052	Likely membrane defects, membrane split and hole at lead drain flashing
2	41	126	Likely membrane defect
3	44	18	Likely membrane defect
4	34	8	Hole in membrane
5	57	123	Hole in membrane
6	61	1081	Prior major split
7	53	157	Likely membrane defect
8	46	10	Drain flashing open

Wet areas identified by both nuclear and infrared testing cover approximately 6% of the roof area.

The approximate size and location of all wet areas is shown on the roof drawing, below.

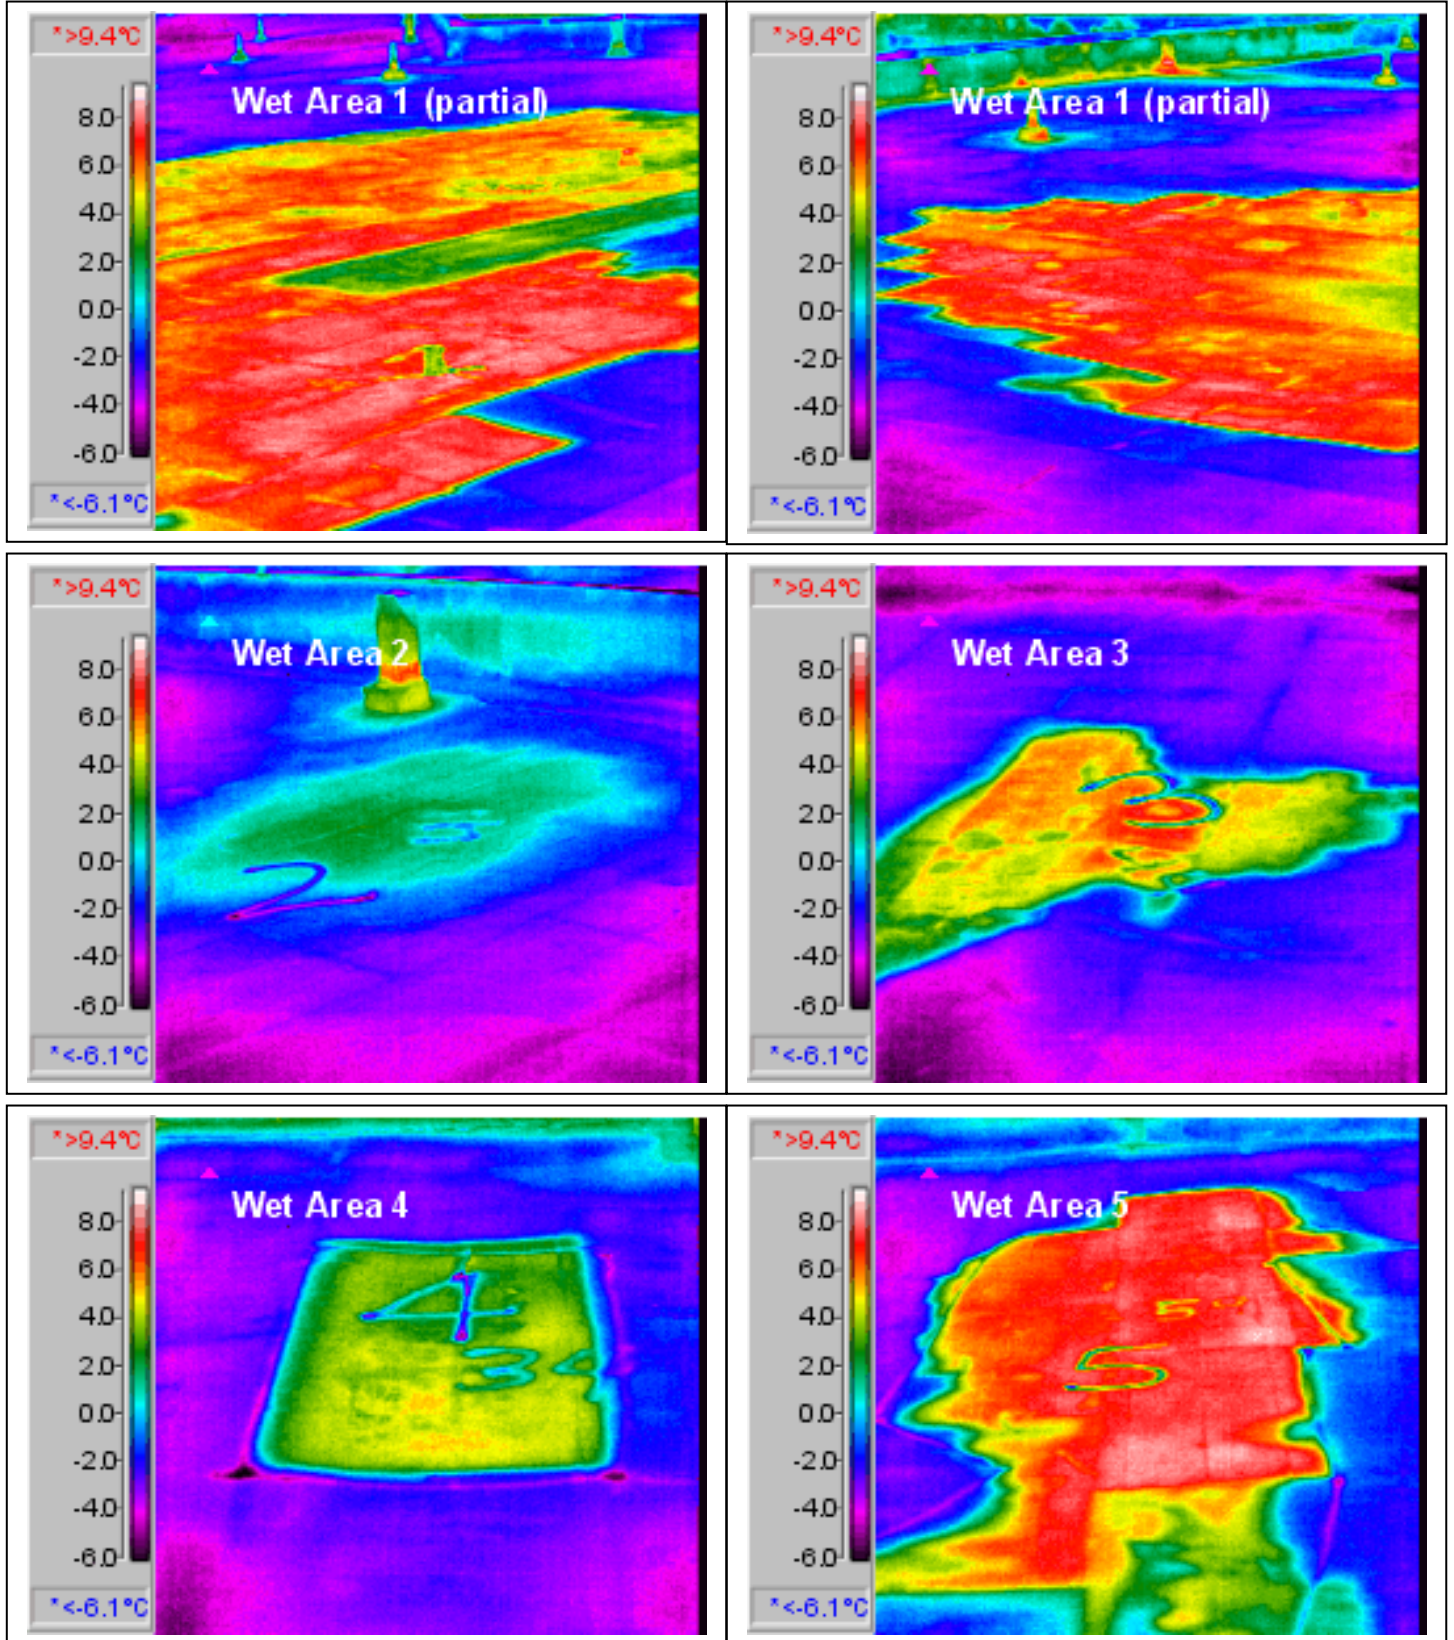
Roof Moisture Images

The infrared test identified a total of eight wet areas. Moisture levels varied in these areas as indicated both the temperature of the images (seen at the end of this section) and the nuclear readings. The maximum nuclear reading and approximate size for each area is as follows:

Thermal images for each area follow this roof drawing.

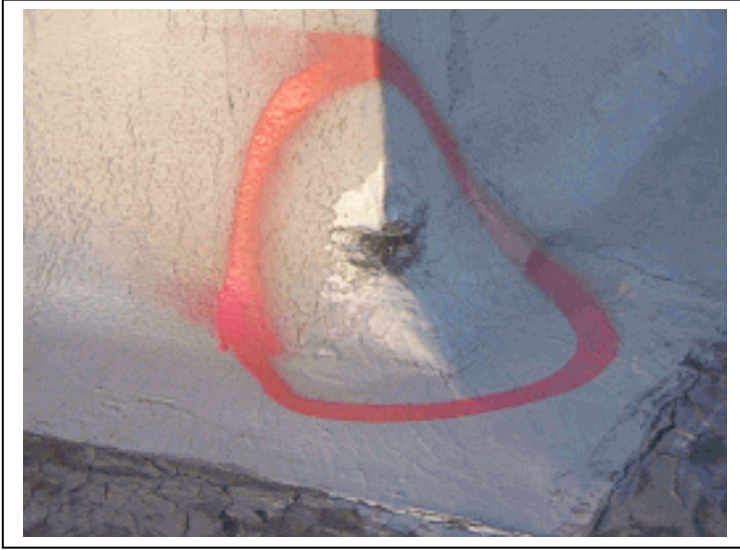
Overall, membrane flashings are in good condition. However, many cuts and other defects are present. Several corners have cuts that appear to be produced by ropes. These cuts are probably the result of ropes used by window washers. A likely rope cut is shown in photograph 1. Various other holes and penetrations were noted. These problems were circled on the roof with red spray paint.

Photograph 1-Rope cut in flashing

We also recommend that the drain flashings at wet area 1 (hole in the lead flashing) and wet area 8 be repaired. The membrane punctures at wet areas 4 and 5 should be repaired. Cuts in the flashings can also be repaired. All of these can be temporarily repaired with patches of fabric and asphalt based roof cement.

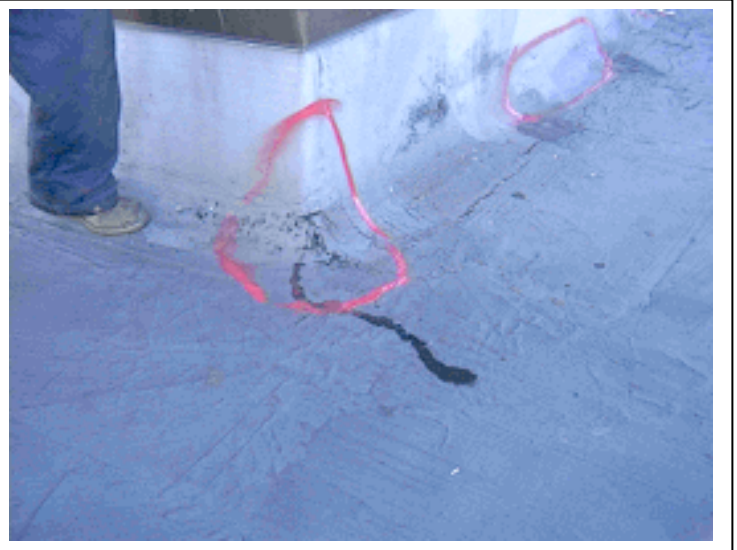
Base flashings at two of the penthouses contain water. Photograph 2 shows water running from a flashing when pressure was applied. Water may be entering the walls as a result of improperly installed scuppers on the elevator penthouses. This will be discussed below.

The elevator penthouse are drained through scuppers. The scuppers are formed from lead drain flashings. These scuppers are improperly formed and sealed. Open gaps are visible in the gravel stops under the edges of the lead scuppers. If the penthouse walls are block construction, water can flow down the blocks. This may explain the presence of water trapped behind some of the elevator penthouse flashings (see photograph 2).

Photograph 2-Water trapped behind flashing

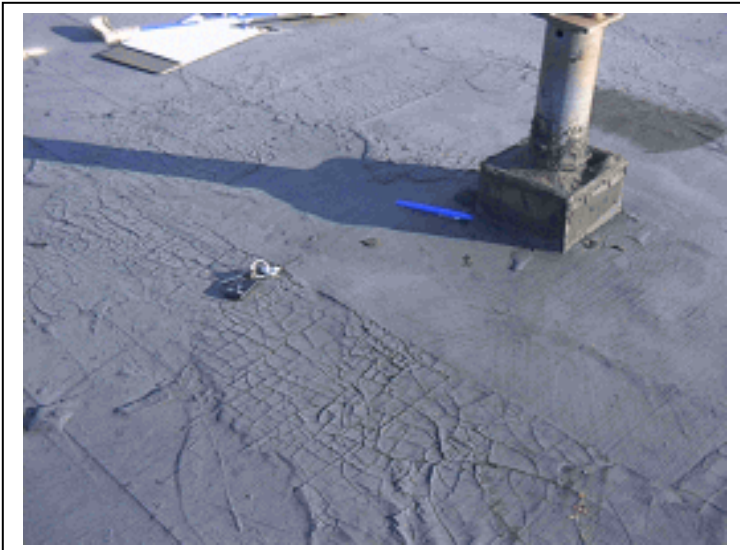
Numerous pitch pockets are used on this roof at window washer supports. These pitch pockets are stripped with membrane material. The moisture inspection revealed low level moisture around several pitch pockets. One pitch pocket is shown in photograph 3. The strippings are open at two points. When pressure is applied air is released at the fishmouth. The roof insulation in this area contains low level moisture. These stripping defects are the likely water sources.

Photograph 3-Penetrations at pitch pocket stripping

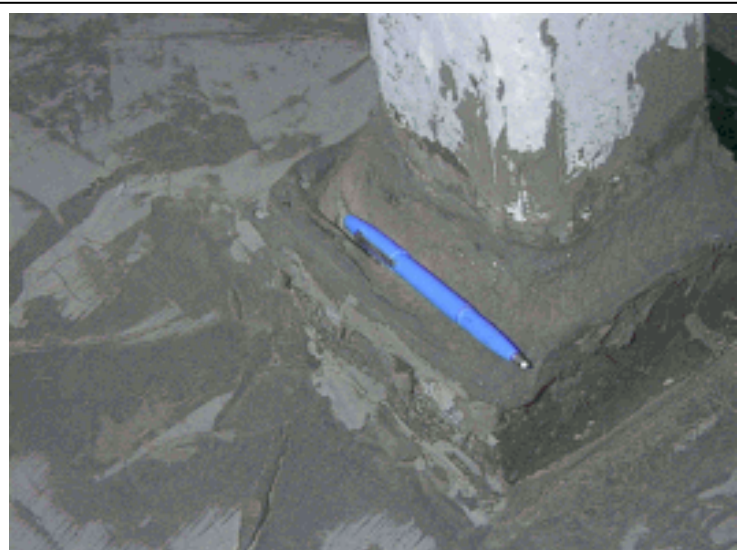
As stated above, numerous pitch pockets are present on this roof. Many pitch pockets have low fill. Pitch pockets lacking proper fill will trap water and can permit water penetration. Photograph 4 illustrates a low pitch pocket.

Photograph 4-Low pitch pocket fill

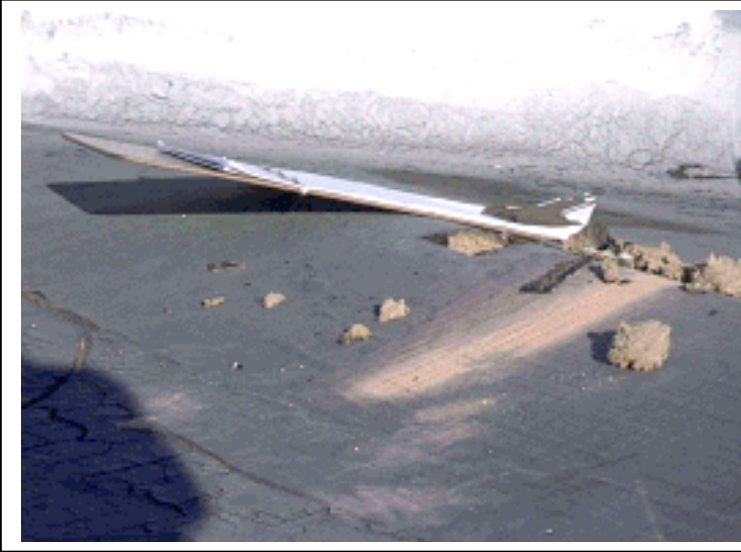
- 1) The roof contains numerous ridges. Photograph 5 shows a clip board placed on a ridge. This photograph shows the size and steepness of a ridge. These ridges are located at both high and low spots in the roof. Ridges may contain wet or dry insulation. The ridges have been reported to be the location of prior roof splits (for example, wet area 6 resulted from a split at a ridge). We made a total of three test cuts

Based on these areas, we believe that the roof insulation is not properly secured to the deck. This is permitting differential movement between the insulation and membrane as the roof membrane heats and cools. This movement is causing the insulation to bend upward in response to stresses imposed by the moving membrane. As past splits have demonstrated, the forces imposed on the membrane at the ridges can produce disastrous roof splits. We expect that movement of the membrane will continue to produce more and larger ridges and produce ongoing roof splits.

Photograph 5-Ridge in insulation

We recommend that immediate steps be taken to reinforce the roofing at all ridged areas. At each ridge, we recommend that a reinforcing patch consisting of a full roll width of modified bitumen roofing be torched over the existing ridge. The material will be Nordpoly 4B or equivalent. The existing membrane will be cleaned and primed with asphalt primer prior to installation of the reinforcing patches.

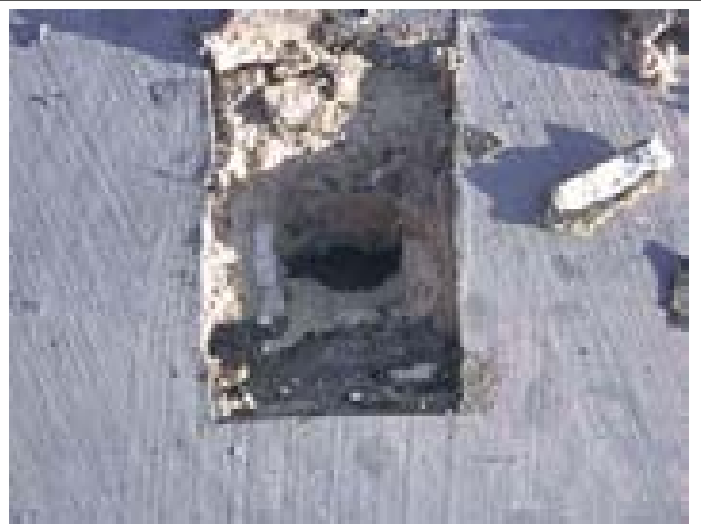
at ridges. Photographs 6 and 7 show two of the cuts. A third cut was made where a roof split was found (in wet area 1). In each case, the underlying isocyanurate insulation is not adhered to the concrete deck. The deck was primed but little or no asphalt was applied between the deck and insulation.

Photograph 6-Void under insulation at ridge

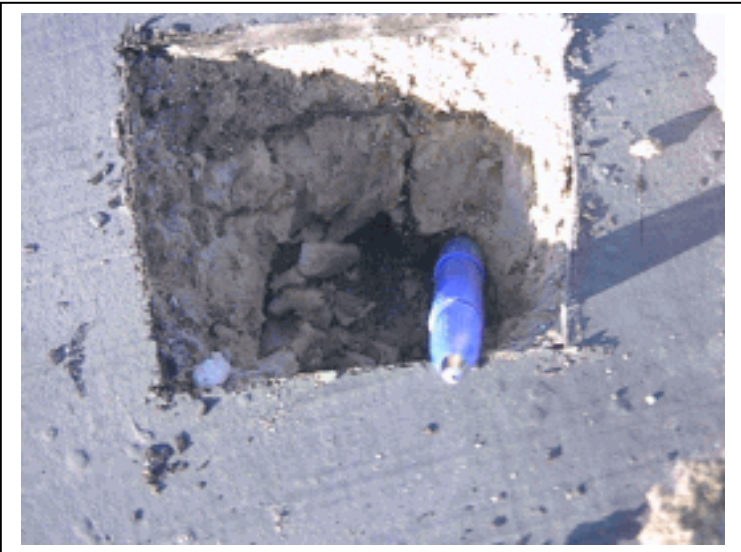
Photograph 7-Void under insulation at ridge

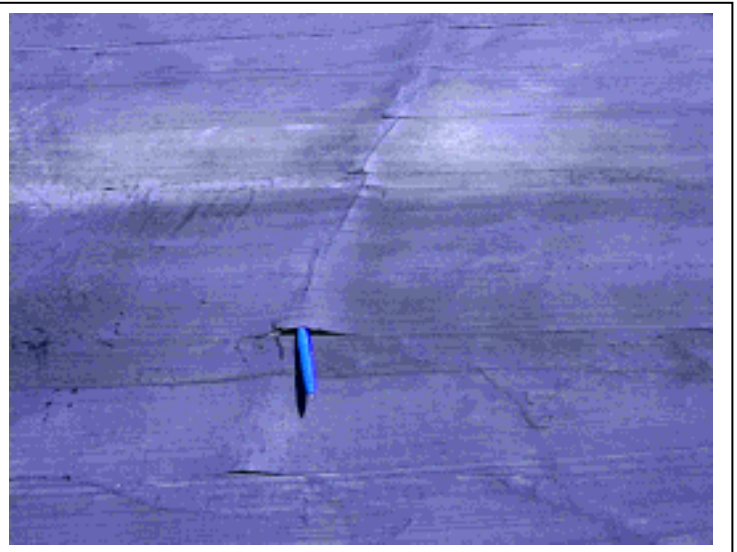
2) The membrane felts are improperly installed. When the membrane felts are installed, wrinkles can form as the felts are unrolled unevenly. When this occurs, the felt is cut to remove the wrinkle. Next, the felt installation continues, lapping, the cut at the former wrinkle. On the present installation, there is little evidence that wrinkles were corrected during installation. The roof membrane contains numerous fishmouths. These fishmouths are the result of wrinkles in the membrane felts. Where the wrinkles extend to the edge of the top ply, water can enter between the plies. Many fishmouths are present that extend under several plies. Photograph 8 shows a fishmouth that extends through 6 plies. Photograph 9 shows a fishmouth that extends through at least two plies. Fishmouths on this roof are widespread, providing ample evidence of a improperly installed membrane with many opportunities for water penetration.

We believe that inadequate moppings of asphalt and widespread fishmouths are responsible for much of the low level wetting found by the roof moisture survey. These types of defects are probably responsible for high level moisture penetration at wet areas 2, 3 and 7.

Photograph 8-Fishmouth through several plies
