# Roof Testing Report

**CLIENT:** ENLIGHTENED MANAGEMENT, INC.

**DATE:** May 25, 2010

**SUBJECT:** Roof evaluation of Oak Grove Square

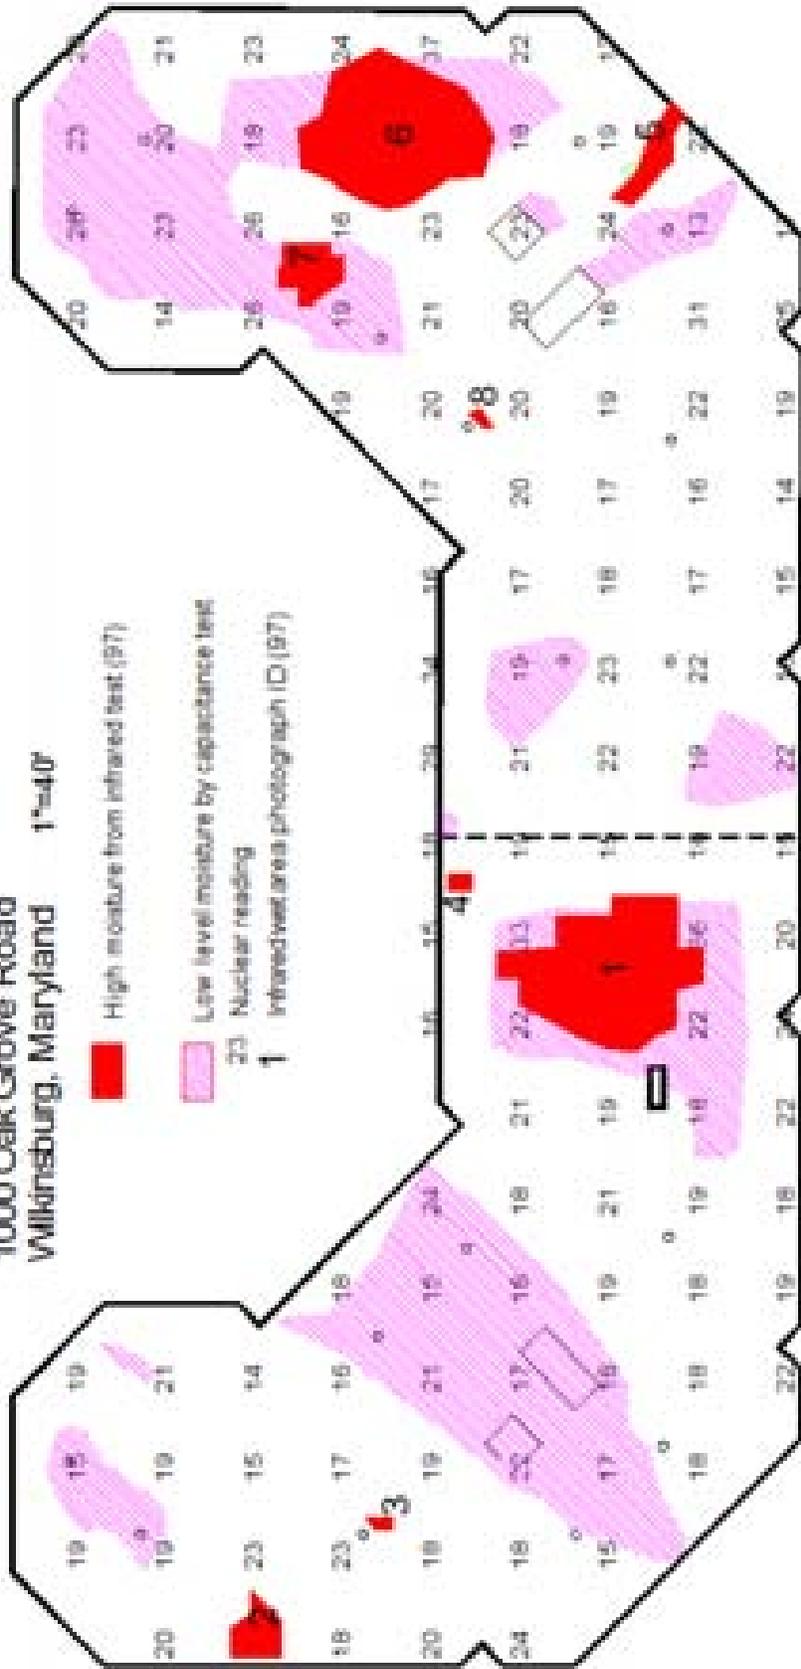
# Oak Grove Square

Wet Area	Nuclear Reading	Approximate Area (ft2)	Leak Source
1	79	1052	Likely membrane defects, membrane split and hole at lead drain flashing
2	41	126	Likely membrane defect
3	44	18	Likely membrane defect
4	34	8	Hole in membrane
5	57	123	Hole in membrane
6	61	1081	Prior major split
7	53	157	Likely membrane defect
8	46	10	Drain flashing open

The approximate size and location of all wet areas is shown on the roof drawing, below.

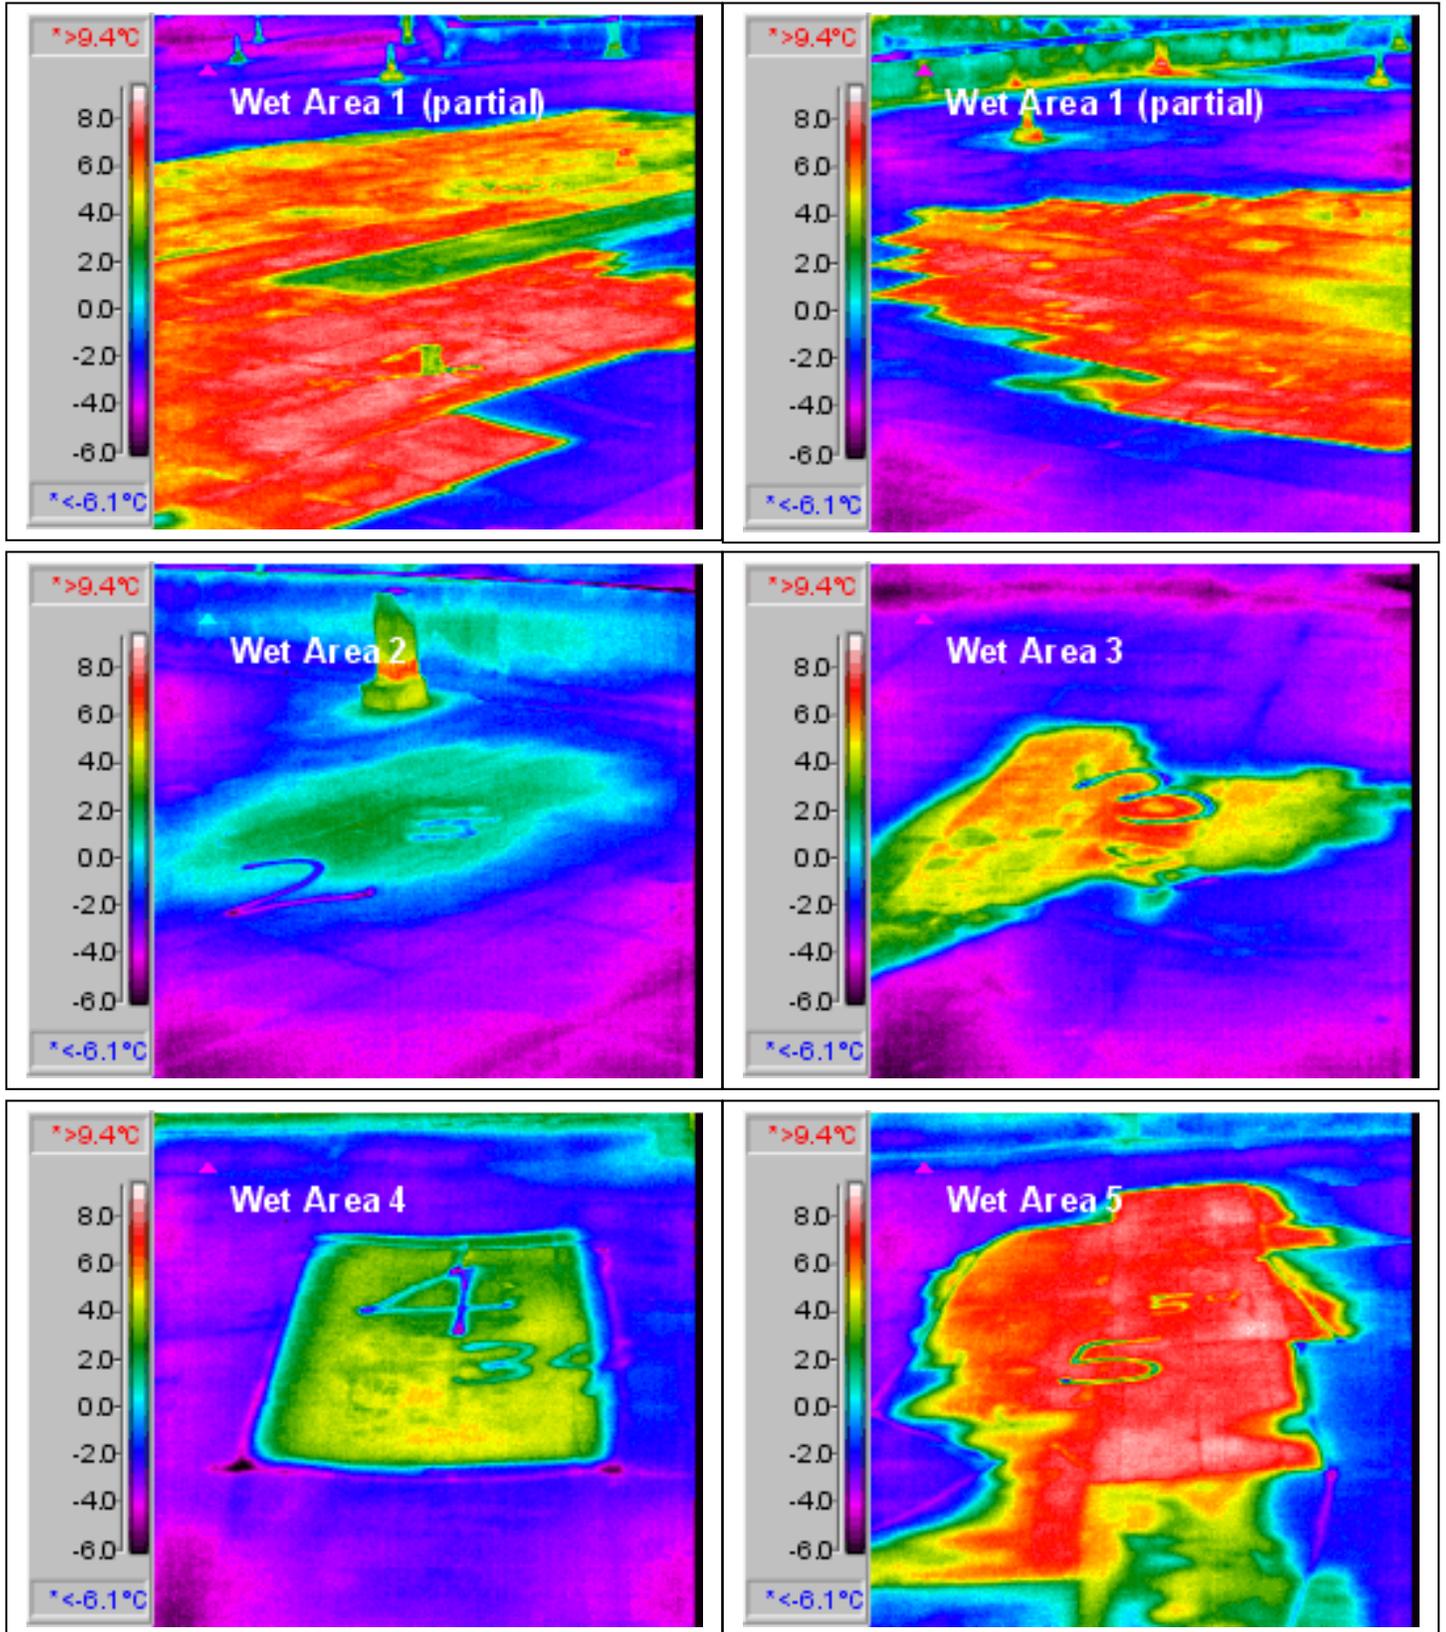
# Roof Moisture Images

The infrared test identified a total of eight wet areas. Moisture levels varied in these areas as indicated both the temperature of the images (seen at the end of this section) and the nuclear readings. The maximum nuclear reading and approximate size for each area is as follows:

Thermal images for each area follow this roof drawing.

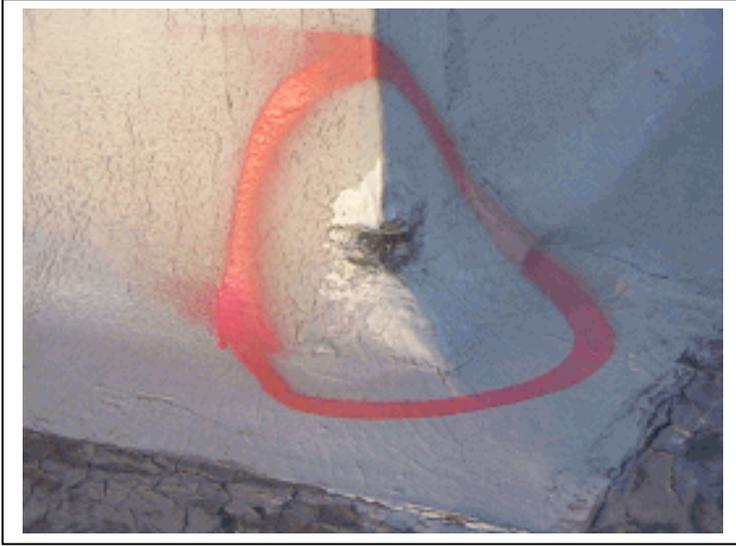
Overall, membrane flashings are in good condition. However, many cuts and other defects are present. Several corners have cuts that appear to be produced by ropes. These cuts are probably the result of ropes used by window washers. A likely rope cut is shown in photograph 1. Various other holes and penetrations were noted. These problems were circled on the roof with red spray paint.

**Photograph 1-Rope cut in flashing**

We also recommend that the drain flashings at wet area 1 (hole in the lead flashing) and wet area 8 be repaired. The membrane punctures at wet areas 4 and 5 should be repaired. Cuts in the flashings can also be repaired. All of these can be temporarily repaired with patches of fabric and asphalt based roof cement.

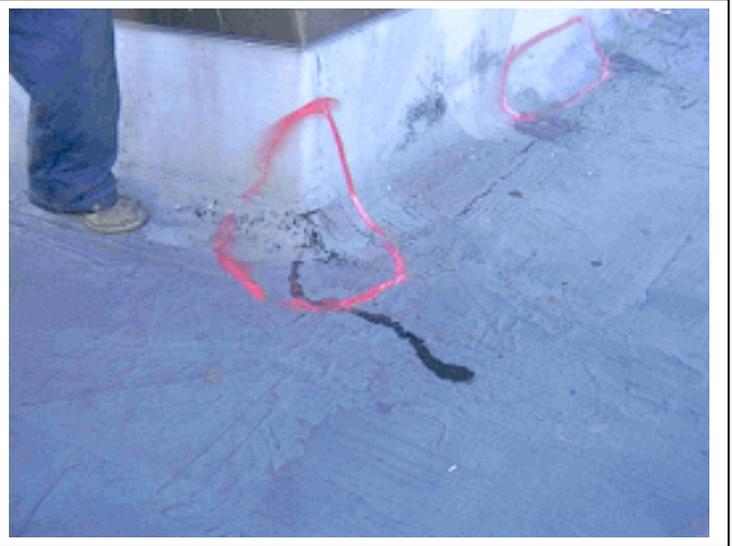
Base flashings at two of the penthouses contain water. Photograph 2 shows water running from a flashing when pressure was applied. Water may be entering the walls as a result of improperly installed scuppers on the elevator penthouses. This will be discussed below.

The elevator penthouse are drained through scuppers. The scuppers are formed from lead drain flashings. These scuppers are improperly formed and sealed. Open gaps are visible in the gravel stops under the edges of the lead scuppers. If the penthouse walls are block construction, water can flow down the blocks. This may explain the presence of water trapped behind some of the elevator penthouse flashings (see photograph 2).

**Photograph 2-Water trapped behind flashing**

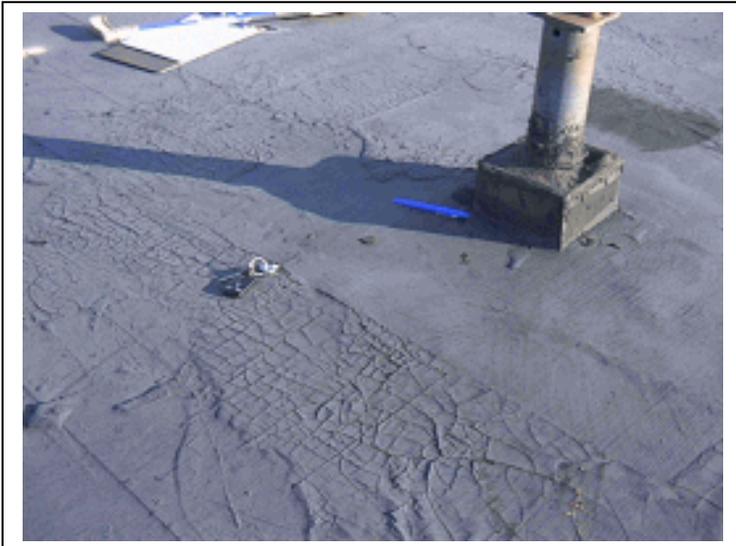
Numerous pitch pockets are used on this roof at window washer supports. These pitch pockets are stripped with membrane material. The moisture inspection revealed low level moisture around several pitch pockets. One pitch pocket is shown in photograph 3. The strippings are open at two points. When pressure is applied air is released at the fishmouth. The roof insulation in this area contains low level moisture. These stripping defects are the likely water sources.

**Photograph 3-Penetrations at pitch pocket stripping**

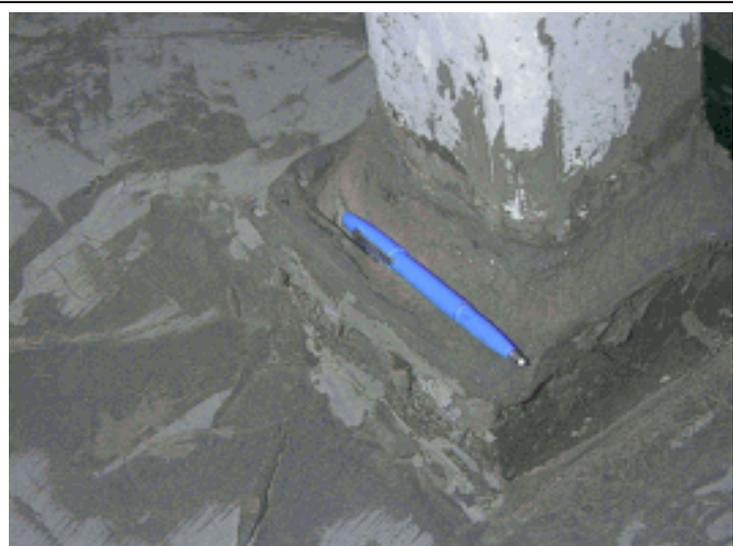
As stated above, numerous pitch pockets are present on this roof. Many pitch pockets have low fill. Pitch pockets lacking proper fill will trap water and can permit water penetration. Photograph 4 illustrates a low pitch pocket.

**Photograph 4-Low pitch pocket fill**

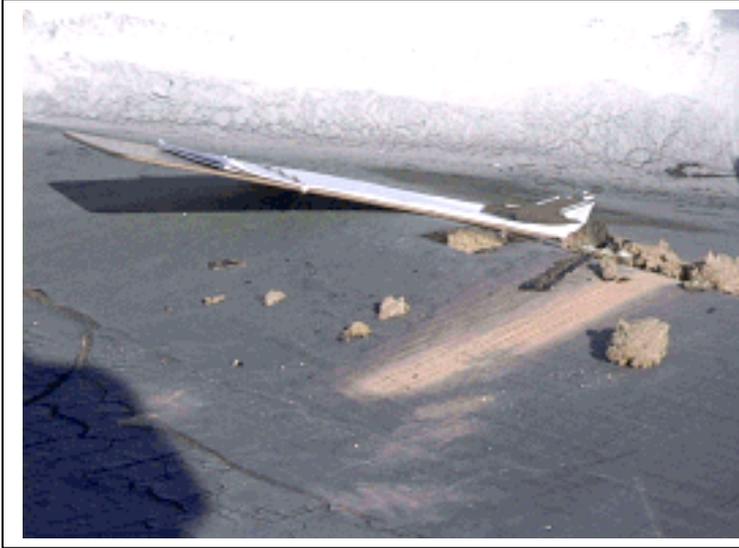
- 1) The roof contains numerous ridges. Photograph 5 shows a clip board placed on a ridge. This photograph shows the size and steepness of a ridge. These ridges are located at both high and low spots in the roof. Ridges may contain wet or dry insulation. The ridges have been reported to be the location of prior roof splits (for example, wet area 6 resulted from a split at a ridge). We made a total of three test cuts

Based on these areas, we believe that the roof insulation is not properly secured to the deck. This is permitting differential movement between the insulation and membrane as the roof membrane heats and cools. This movement is causing the insulation to bend upward in response to stresses imposed by the moving membrane. As past splits have demonstrated, the forces imposed on the membrane at the ridges can produce disastrous roof splits. We expect that movement of the membrane will continue to produce more and larger ridges and produce ongoing roof splits.

**Photograph 5-Ridge in insulation**

We recommend that immediate steps be taken to reinforce the roofing at all ridged areas. At each ridge, we recommend that a reinforcing patch consisting of a full roll width of modified bitumen roofing be torched over the existing ridge. The material will be Nordpoly 4B or equivalent. The existing membrane will be cleaned and primed with asphalt primer prior to installation of the reinforcing patches.

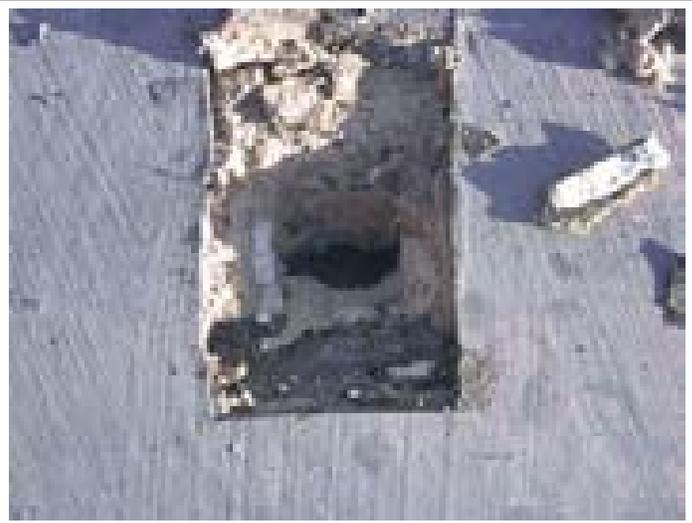
at ridges. Photographs 6 and 7 show two of the cuts. A third cut was made where a roof split was found (in wet area 1). In each case, the underlying isocyanurate insulation is not adhered to the concrete deck. The deck was primed but little or no asphalt was applied between the deck and insulation.

**Photograph 6-Void under insulation at ridge**

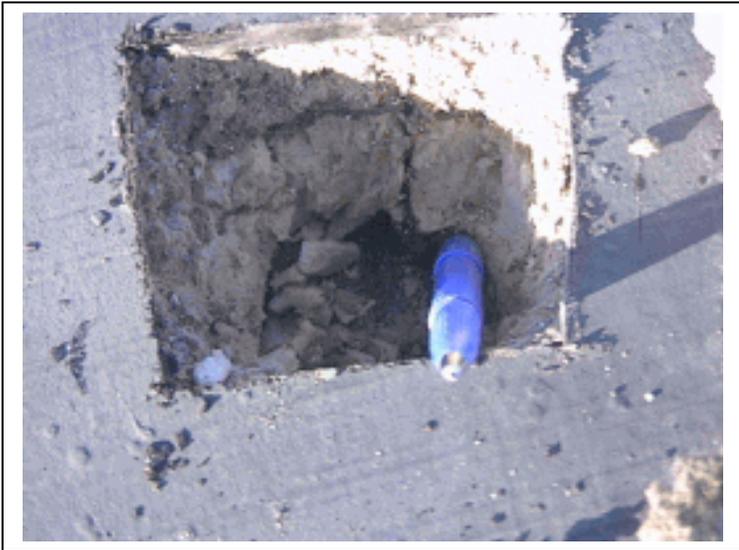
**Photograph 7-Void under insulation at ridge**

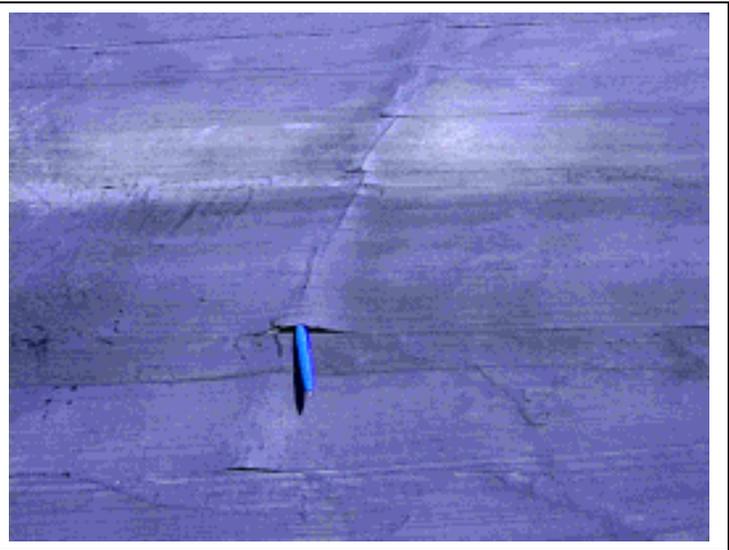
2) The membrane felts are improperly installed. When the membrane felts are installed, wrinkles can form as the felts are unrolled unevenly. When this occurs, the felt is cut to remove the wrinkle. Next, the felt installation continues, lapping, the cut at the former wrinkle. On the present installation, there is little evidence that wrinkles were corrected during installation. The roof membrane contains numerous fishmouths. These fishmouths are the result of wrinkles in the membrane felts. Where the wrinkles extend to the edge of the top ply, water can enter between the plies. Many fishmouths are present that extend under several plies. Photograph 8 shows a fishmouth that extends through 6 plies. Photograph 9 shows a fishmouth that extends through at least two plies. Fishmouths on this roof are widespread, providing ample evidence of a improperly installed membrane with many opportunities for water penetration.

**Photograph 8-Fishmouth through several plies**
