AERIAL INFRARED SURVEYS: PREDICTIVE TESTING FOR STEAM DISTRIBUTION

Published by International District Energy Association, Proceedings, June, 1998

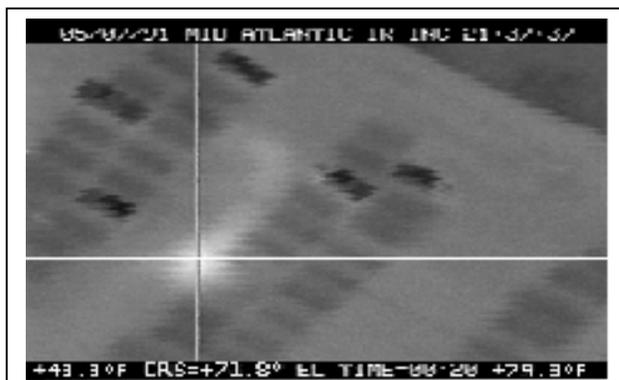
Figure 2:1991 Image with Temperature Measurement

Figure 2 shows a steam line defect acquired in 1991. This image displays on-screen temperature measurement, which was a major advance in instrumentation. The instrument provided absolute

temperature measurements of any point in the image. The ground surface temperature at the cross hair is 71.8°F. The measurement capability of this instrument provided the basic data required for predictive testing. The thermal imager that produced this image could resolve a hot spot of two feet across at 1,000 feet of altitude. An accurate temperature measurement at 1,000 feet of altitude required a hot spot greater than 10 feet across.

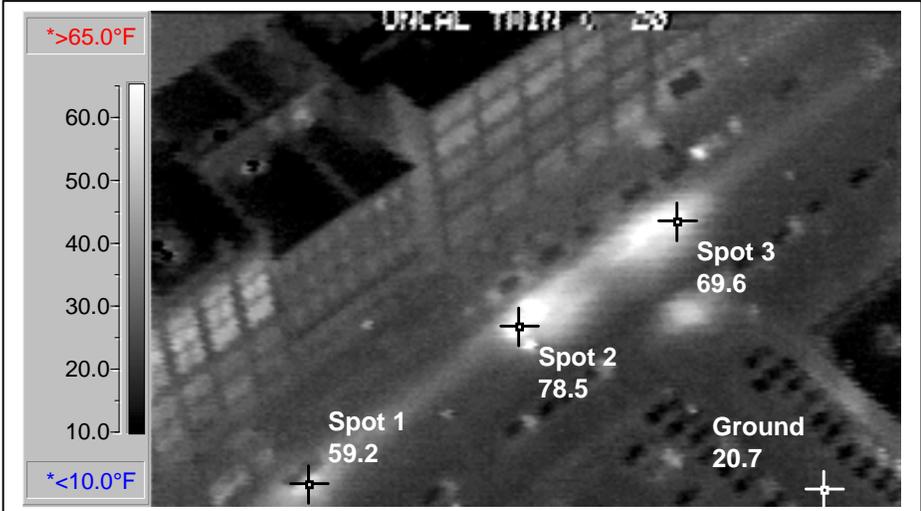
Figure 3:1996 Image, computer post processed

Figure 3 shows a post-processed image acquired in 1996. Post processing permits the measurement and annotation of actual temperatures right on the image.

Figures 3 and 4 show the same location, and demonstrate temperature trending over time. Changes may be evaluated by comparing the temperature rise above ground temperature and each hot spot. The ground temperature in Figure 3 is 20.7°F. The ground temperature in Figure 4 is 29.7°F. The comparison is as follows:

Hot Spot	'96 Temp Rise (°F)	'98 Temp Rise (°F)	Comments
1	38.5	42.6	No change
2	57.8	103.7	Severe degradation
3	48.9	23.1	Problem repaired
