Aerial Steam System Report

CLIENT: LARGE UNIVERSITY

DATE: November 28, 2011

SUBJECT: Aerial Infrared Steam System Survey

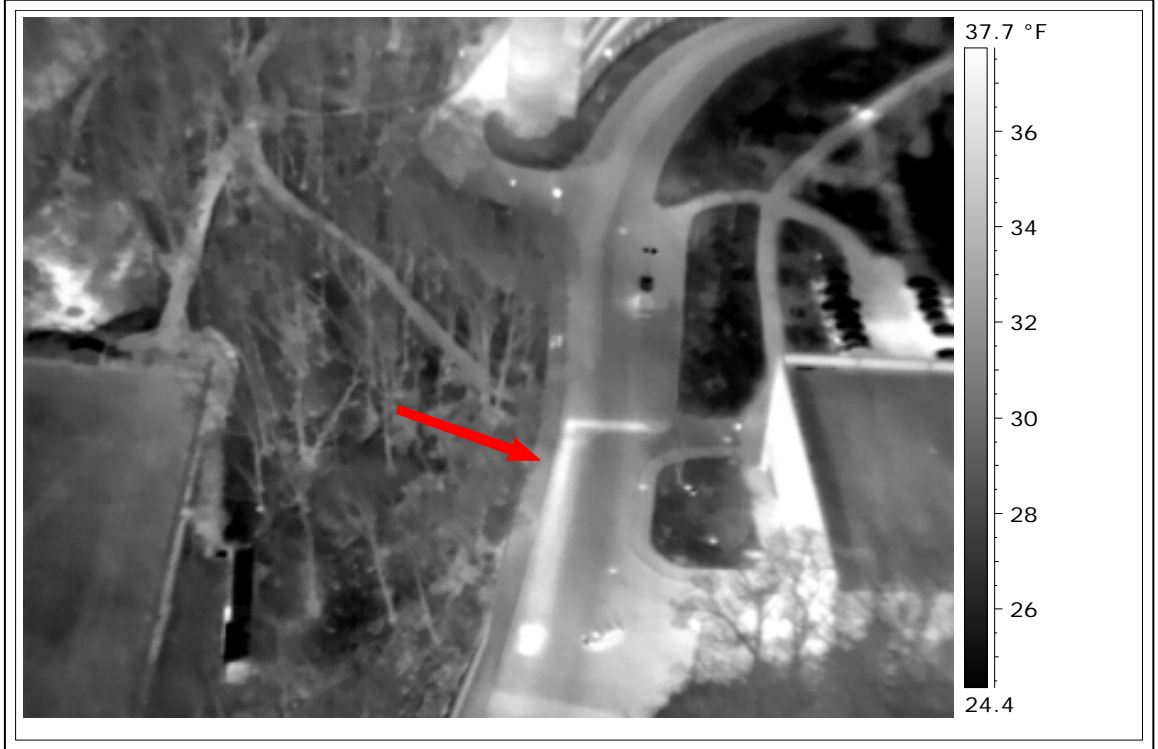
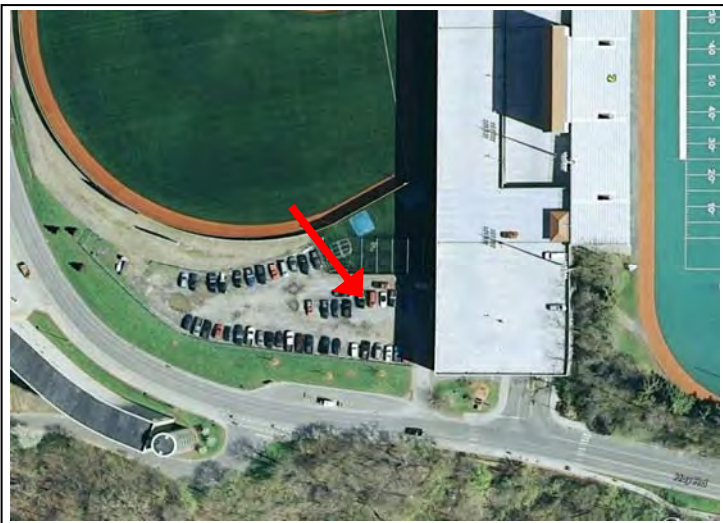
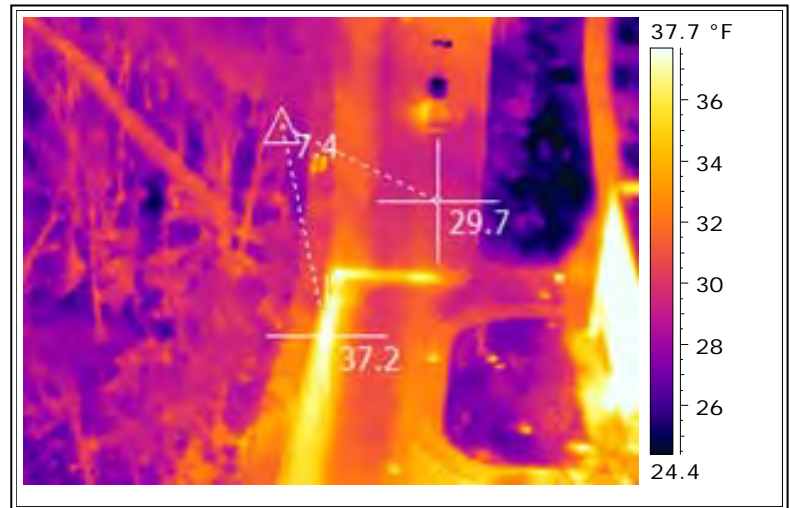
Problem # 1

Location:
Parking Garage, west of manhole 27-1

Analysis:
The 90° bend that is clearly seen here was not visible in prior surveys. Insulation may be damaged here and a leak may be present. The temperature rise is relatively low. This could be a condensate leak.

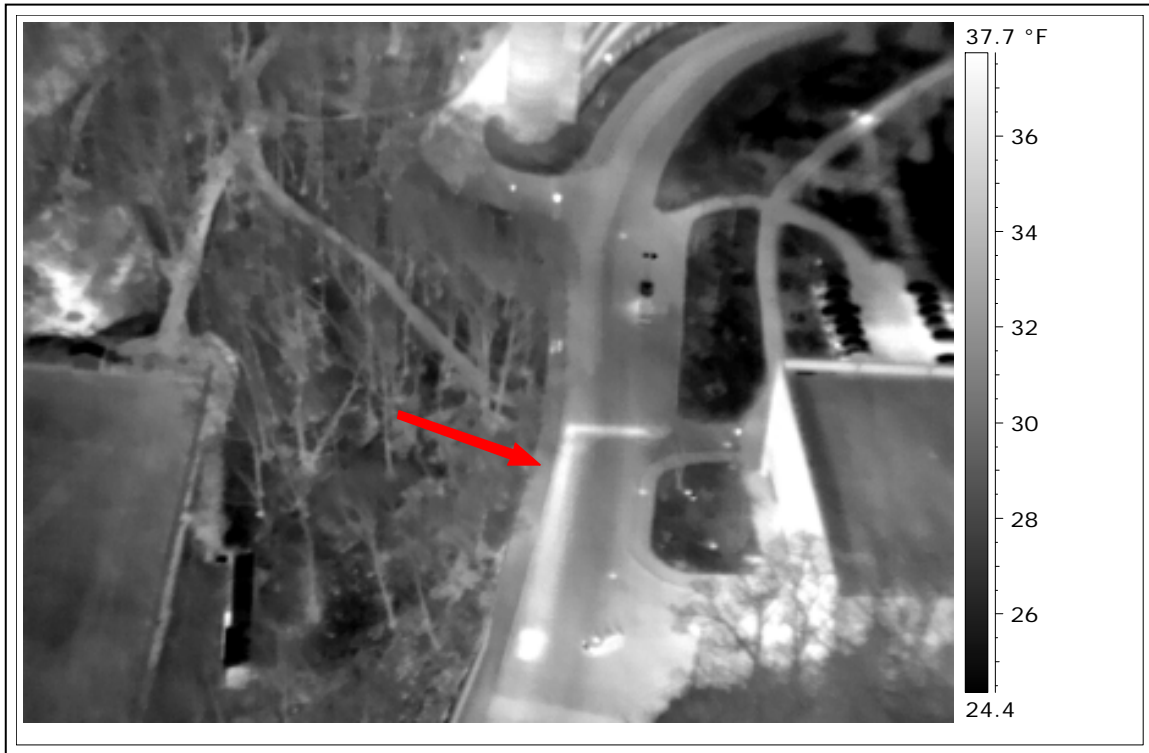
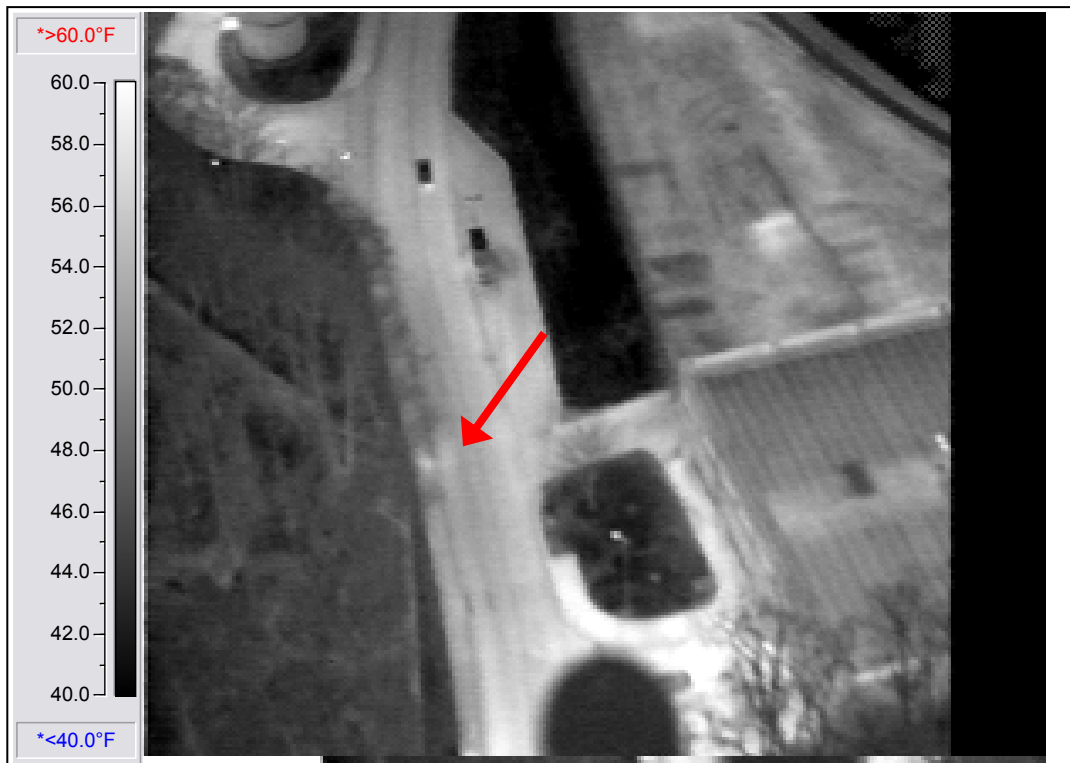
Comparative 2005 Image-Steam Lines are not visible.

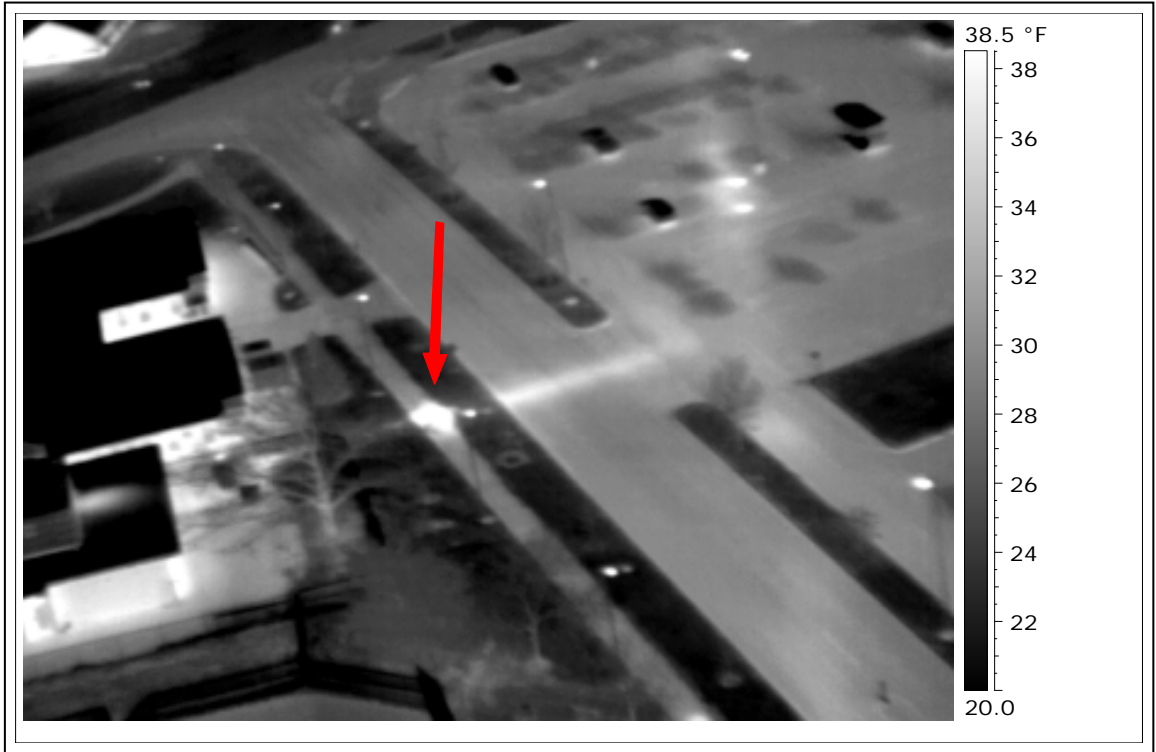
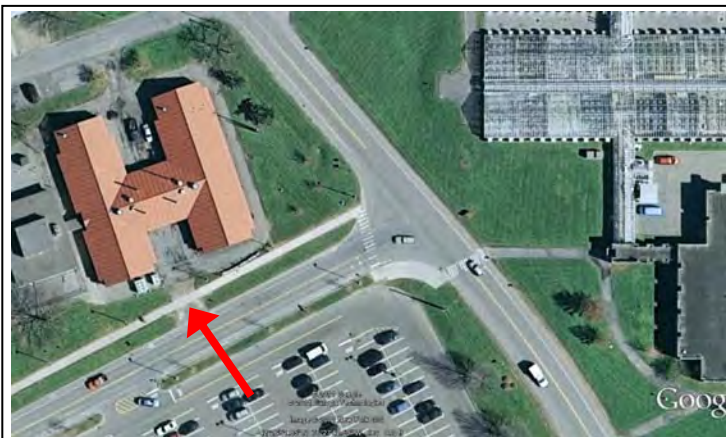
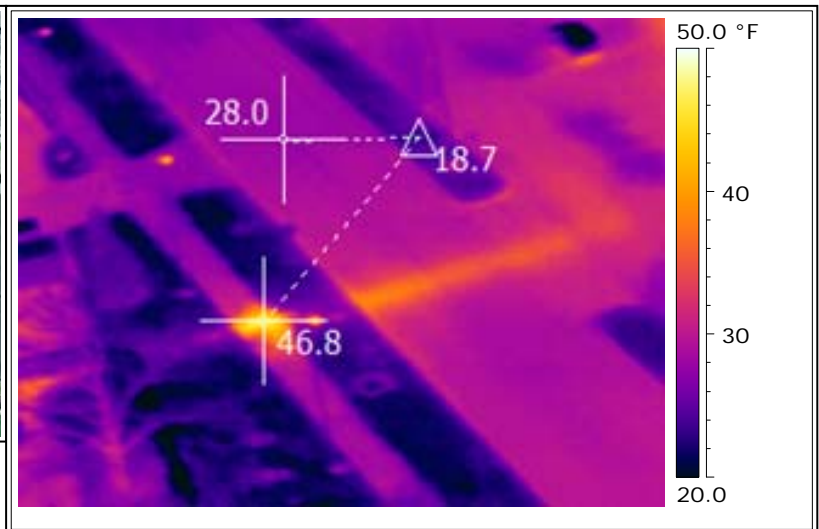
Problem # 2

Location:
Isolation Building, at sidewalk crossing

Analysis:
A well defined hot spot is present in the sidewalk. No heating was present here in prior surveys.

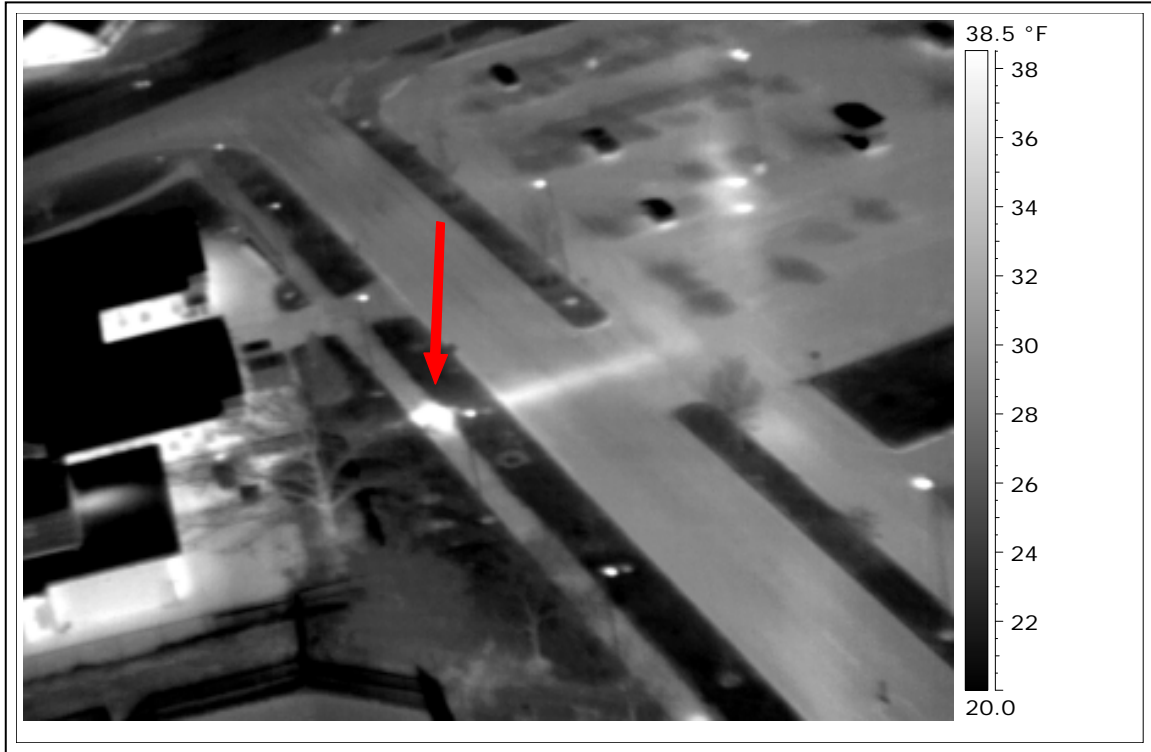
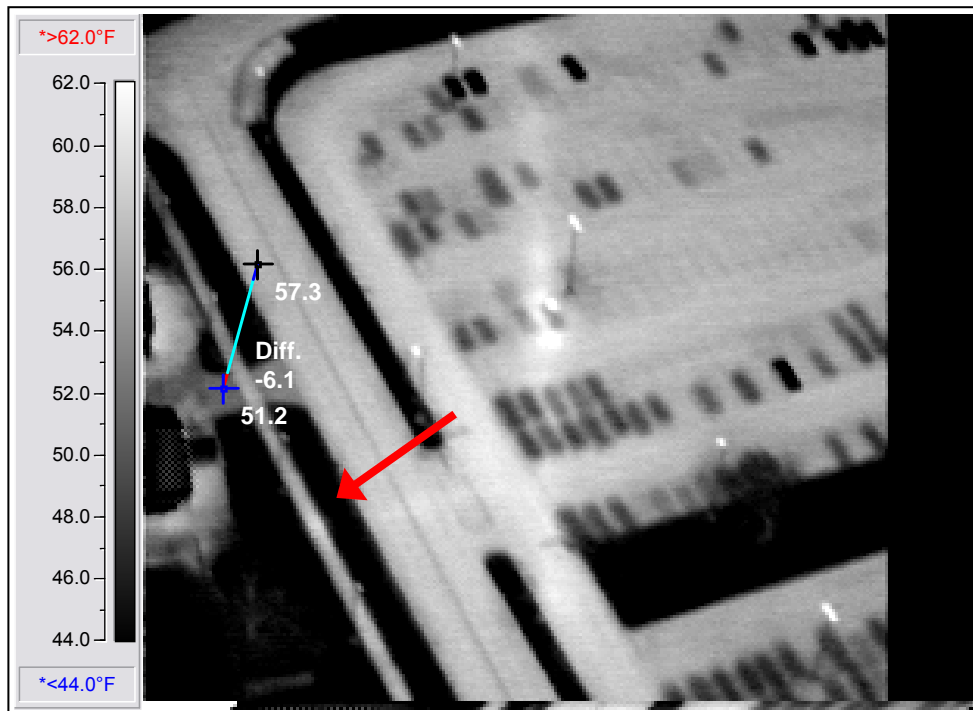
Comparative 2005 Image. The steam line to the Large Animal Isolation building is not visible.

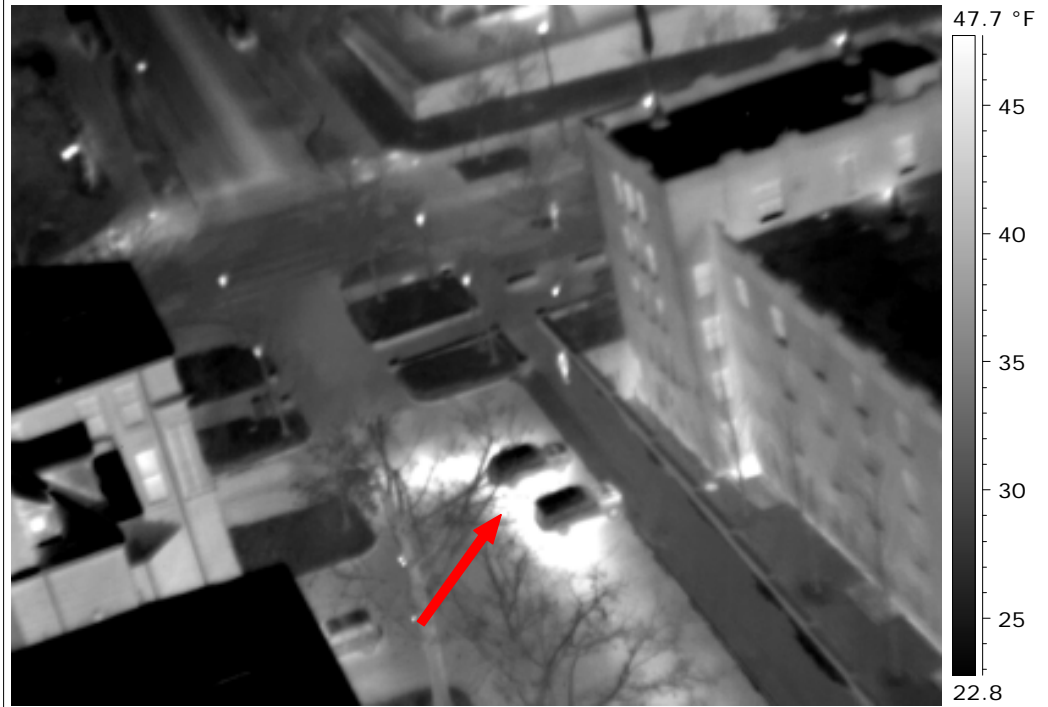
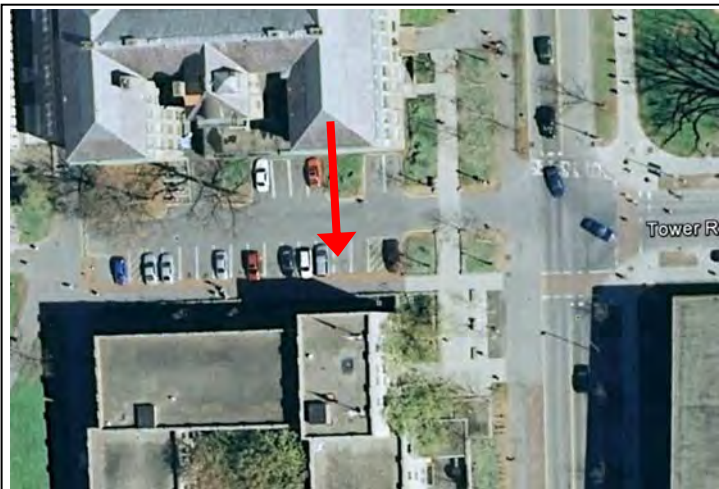
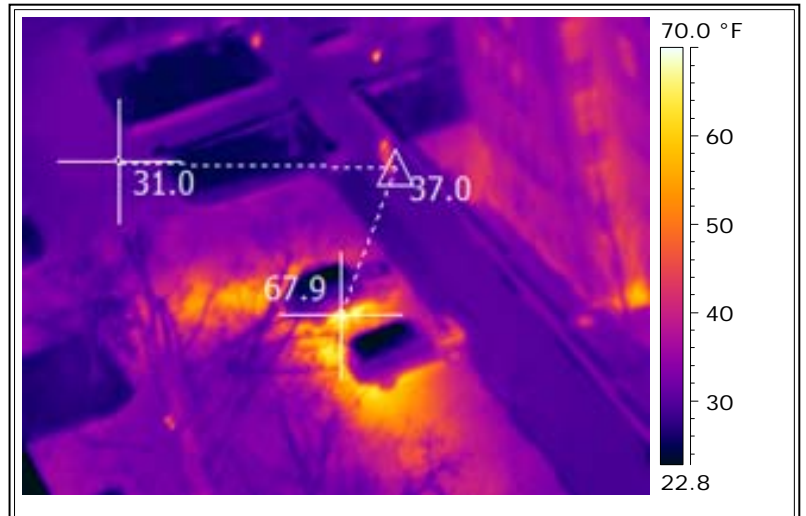
Problem # 3

Friend Hall at Lower Road

A large area with substantial heating is present here. This is a likely steam leak.

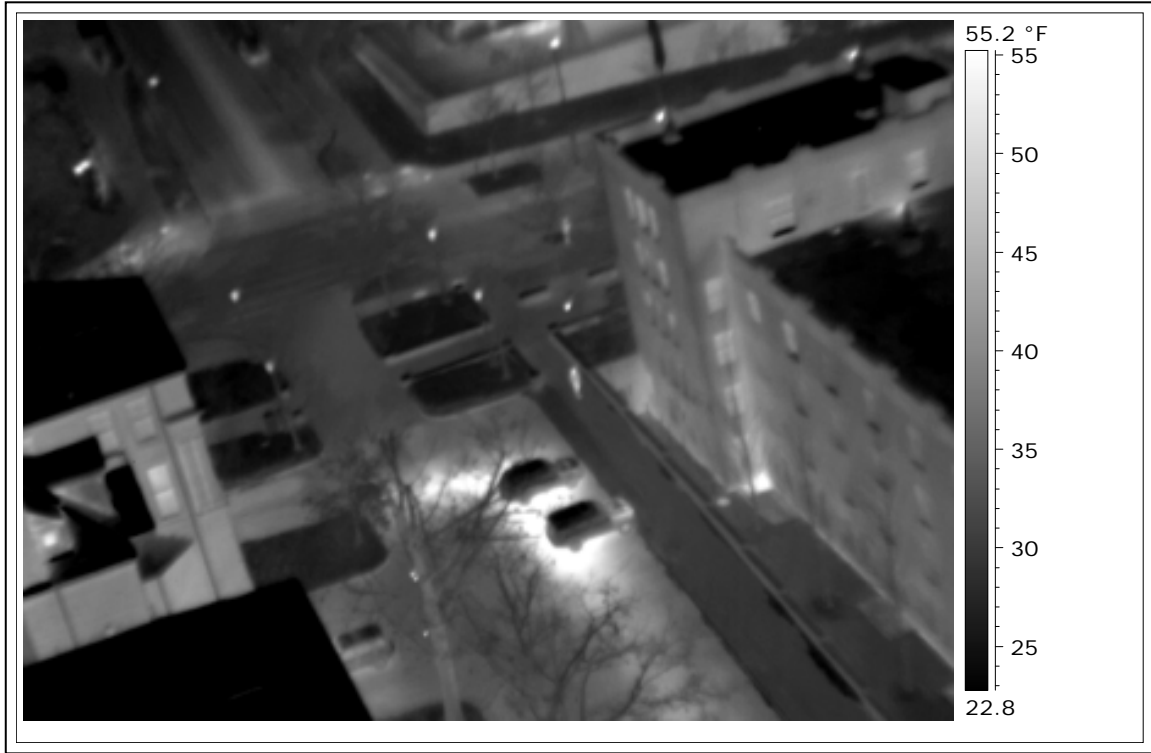
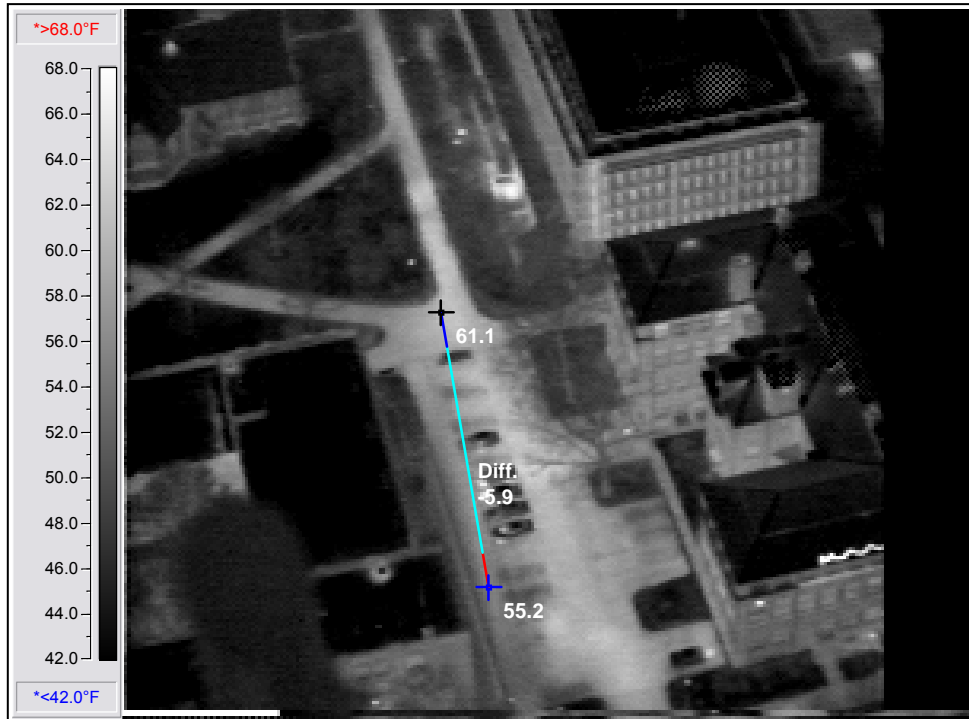
Comparative 2005 image. No heating is seen at the location of the current suspected leak. Note: Image angle is reversed 180° from present image.

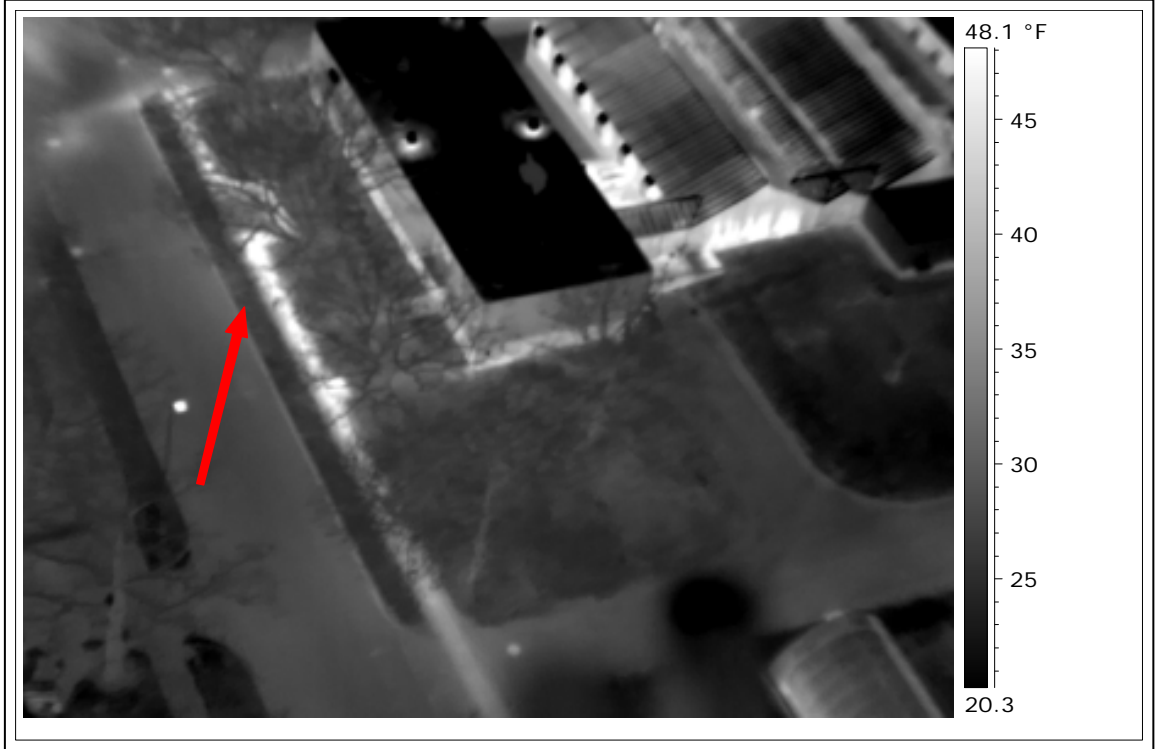
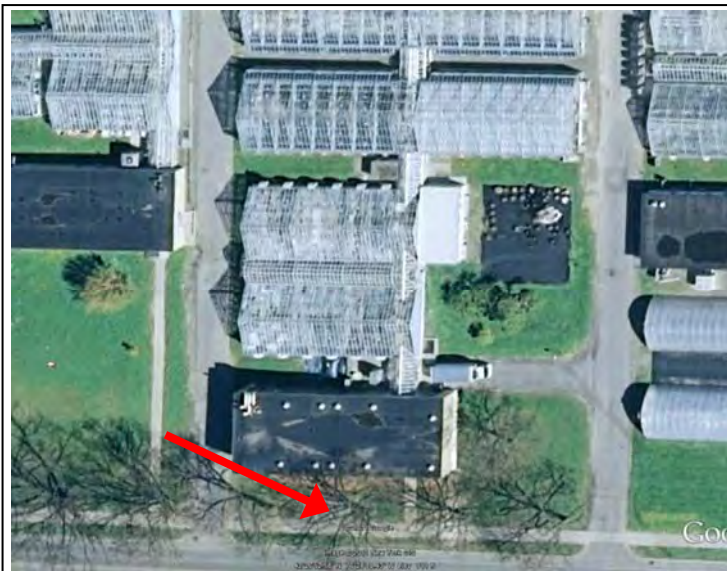
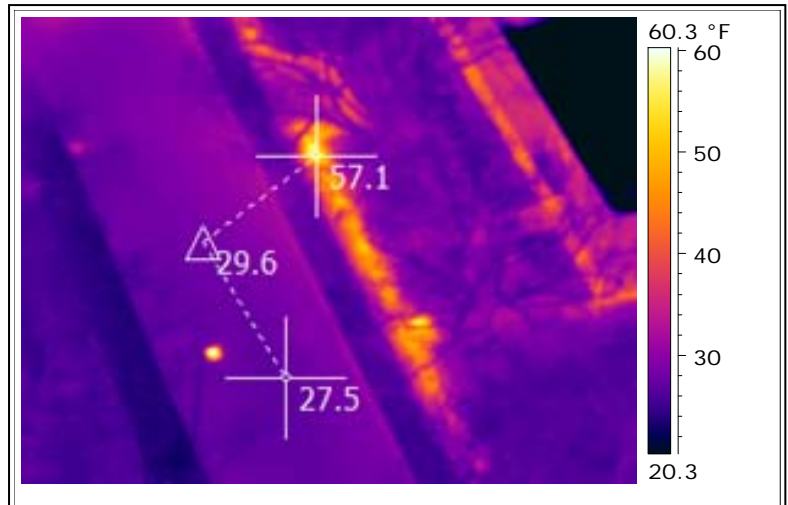
Problem # 5

Location:
Lab, at expansion loop

Analysis:
Significant heating occurs on the east side of the loop and extends past the end of the building. The image is obscured by adjacent trees. The line at the street is substantially cooler than the loop. The comparative picture on the next page shows the 2005 image. It is partially blocked by the helicopter skid, but shows little heating. A leak is likely here.

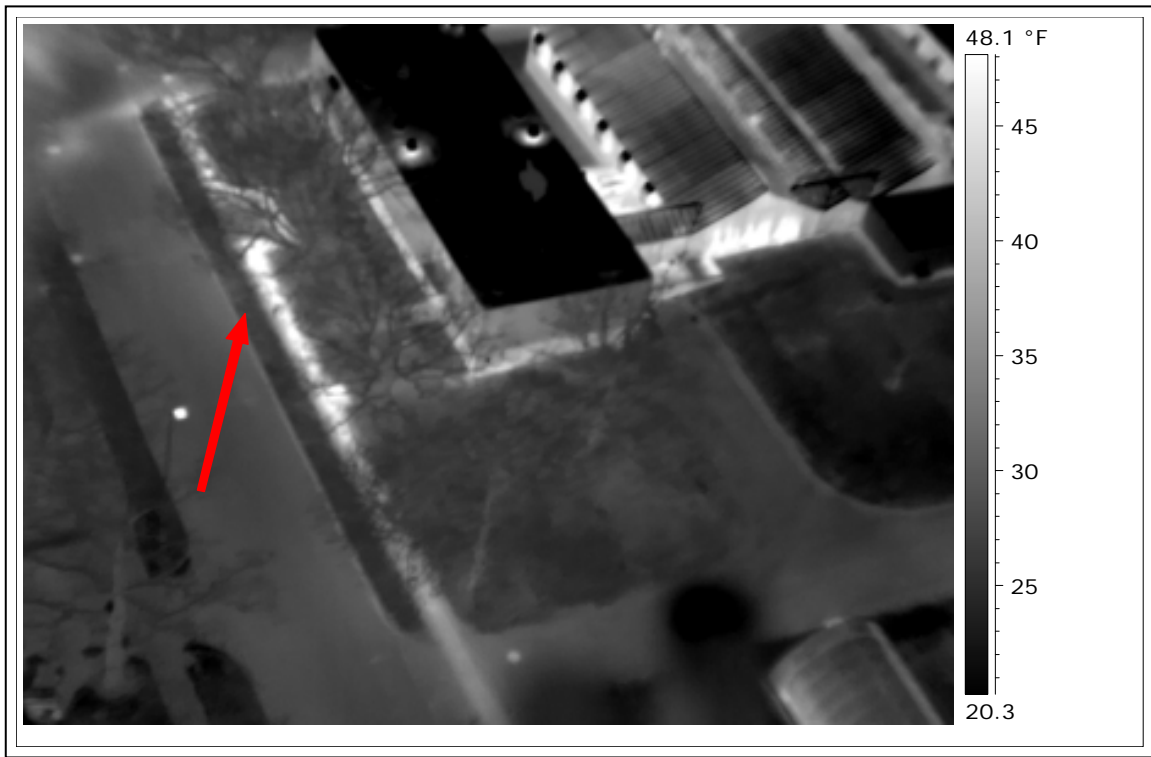
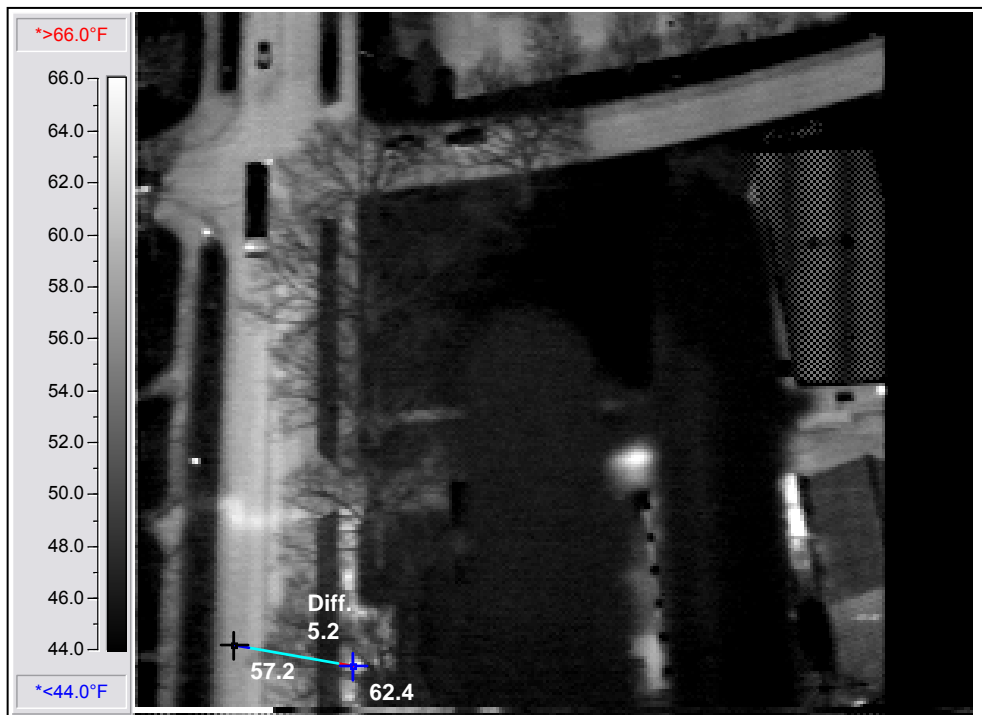
Comparative 2005 image shows minimal heating at the east side of the expansion loop.

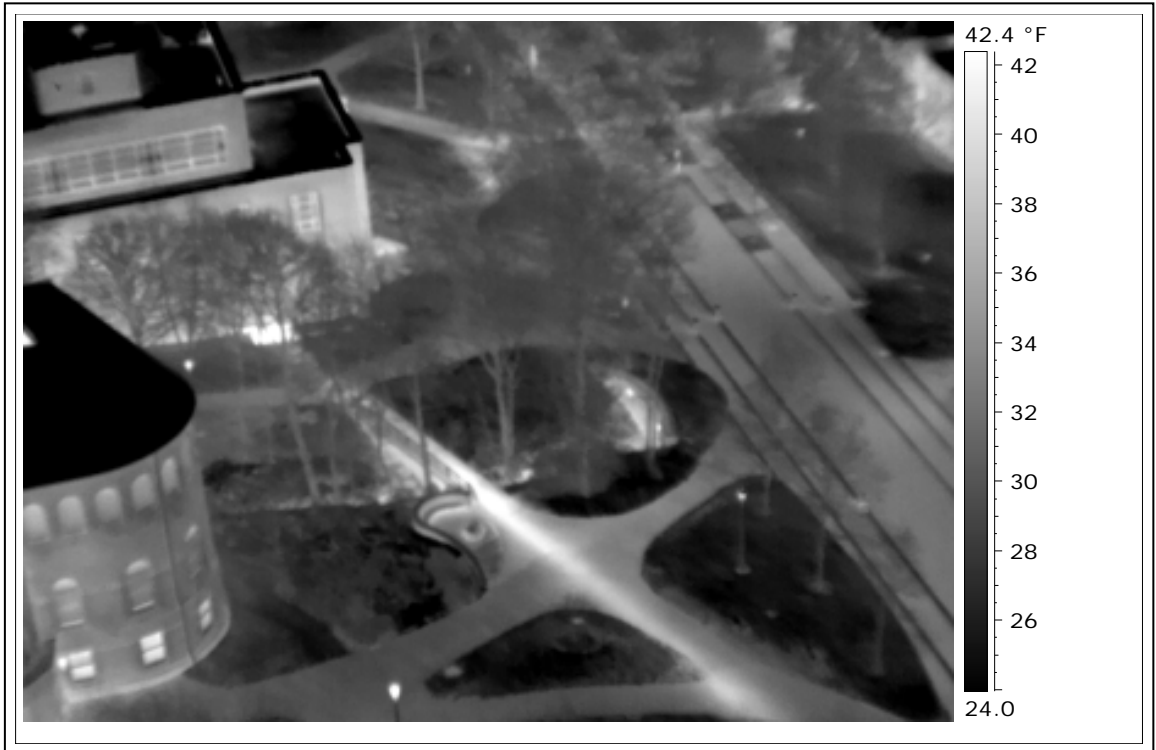
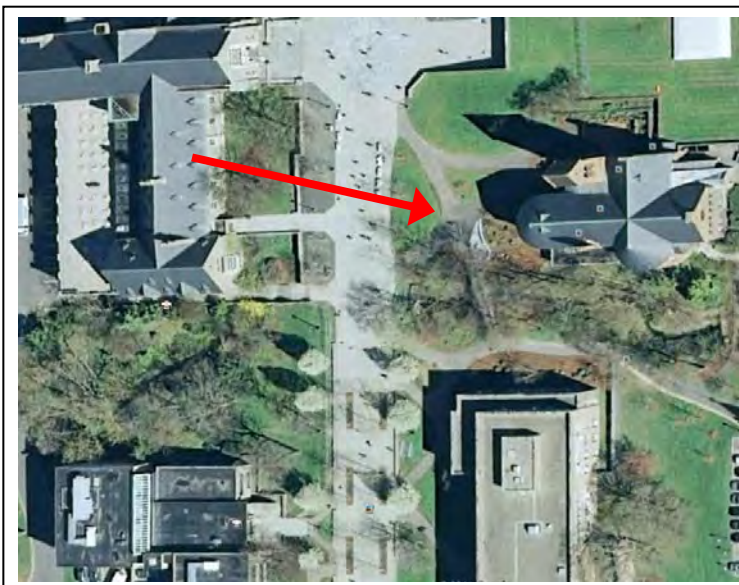
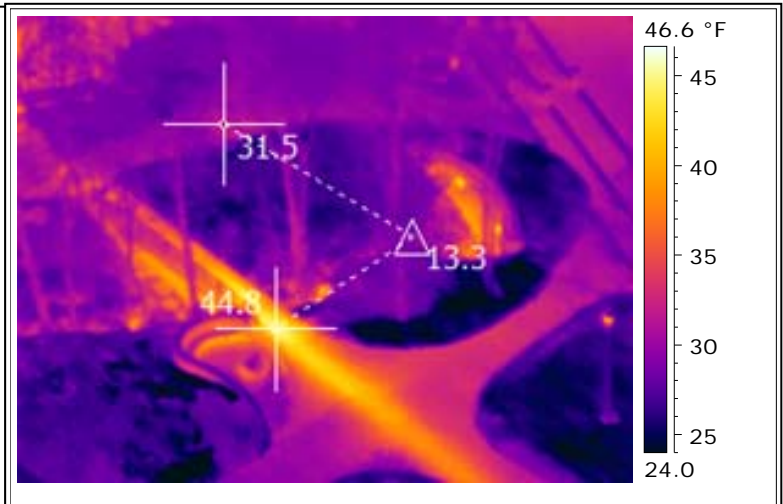
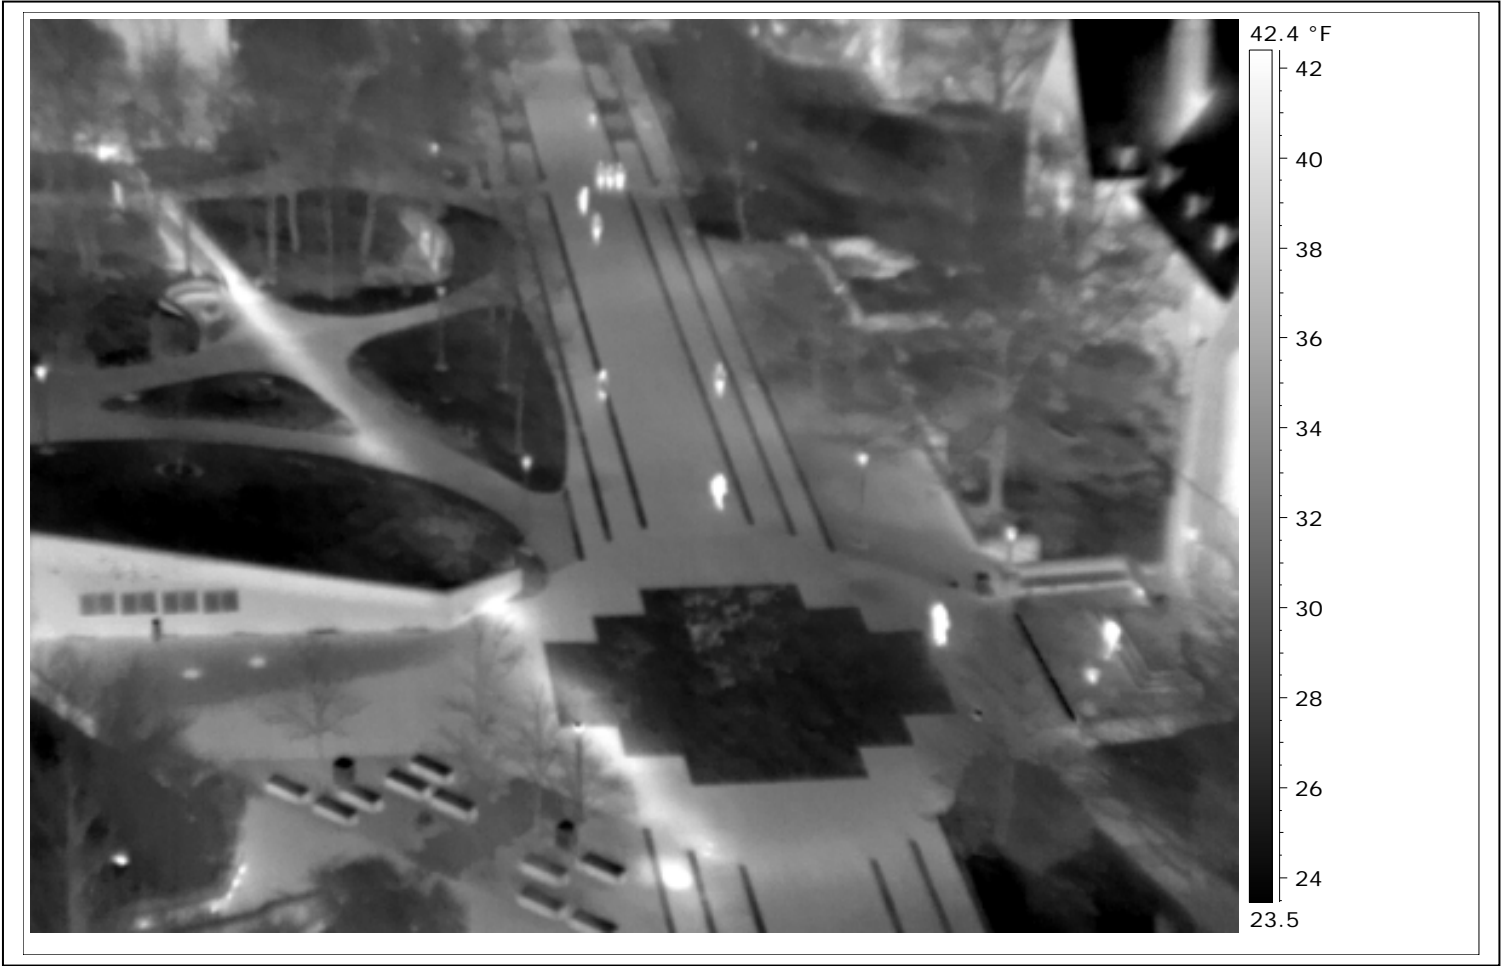
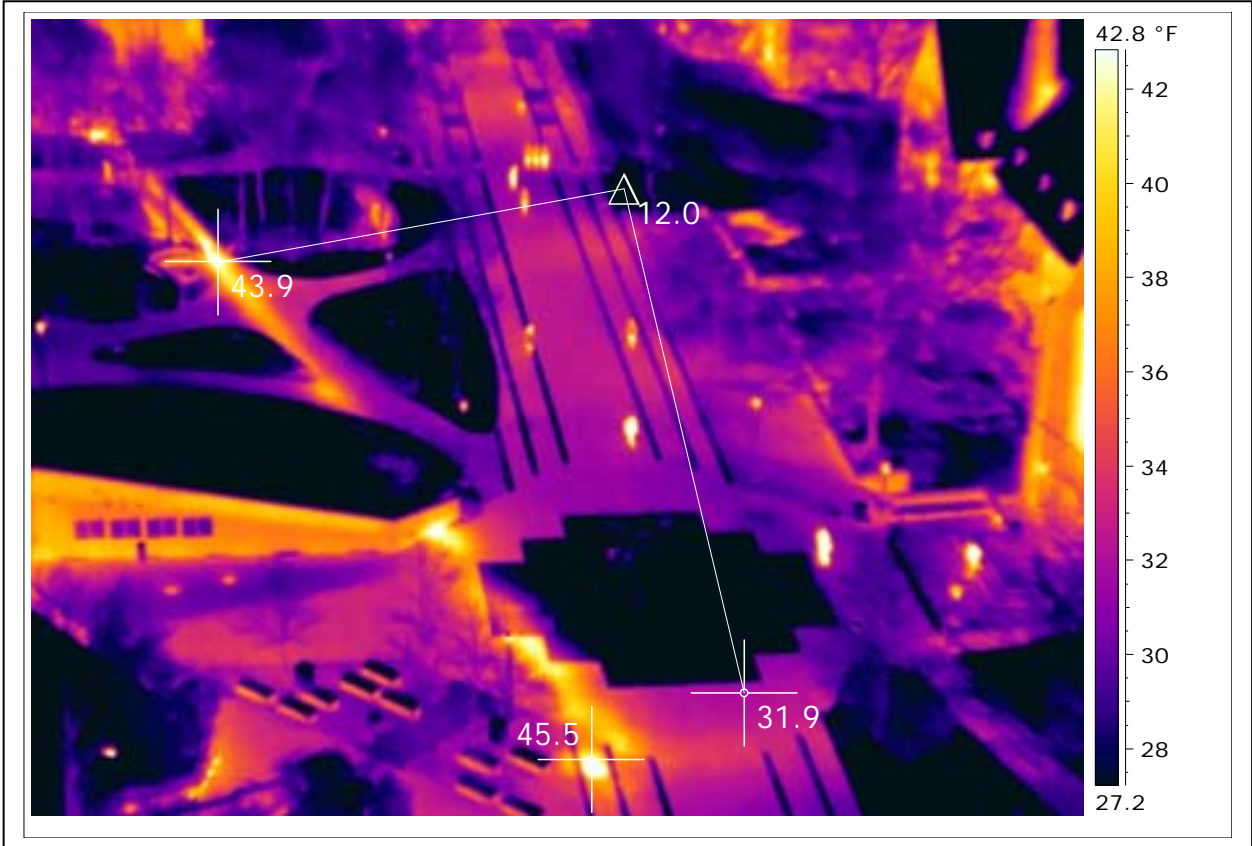
Problem # 6

Entire line segment from Fred Hall to manhole WS

In 2006, heating was noted at the courtyard between Will Hall and Page. The heating now extends up the line toward Olin hall, with the greatest heating adjacent to Barnes. The images on the following page show the entire length. This is followed by prior images of the line adjacent to Barnes.

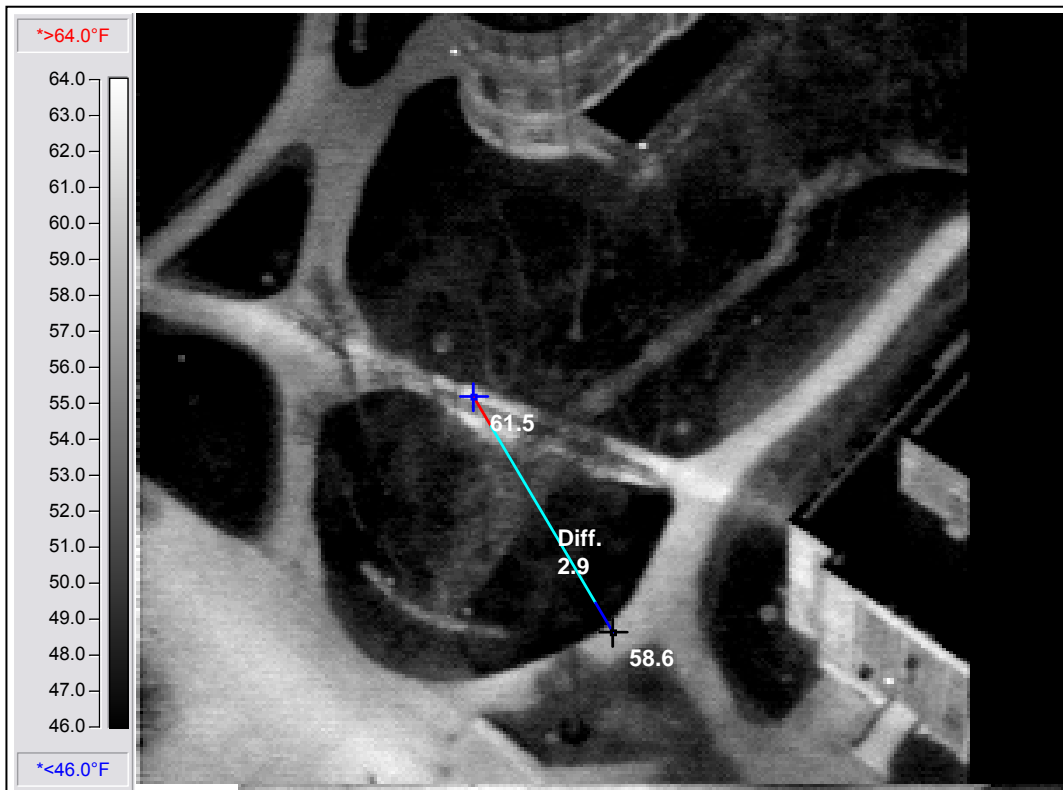
Comparative2005 image shows minor heating at the location of the present hot spot.

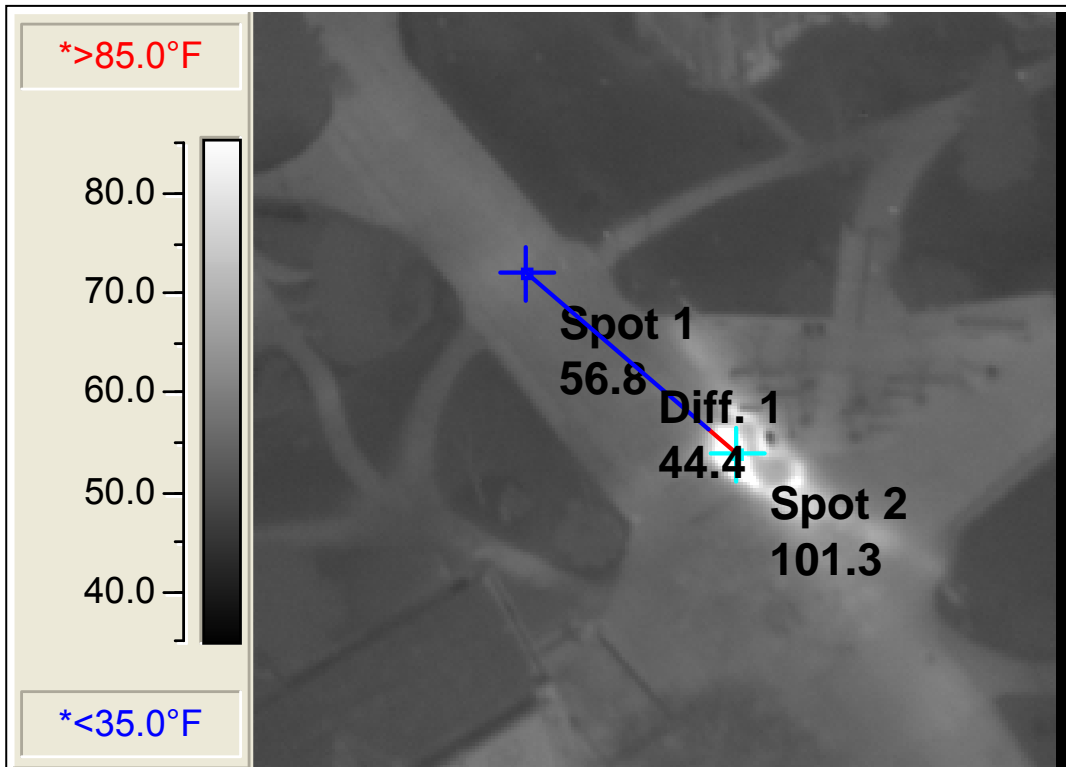
2006 image from Will Hall/ Page showing hot spot that was not present in 2005. Orientation of this image is reversed from the current problem views.

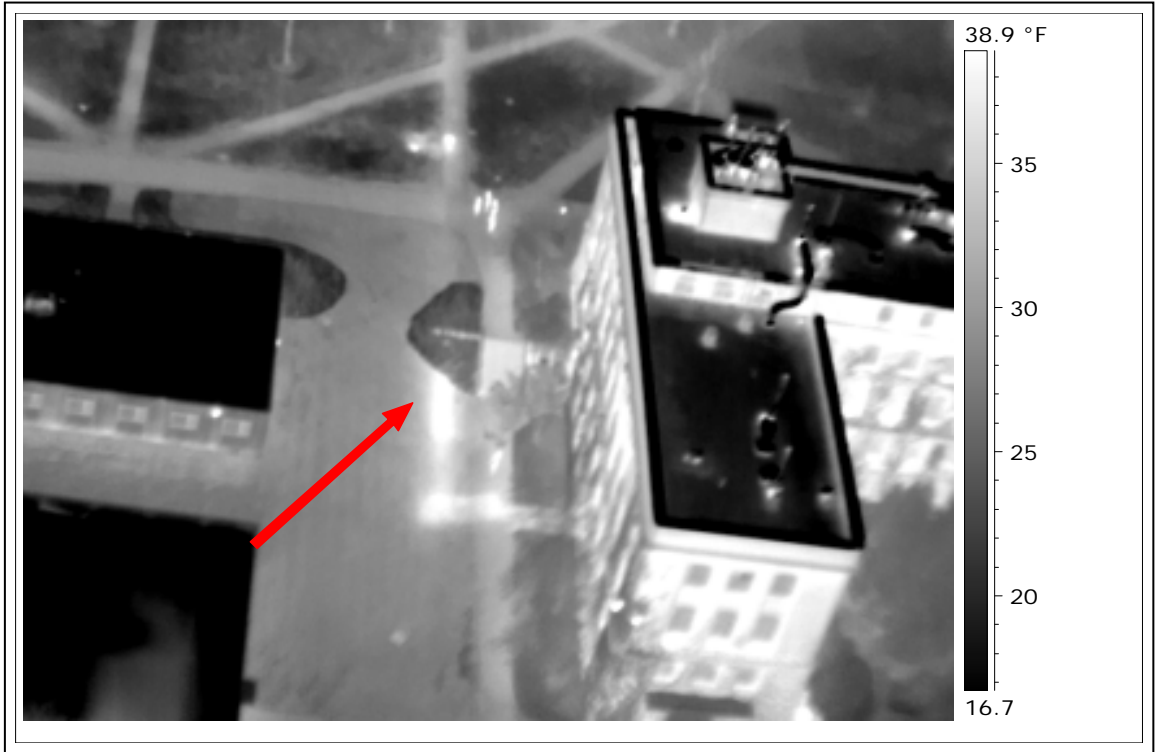
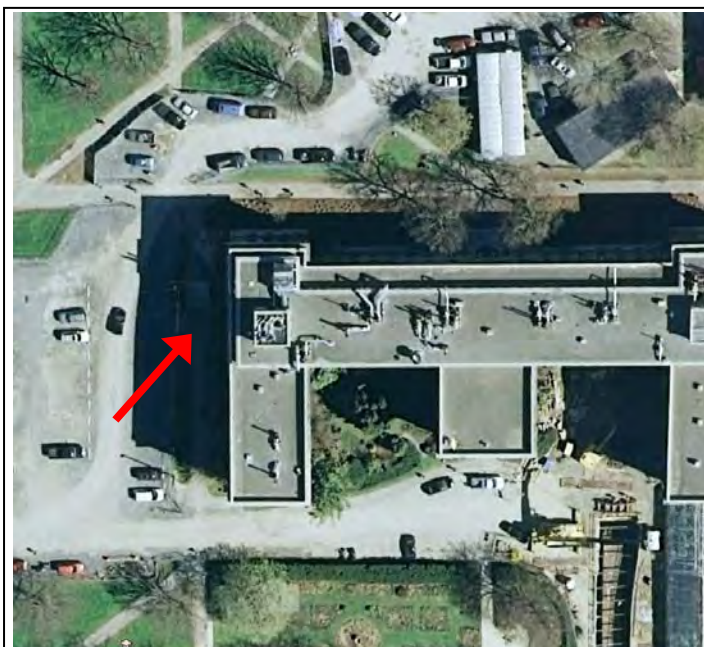
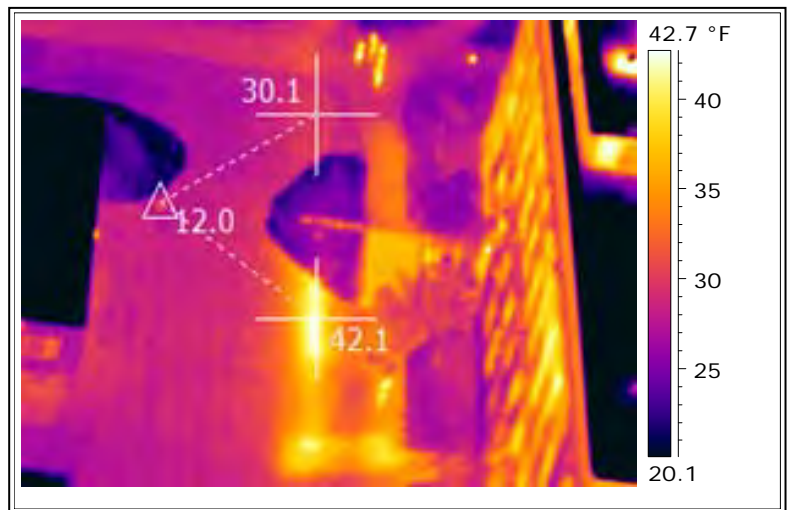
Problem #8

Location:
Science, West end

Analysis:
Prior to the line entrance into the building, a line segment is sharply warmer than the segment just to the north. A minor steam leak or a condensate leak may be present here.

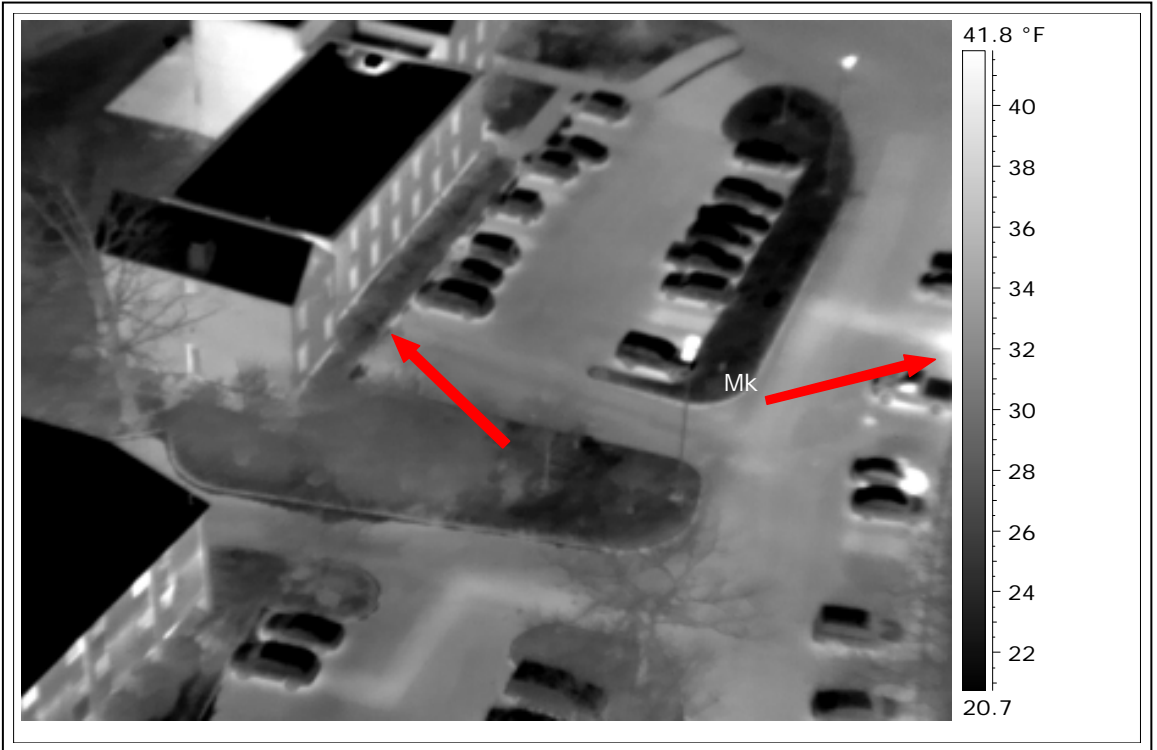
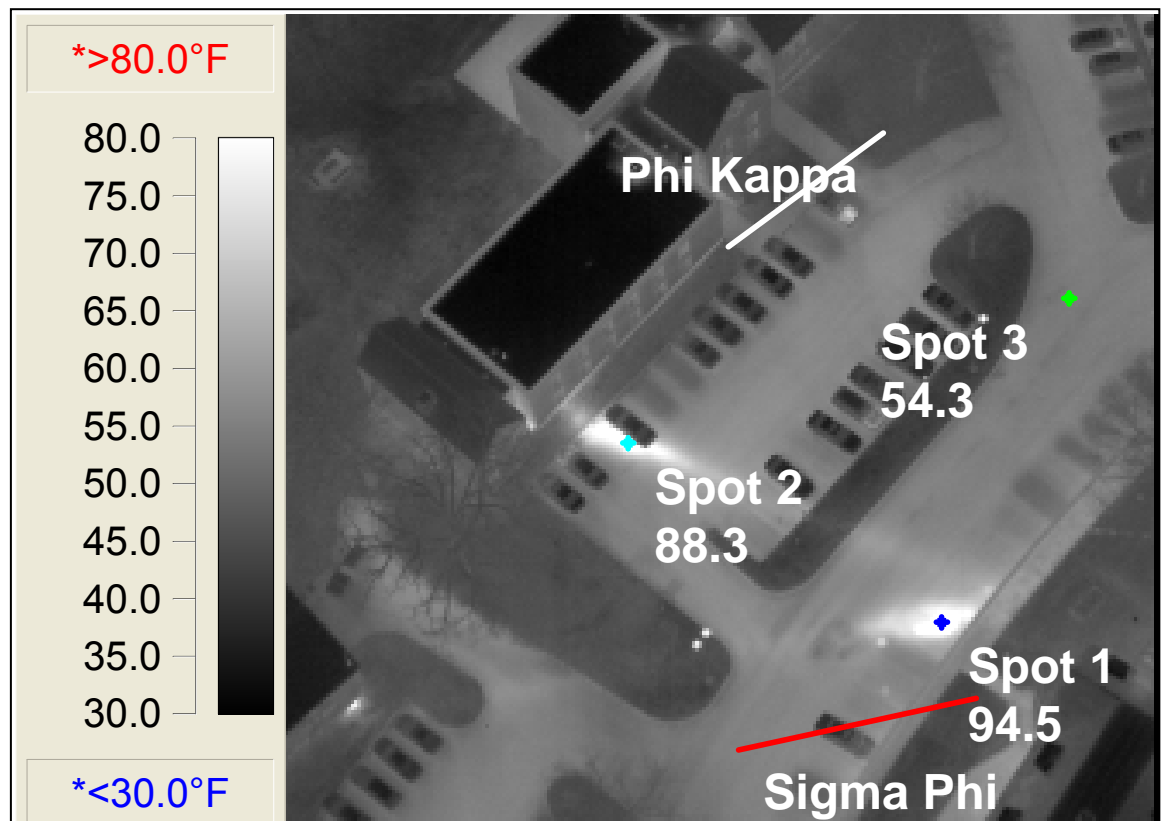
Problem #9

Location:
Kappa Kappa and
Sigma Tau

Analysis:
Two leaks were found
here in the 2005
survey. The image
from that survey is
shown in the lower
image. The upper
image shows the
results of repairs.
