Aerial Steam System Report

CLIENT: LARGE UNIVERSITY

DATE: November 28, 2011

SUBJECT: Aerial Infrared Steam System Survey

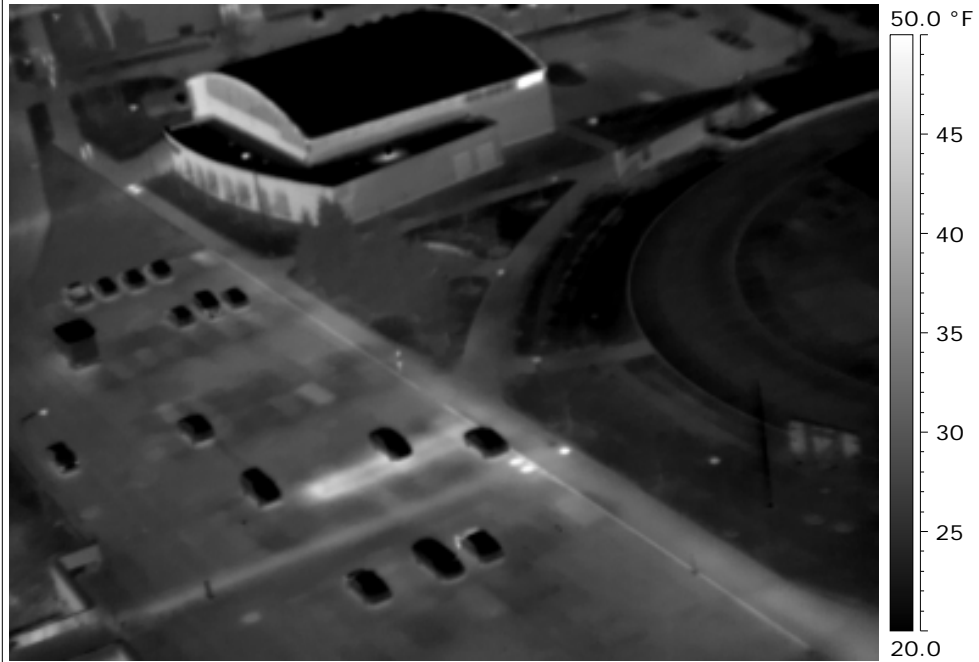
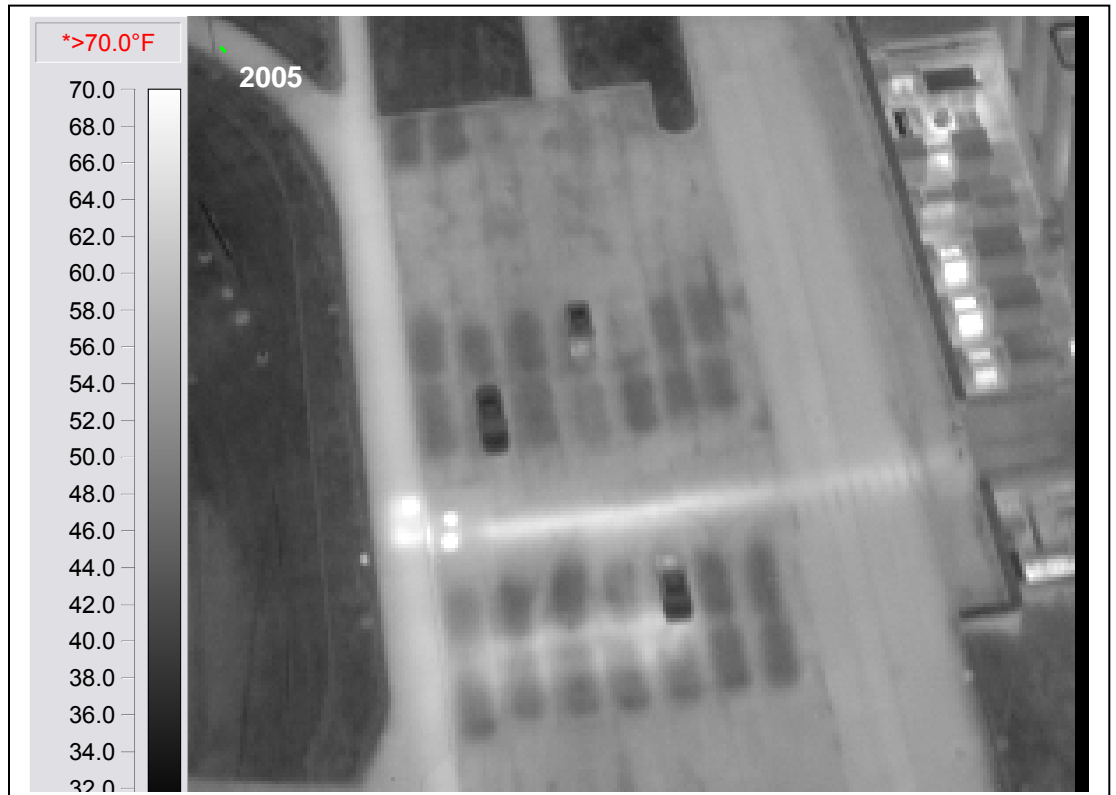
Problem #10

Line to Nelson

The condensate leak formerly noted in the line to Nelson is now repaired. The line of elevated heating beneath the parked cars is an expansion loop.
