Roof Testing Report

SUBJECT: Roof evaluation of Oak Grove Square

This document presents the results of our inspection of the roof at Oak Grove Square, located at the above address. The objective of the inspection was to locate and recommend remedial actions for deficiencies in the roofing system.

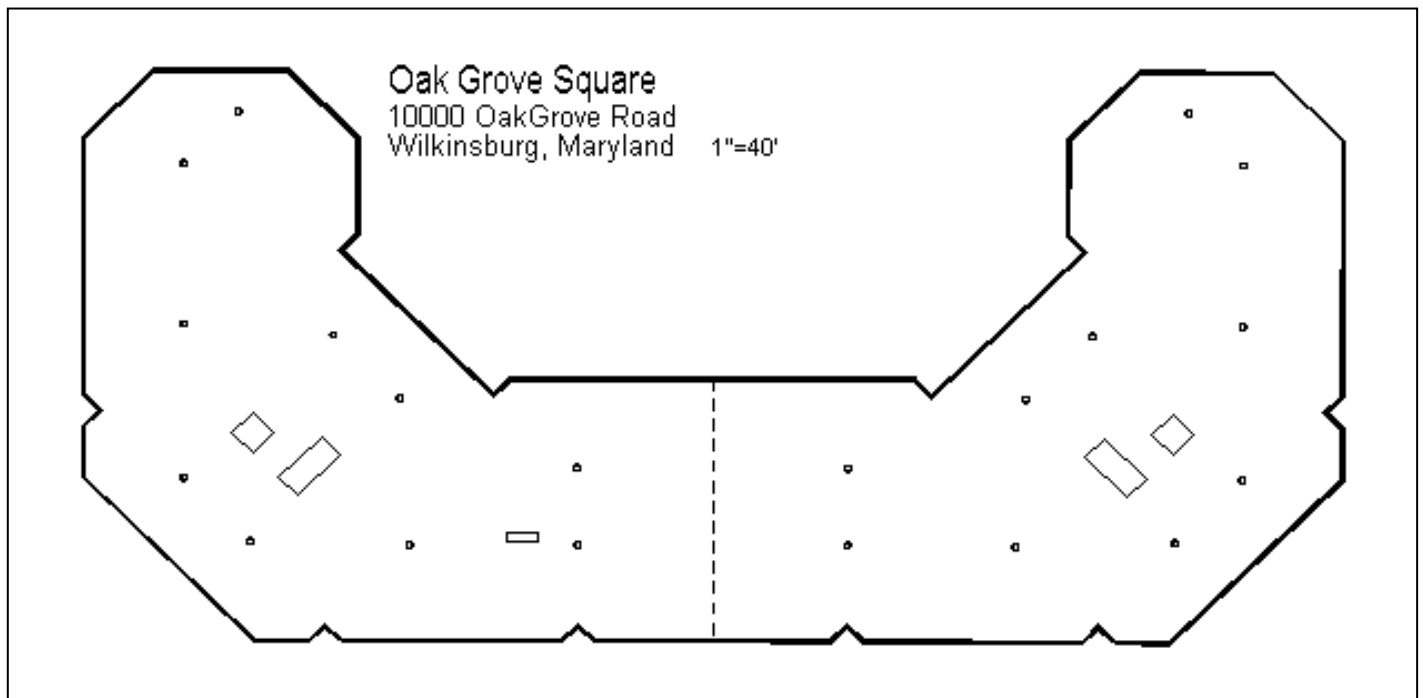
The infrared test identified a total of eight wet areas. Moisture levels varied in these areas as indicated both the temperature of the images (seen at the end of this section) and the nuclear readings. The maximum nuclear reading and approximate size for each area is as follows:

Wet Area	Nuclear Reading	Approximate Area (ft2)	Leak Source
1	79	1052	Likely membrane defects, membrane split and hole at lead drain flashing
2	41	126	Likely membrane defect
3	44	18	Likely membrane defect
4	34	8	Hole in membrane
5	57	123	Hole in membrane
6	61	1081	Prior major split
7	53	157	Likely membrane defect
8	46	10	Drain flashing open

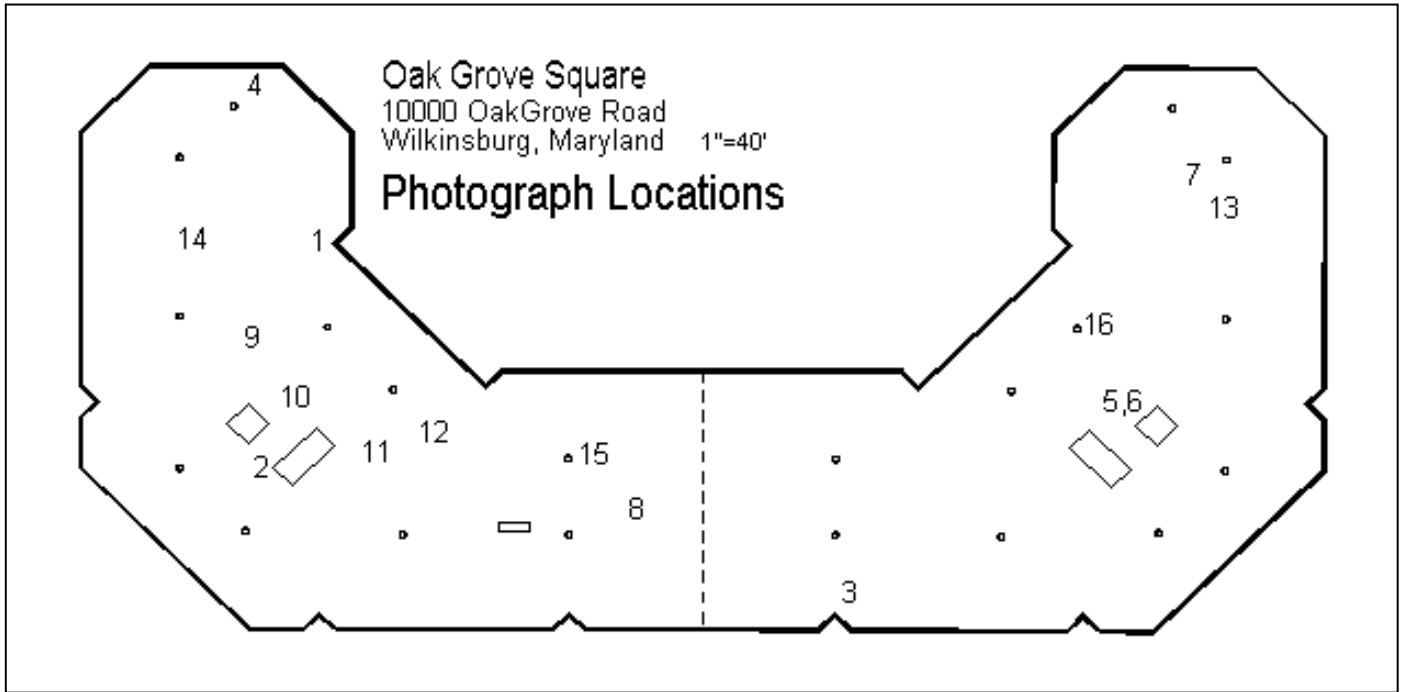
Photographs

The elevator penthouse are drained through scuppers. The scuppers are formed from lead drain flashings. These scuppers are improperly formed and sealed. Open gaps are visible in the gravel stops under the edges of the lead scuppers. If the penthouse walls are block construction, water can flow down the blocks. This may explain the presence of water trapped behind some of the elevator penthouse flashings (see photograph 2).
