# Roof Testing Report

**CLIENT:** ENLIGHTENED MANAGEMENT, INC.

**DATE:** May 25, 2010

**SUBJECT:** Roof evaluation of Oak Grove Square

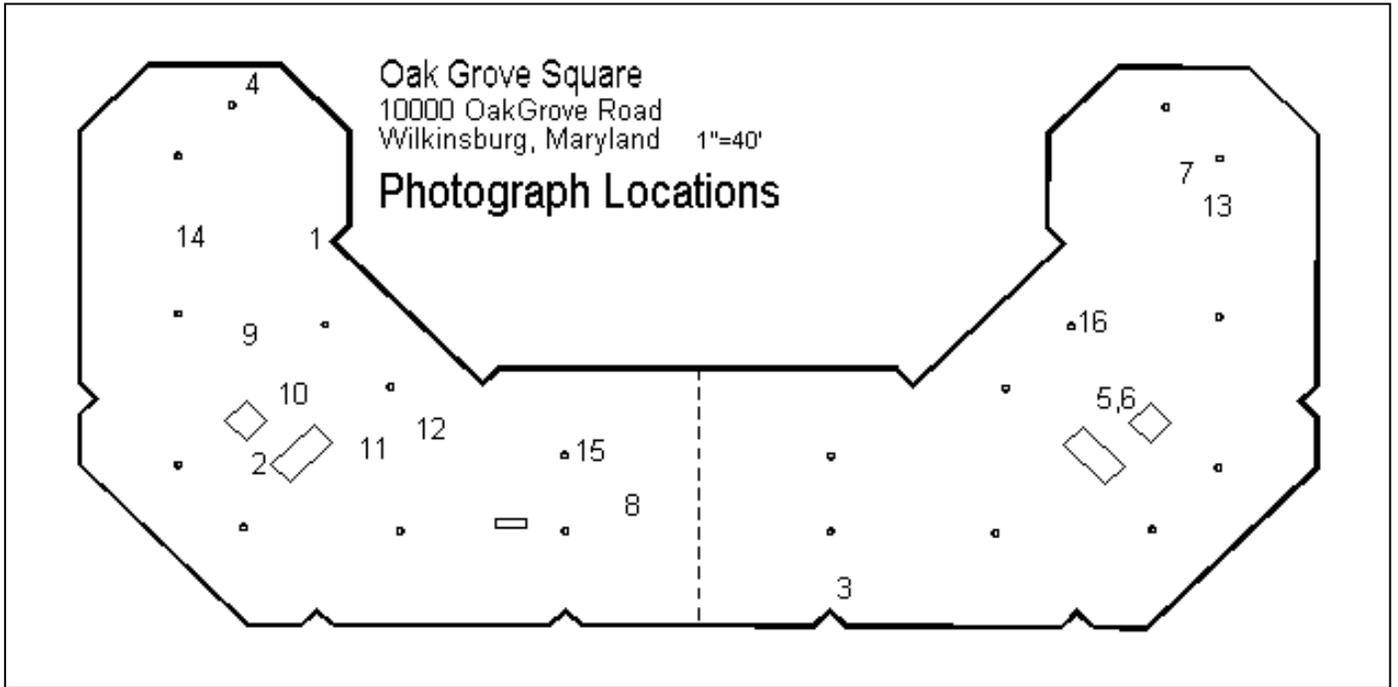
The elevator penthouse are drained through scuppers. The scuppers are formed from lead drain flashings. These scuppers are improperly formed and sealed. Open gaps are visible in the gravel stops under the edges of the lead scuppers. If the penthouse walls are block construction, water can flow down the blocks. This may explain the presence of water trapped behind some of the elevator penthouse flashings (see photograph 2).
