Big Strides in Refractory Management: Improved Infrared Hardware and Software

Stephen A. Seeber
President
Mid Atlantic Infrared Services, Inc.
5309 Mohican Road
Bethesda, MD 20816

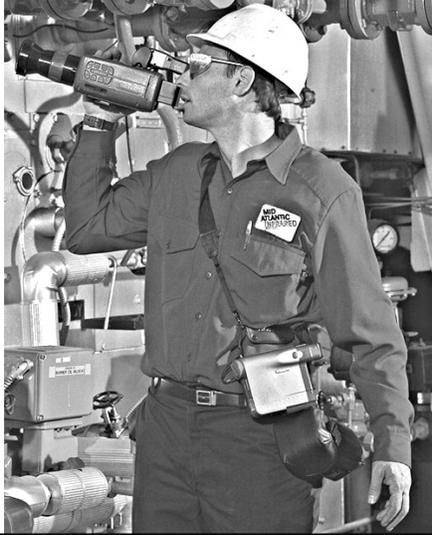
Figure 1 shows all of the equipment required to perform a comprehensive survey: the imager, a telescope and wide angle lens (worn on belt) and a digital camera. The entire set of equipment weighs approximately 12 pounds.

Figure 1: Inframetrics Thermo-cam, digital camera and lenses

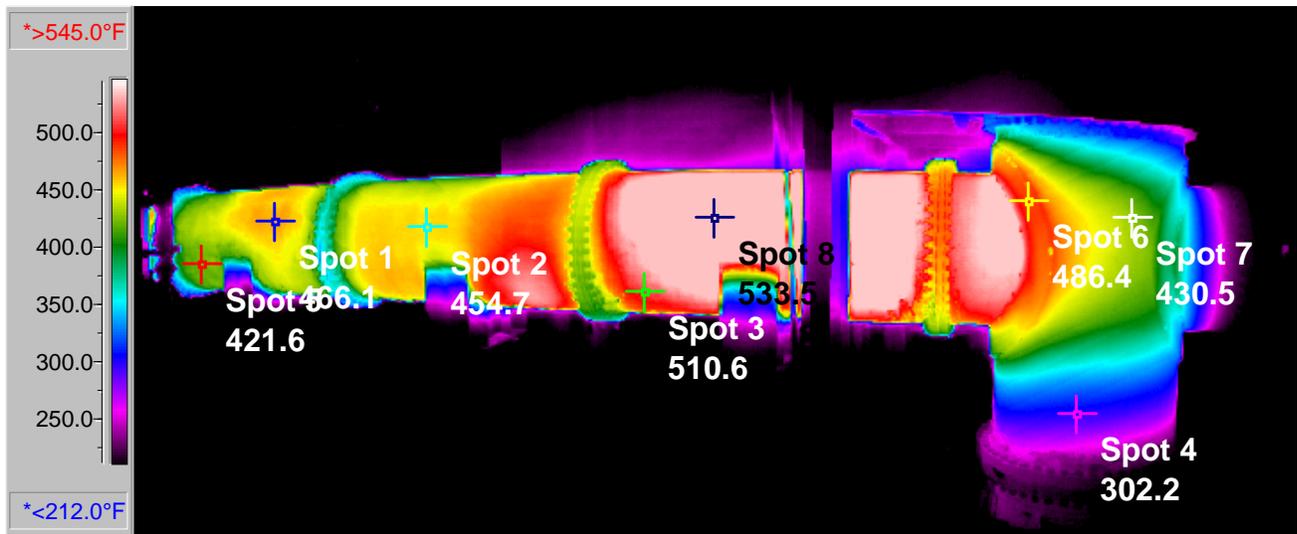
Figure 2 shows a mosaic image of a refractory lined duct. The image consists of 4 individual images. The gradual temperature changes across the entire structure can be readily assessed in a single picture. This greatly facilitates present and future analysis.

Figure 2: Insulated duct, 60' across, four images in mosaic

At least one instrument vendor has effectively solved the problem of showing a continuous large surface. The vendor has developed software that “mosaics” the individual images. The mosaic process operates by joining adjacent infrared images at three user selected “handles” on each image. A total of 16 images (a four image by four image array) can be joined into a single, continuous infrared picture. The software automatically adjusts the temperature span of the individual images to provide a single range for the entire picture. Although a large area is shown, the spatial resolution of the original images is retained. Any area of interest can be readily resized for closer study. Finally, image subtraction may be used to compare temperature changes between the large image areas over time.
